EXECUTIVE SUMMARY

Report Objectives. GNS Science (GNS) and URS Corp NZ Ltd. are presently engaged by Hauraki District Council (HDC) to review the 2002 GNS report, and if appropriate to extend the sink hole risk assessment methodology to the Martha Lodes, and to report on the ground cracking now being observed outside the sink-hole subsidence hazard zones outlined in 2002.

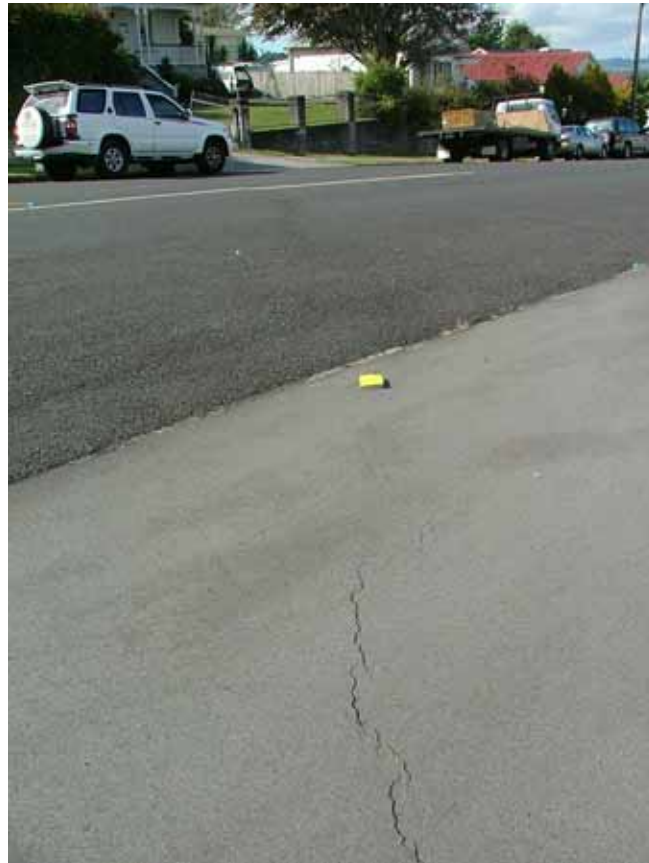
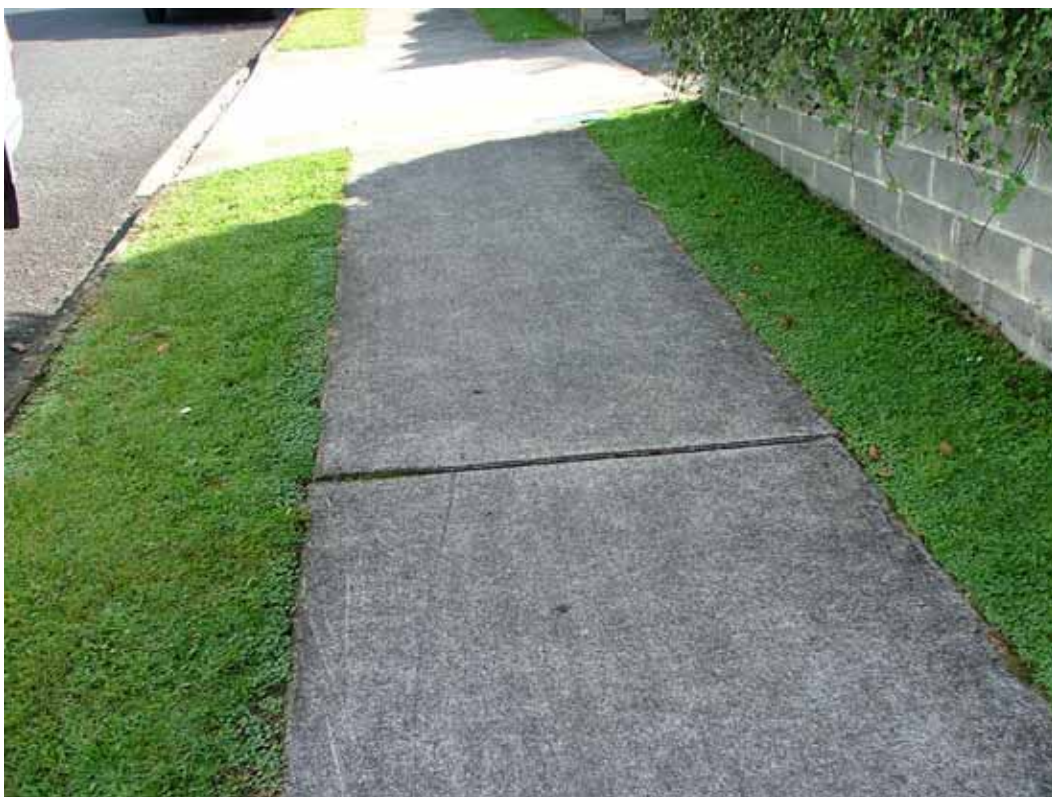
Photos 1&2 Cracking in Haszard Street with an unusual north (pit wall) side up and small right lateral component, suggestive of large “block” movement on a through-going rock mass defect.

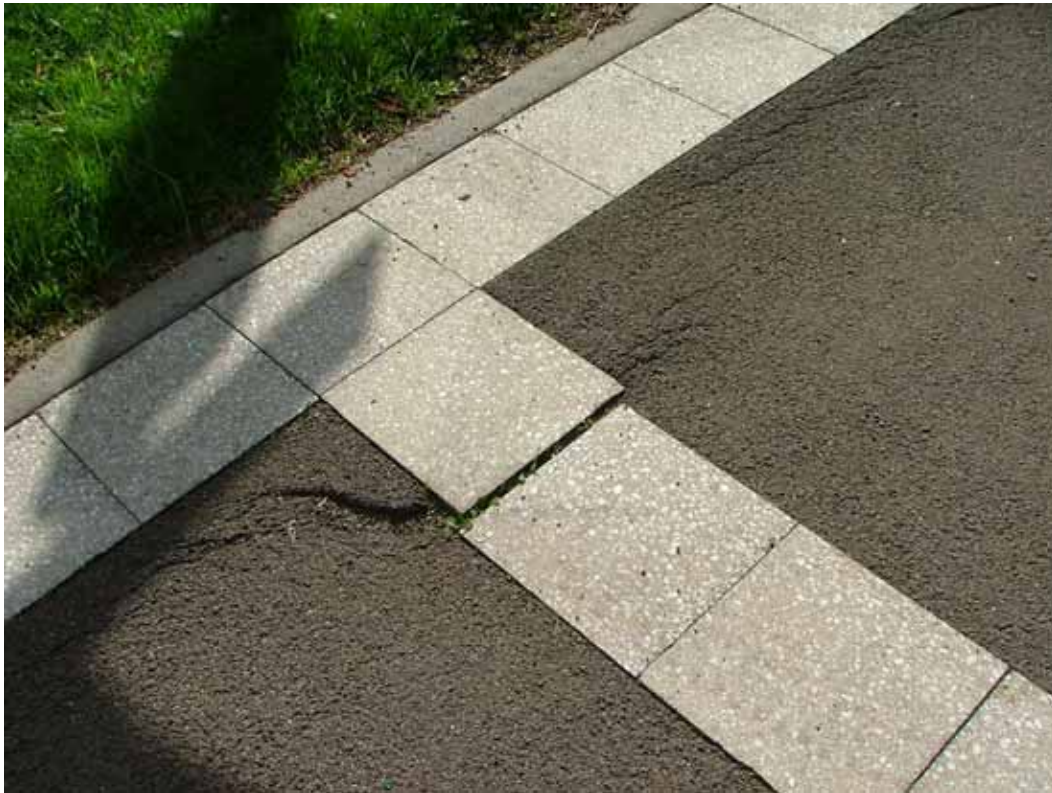
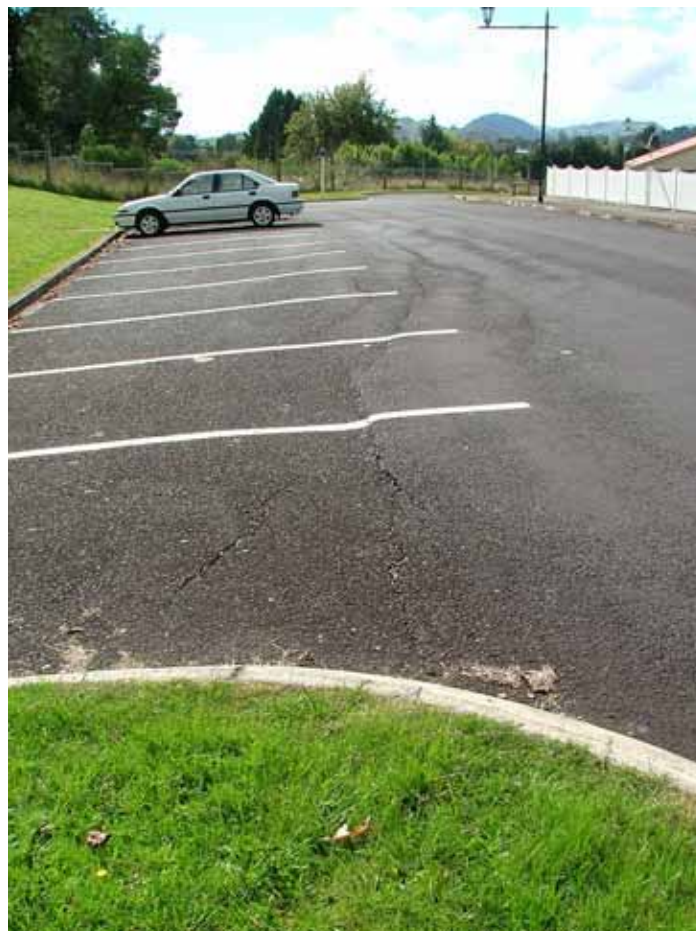
Photos 3&4 Cracking in Seddon Street appears to be extensional but also has a small right lateral component of movement in the pavement above.
