# Dewatering and Settlement Monitoring Report

Document Reference: WAI-200-REP-007-004

## DEWATERING & SETTLEMENT MONITORING REPORT 2020

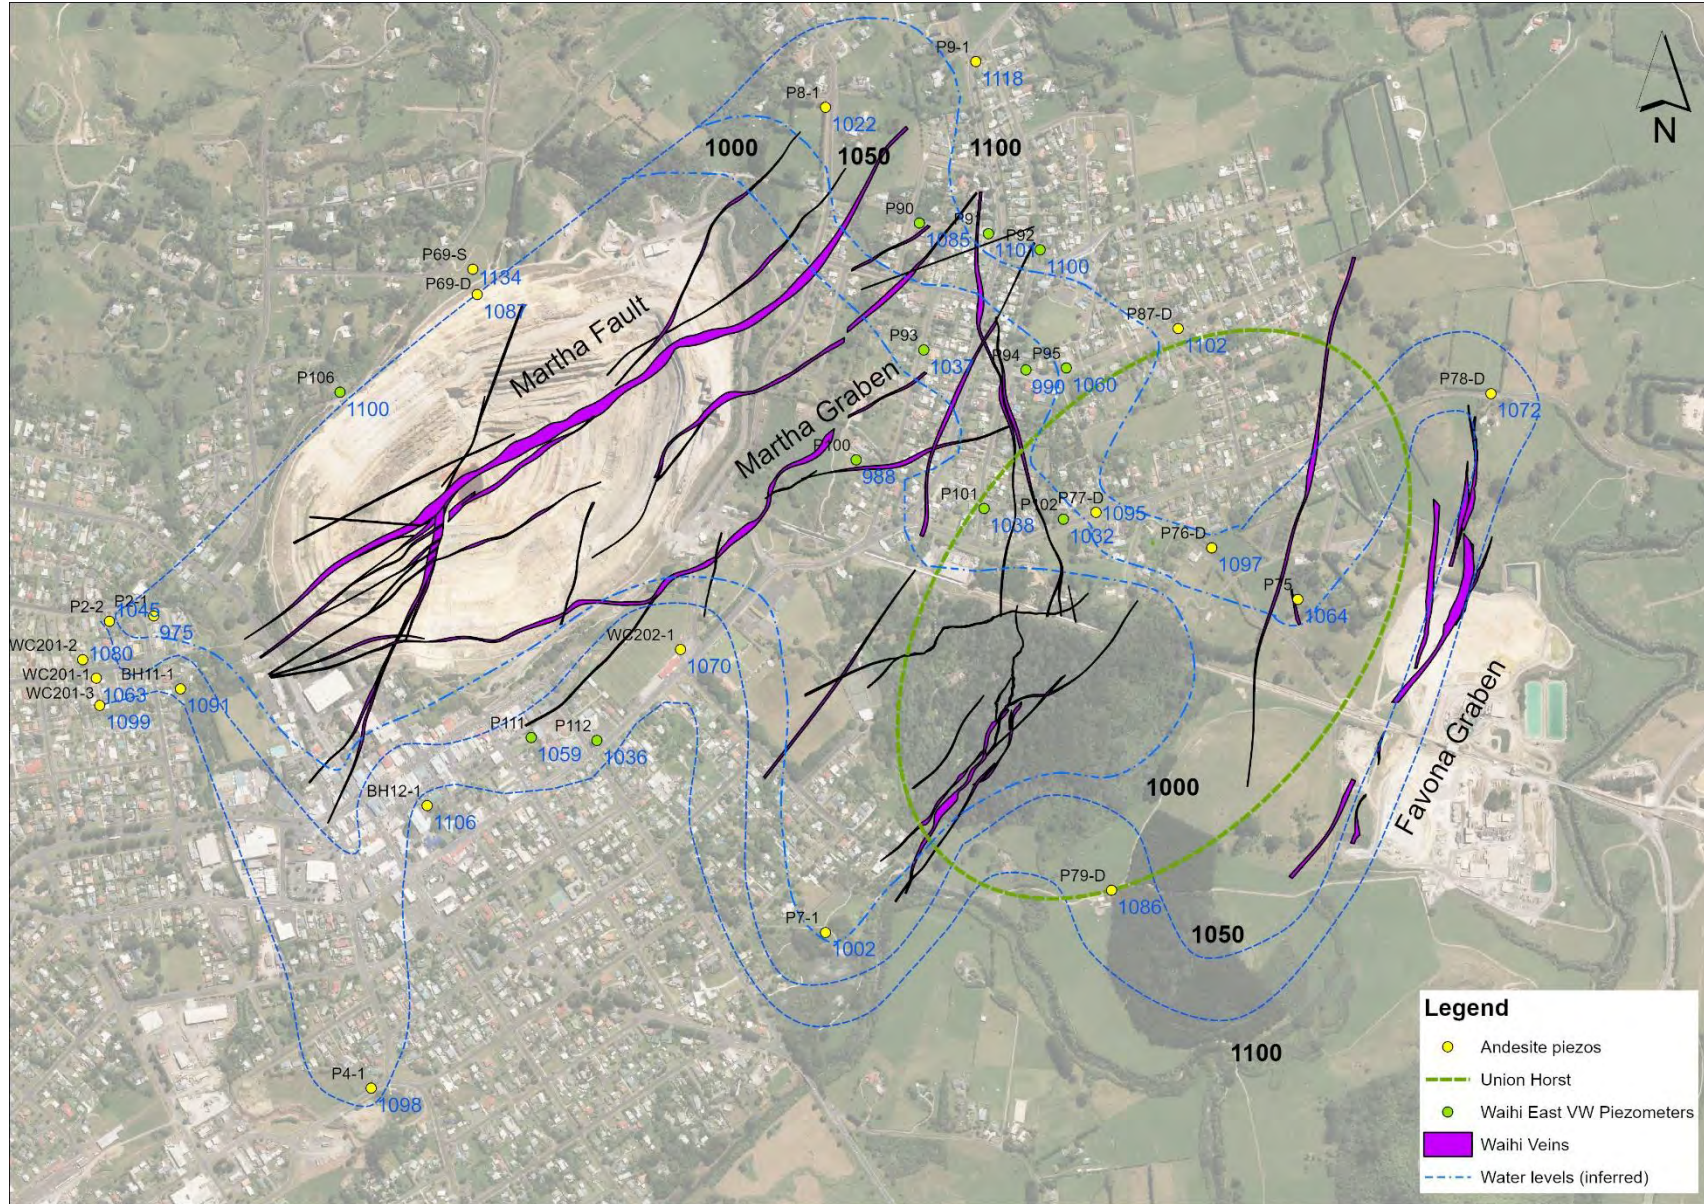
Figure 14: Andesite water level contours

Figure 14 also indicates the dewatering centralised on the Favona system with the restriction of connection between Favona and the Union systems. The geological model in Section 3 indicates an up-thrown block (Union Horst, Figure 14) between the Union and Favona systems. This structural hiatus is likely to account for the restricted groundwater interconnection between the Martha-Union and Favona systems.

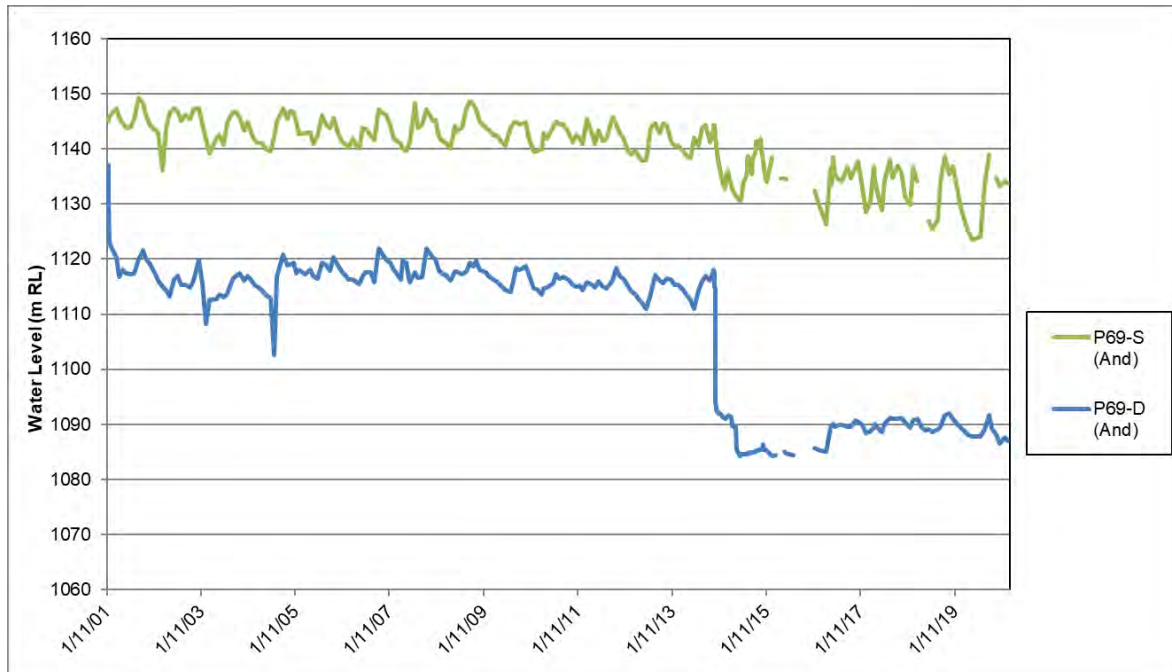
Figure 16: Water Levels P69 Pit North Wall

P69D & P69S were installed in 2001 and are located close to the rim of the North Wall of Martha Pit. They were considered control bores and previously uninfluenced by dewatering. Geotechnical stability work in the North Wall was undertaken in October 2014, partly due to excessive water. Drainage holes were drilled into the lower wall. Localised drainage of the wall resulted, and the water levels in P69D and P69S declined. By March 2015 the piezometers had stabilized with P69D and P69S declining by 32m and 12m respectively (Figure 16). With the large North Wall slip in April 2016, access to the piezometers was briefly restricted. Real time loggers were installed in mid-2017 and are currently programmed to record hourly. Water levels have remained stable in both the shallow and the deep hole since that time.

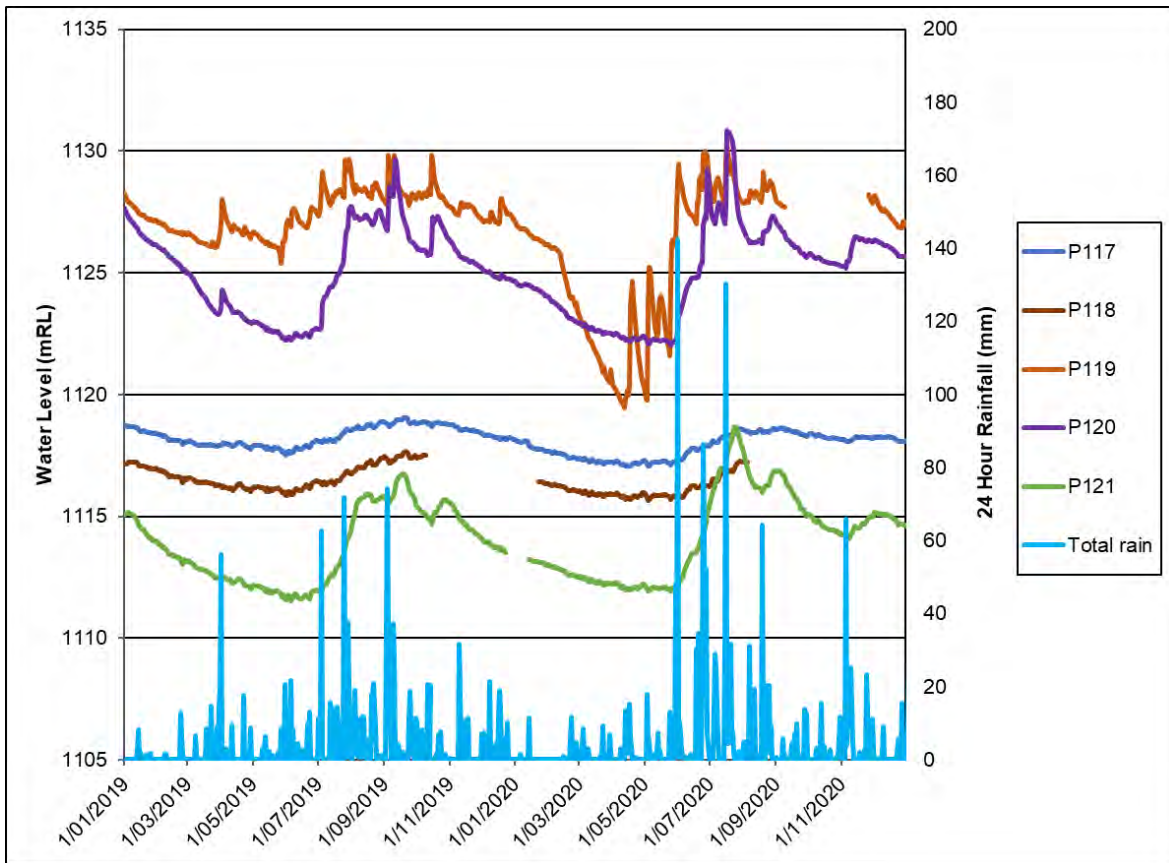
Figure 17: Pit North Wall Piezometer Levels

In mid-2018, five real time loggers recording hourly were installed in new wells (wells P117 – P121) to investigate the source of an area of seepage on the north wall of the pit (Figure 17). Water levels in wells P119, P120 and P121 appear to fluctuate with rainfall while in wells P117 and P118, levels follow long term trends within the andesite. Fluctuations in water level in P117 were observed for the first few months following the installation of loggers before a sudden drop in water level. This effect is likely as a result of the piezometer initially recording the shallower level and responding to rainfall before long term drainage to the pit through the screen occurred, causing the drop to approximately 1118 mRL.

*N.B Gaps in data are due to logger malfunction or battery failure.*

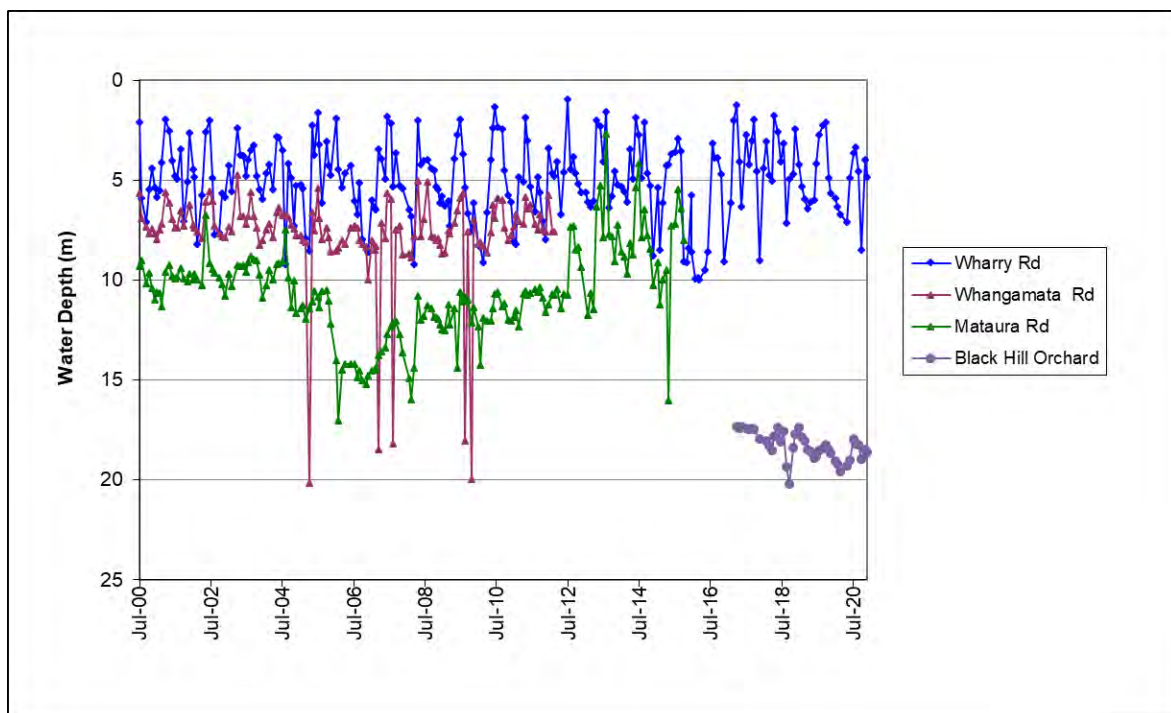
Figure 18: Private Bore Water Levels

Overall, there is no indication of any influence in the bores from mine dewatering (Figure 18Figure ).

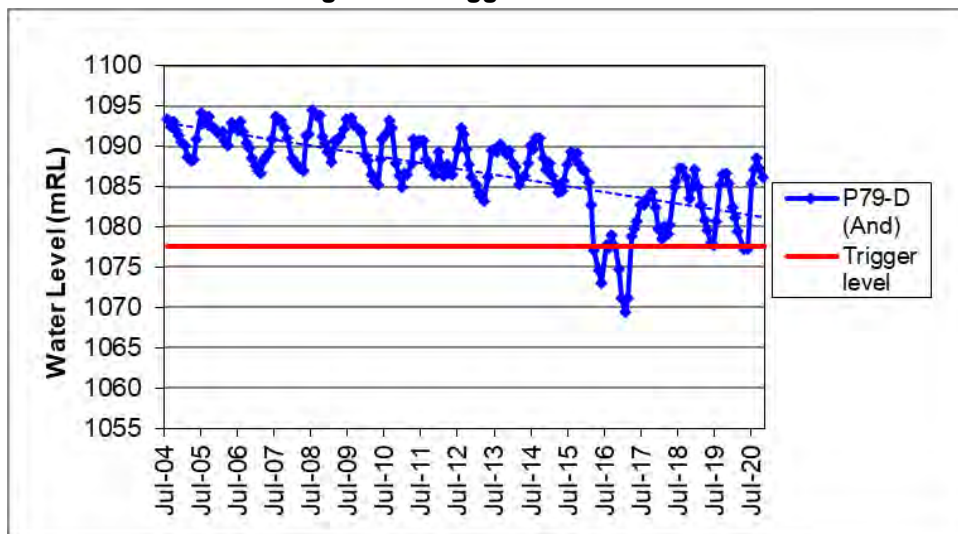
Figure 22: Trigger Level P79-D

Piezometer P79-D reached the trigger limit in 2016 when the piezometer recorded a rapid loss in pressure, most likely due to a reaction to water loss from an underground horizontal drill hole. The drill hole was grouted and no further water loss from the hole occurred. Water levels subsequently recovered to above the trigger level with amplified seasonal variation noted since this time. During May and June 2020, water levels in P79D dropped below the trigger level before recovering in July. This is likely due to the amplified seasonal variation caused by a reduction in rock mass storage following the grouting of the drill hole nearby. Continuous water levels are now being recorded in the P79 well set to monitor the trend (Figure 22). Overall, there appears to be a stabilisation in pressure since 2016. Refer to Appendix G for GWS Limited’s review of the trigger breach.

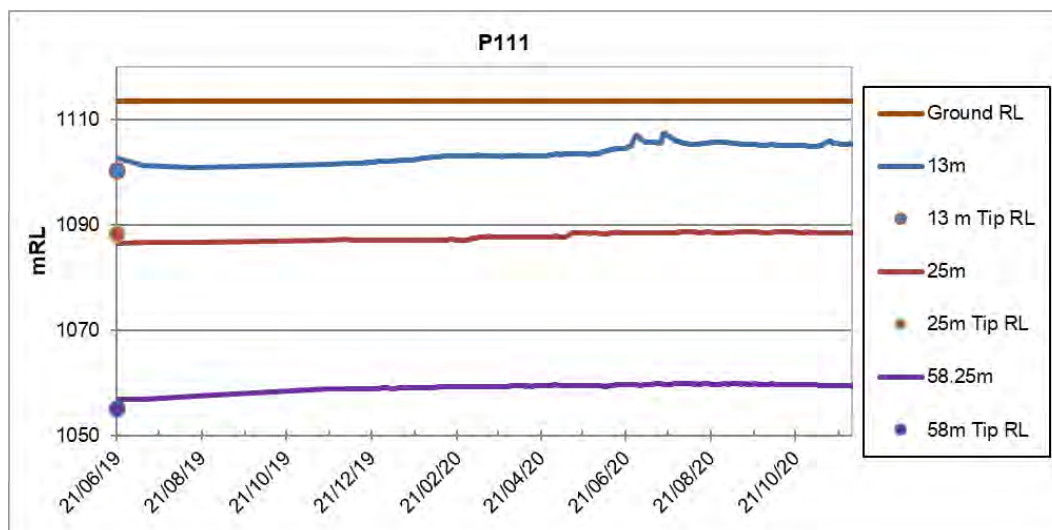
Figure 35: P111 Vibrating Wire Piezometer

Vibrating wire piezometer P111 (Figure 35) was installed with three tips, one in the young volcanics and two in the andesite layer. The younger volcanic piezometer is measuring some water pressure at 1102mRL. The upper andesite piezometer appears to be dry with levels recorded below the tip level (1087mRL cf. 1088mRL), indicating this area may be previously affected by dewatering. The lower andesite piezometer is measuring around 4m of water pressure above the tip, at 1059mRL.

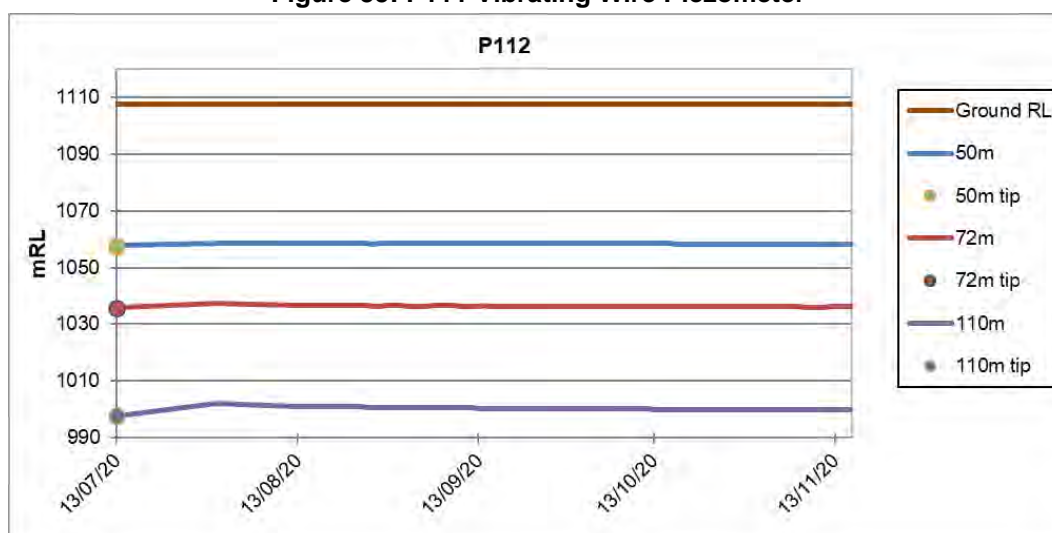
Figure 36: P112 Vibrating Wire Piezometer

P112 is also a vibrating wire design installed with three tips: one in the young volcanics and two in the andesite layer. Water levels have remained stable in all three piezometers since installation in July 2020 (Figure 36).

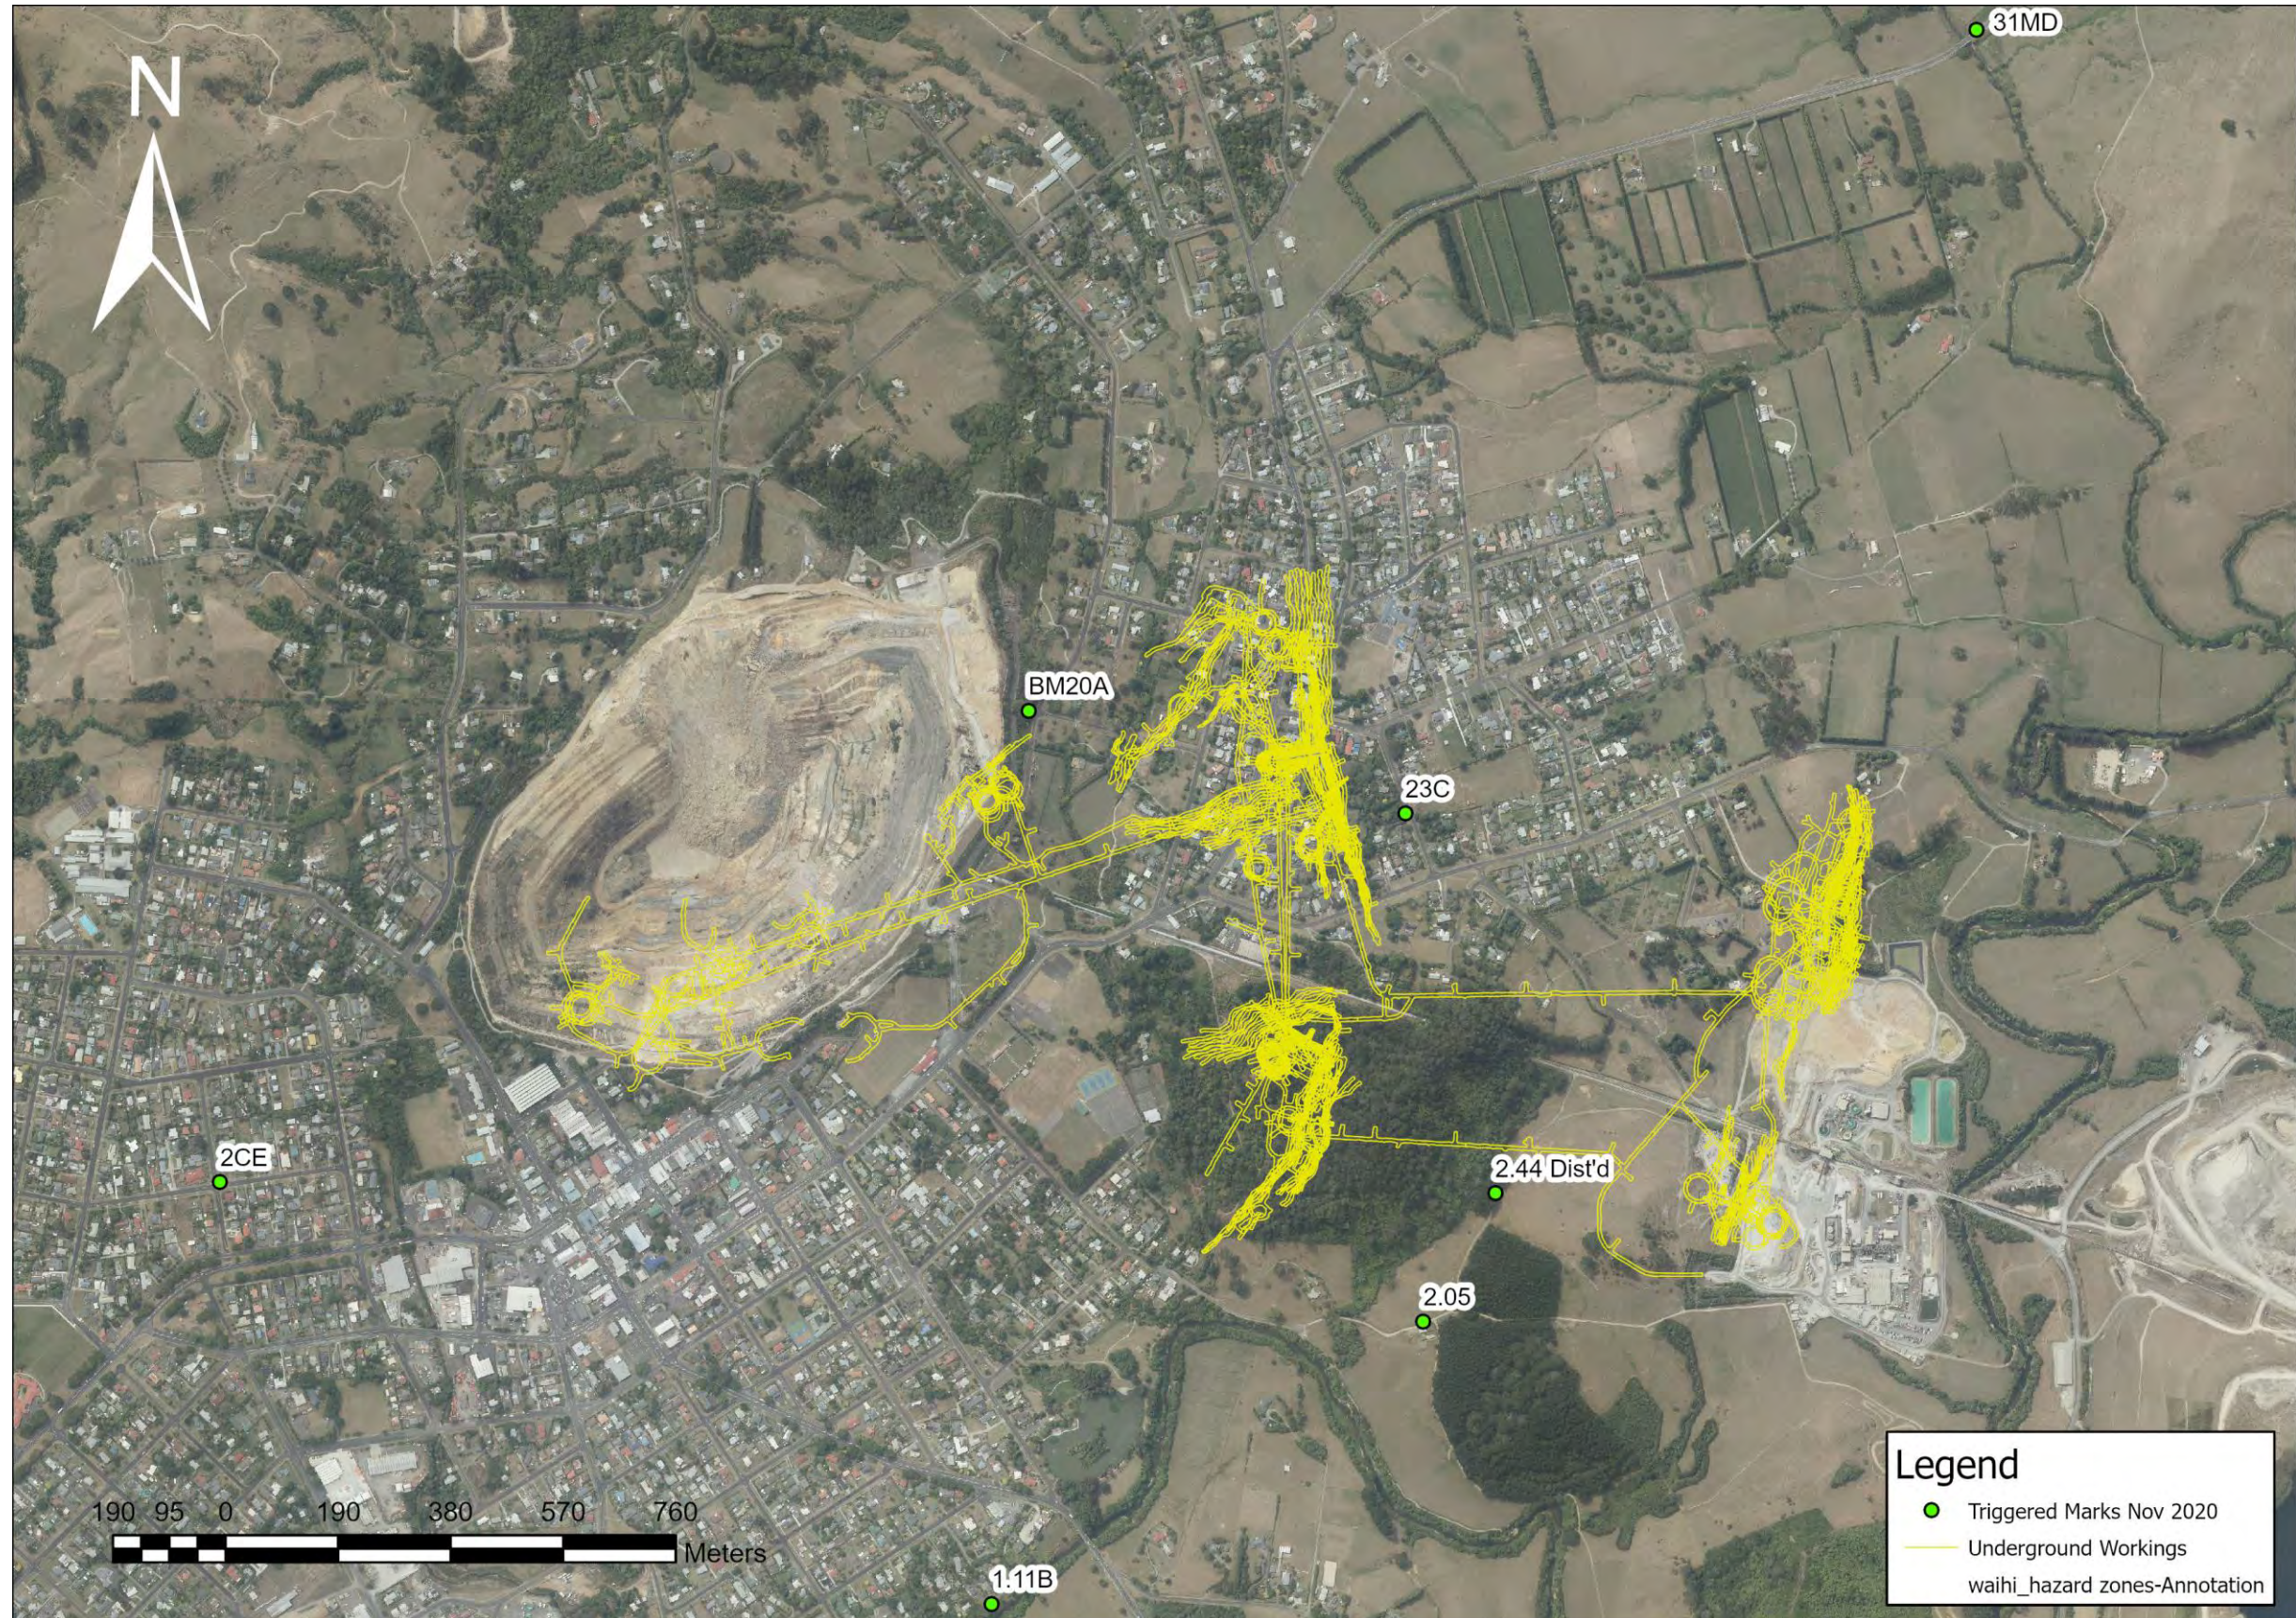
Figure 40: Settlement Marks Triggered During November 2020 Survey

Settlement predictions for Project Martha have been updated for the zone encompassing Favona marks to reflect the effects outlined above. Four Favona marks exceeded the maximum predicted settlement in the November 2020 survey: F17B, F18, F20 and F21. All are located above underground workings, on company owned land. Marks F18 and F20 are noted by the surveyor as being disturbed (Figure 40)

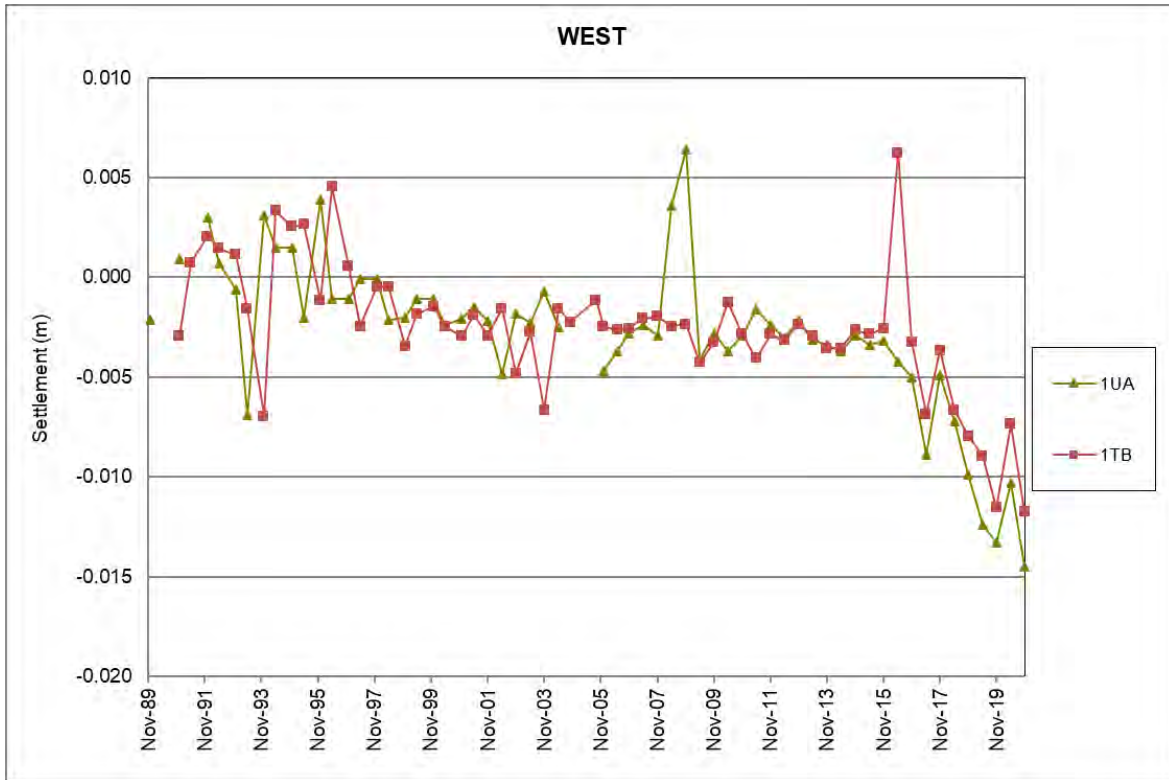
**Figure 43: Zone 1 West of Waihi**

This grouping shows that the marks with a slow downward trend are located along Waihi Whangamata Road to the east of Waihi and to the south of Waihi. A steady increase in settlement from about 1999 can also be observed in most marks in Zones 2 to 6, suggesting that there is a small and widespread effect occurring. Two settlement marks to the west show little settlement until 2015 and then a steady on-going, but small increase in settlement (Figure 43).
