# Dewatering and Settlement Report 2024

Document Reference: WAI-200-REP-007

# DEWATERING & SETTLEMENT MONITORING REPORT 2024

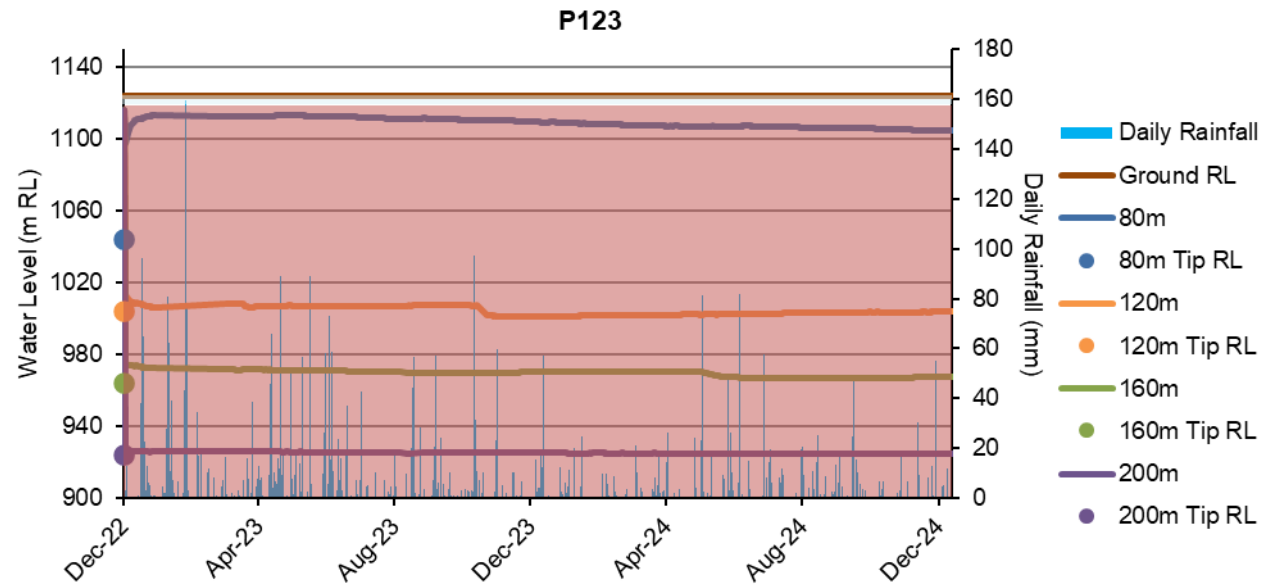
Figure 23. P123 vibrating wire piezometer.

- Tip 1 (80 m BGL - 1044 m RL): Andesite with argillic clay alteration and propylitic alteration.
- Tip 2 (120 m BGL – 1004 m RL): Andesite with argillic clay alteration with a silicified overprint. Fractured with calcite veining.
- Tip 3 (160 m BGL – 964 m RL): Andesite with argillic clay alteration with a silicified overprint. Massive quartz after calcite veining.
- Tip 4 (200 m BGL – 924 m RL): Andesite with silicified overprint. Some fracturing.

In summary, our interpretation is that rainfall infiltration, combined with the higher water holding capacity and lower permeability of clay altered andesite, results in water being retained in the circa. 110 m below the land surface.

P123 was installed in December 2022 with all four tips in the andesite layer and these seem to have now stabilised. The 1044mRL tip is measuring around 63m of water pressure above the tip at 1107mRL, the 1004mRL tip is measuring around 0m of water pressure at 1003mRL and is considered to be dry. The 964mRL tip is measuring around 4m of water pressure at 968mRL, and the 924mRL tip is measuring around 1m of water pressure at 925mRL (Figure 23).

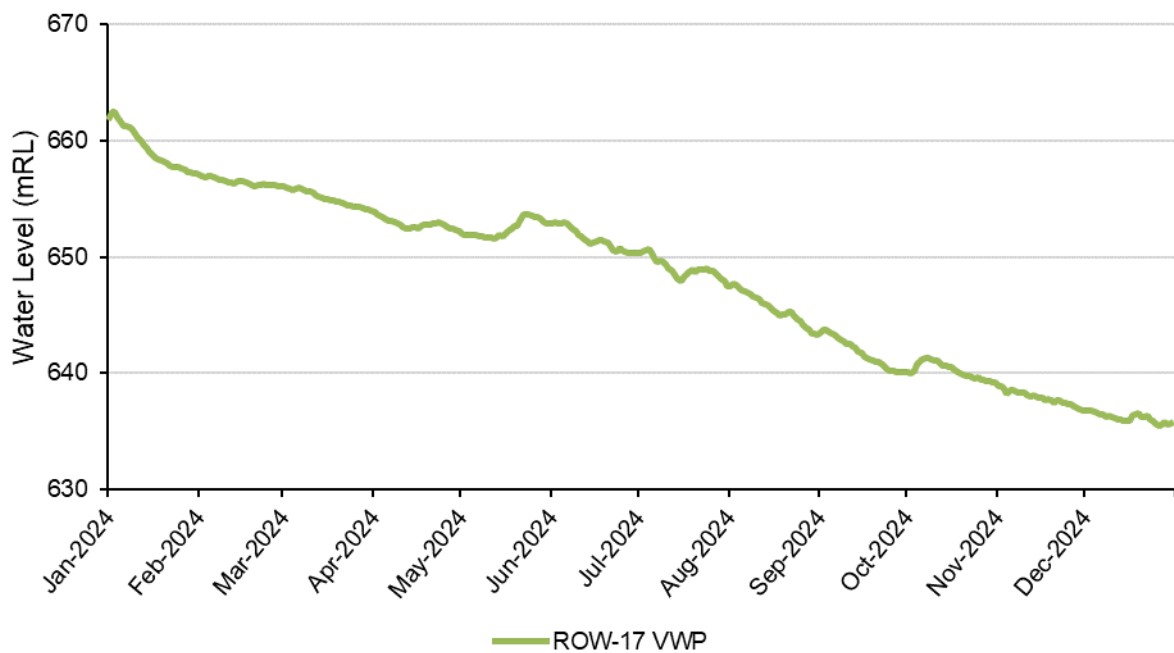
Figure 25. Underground piezometer water level.

In July 2022 a piezometer was installed in an existing exploration drill hole (Figure 24). The drill hole collar is in the Edward decline at 773 mRL and the piezometer tip is at 472 mRL. The hole length is around 350 m, however vertically it is 300 m. It terminates approximately under the Empire West orebody and is set in deep Martha andesite. Piezometer readings show the December 2024 water level at 636 mRL (Figure 25).

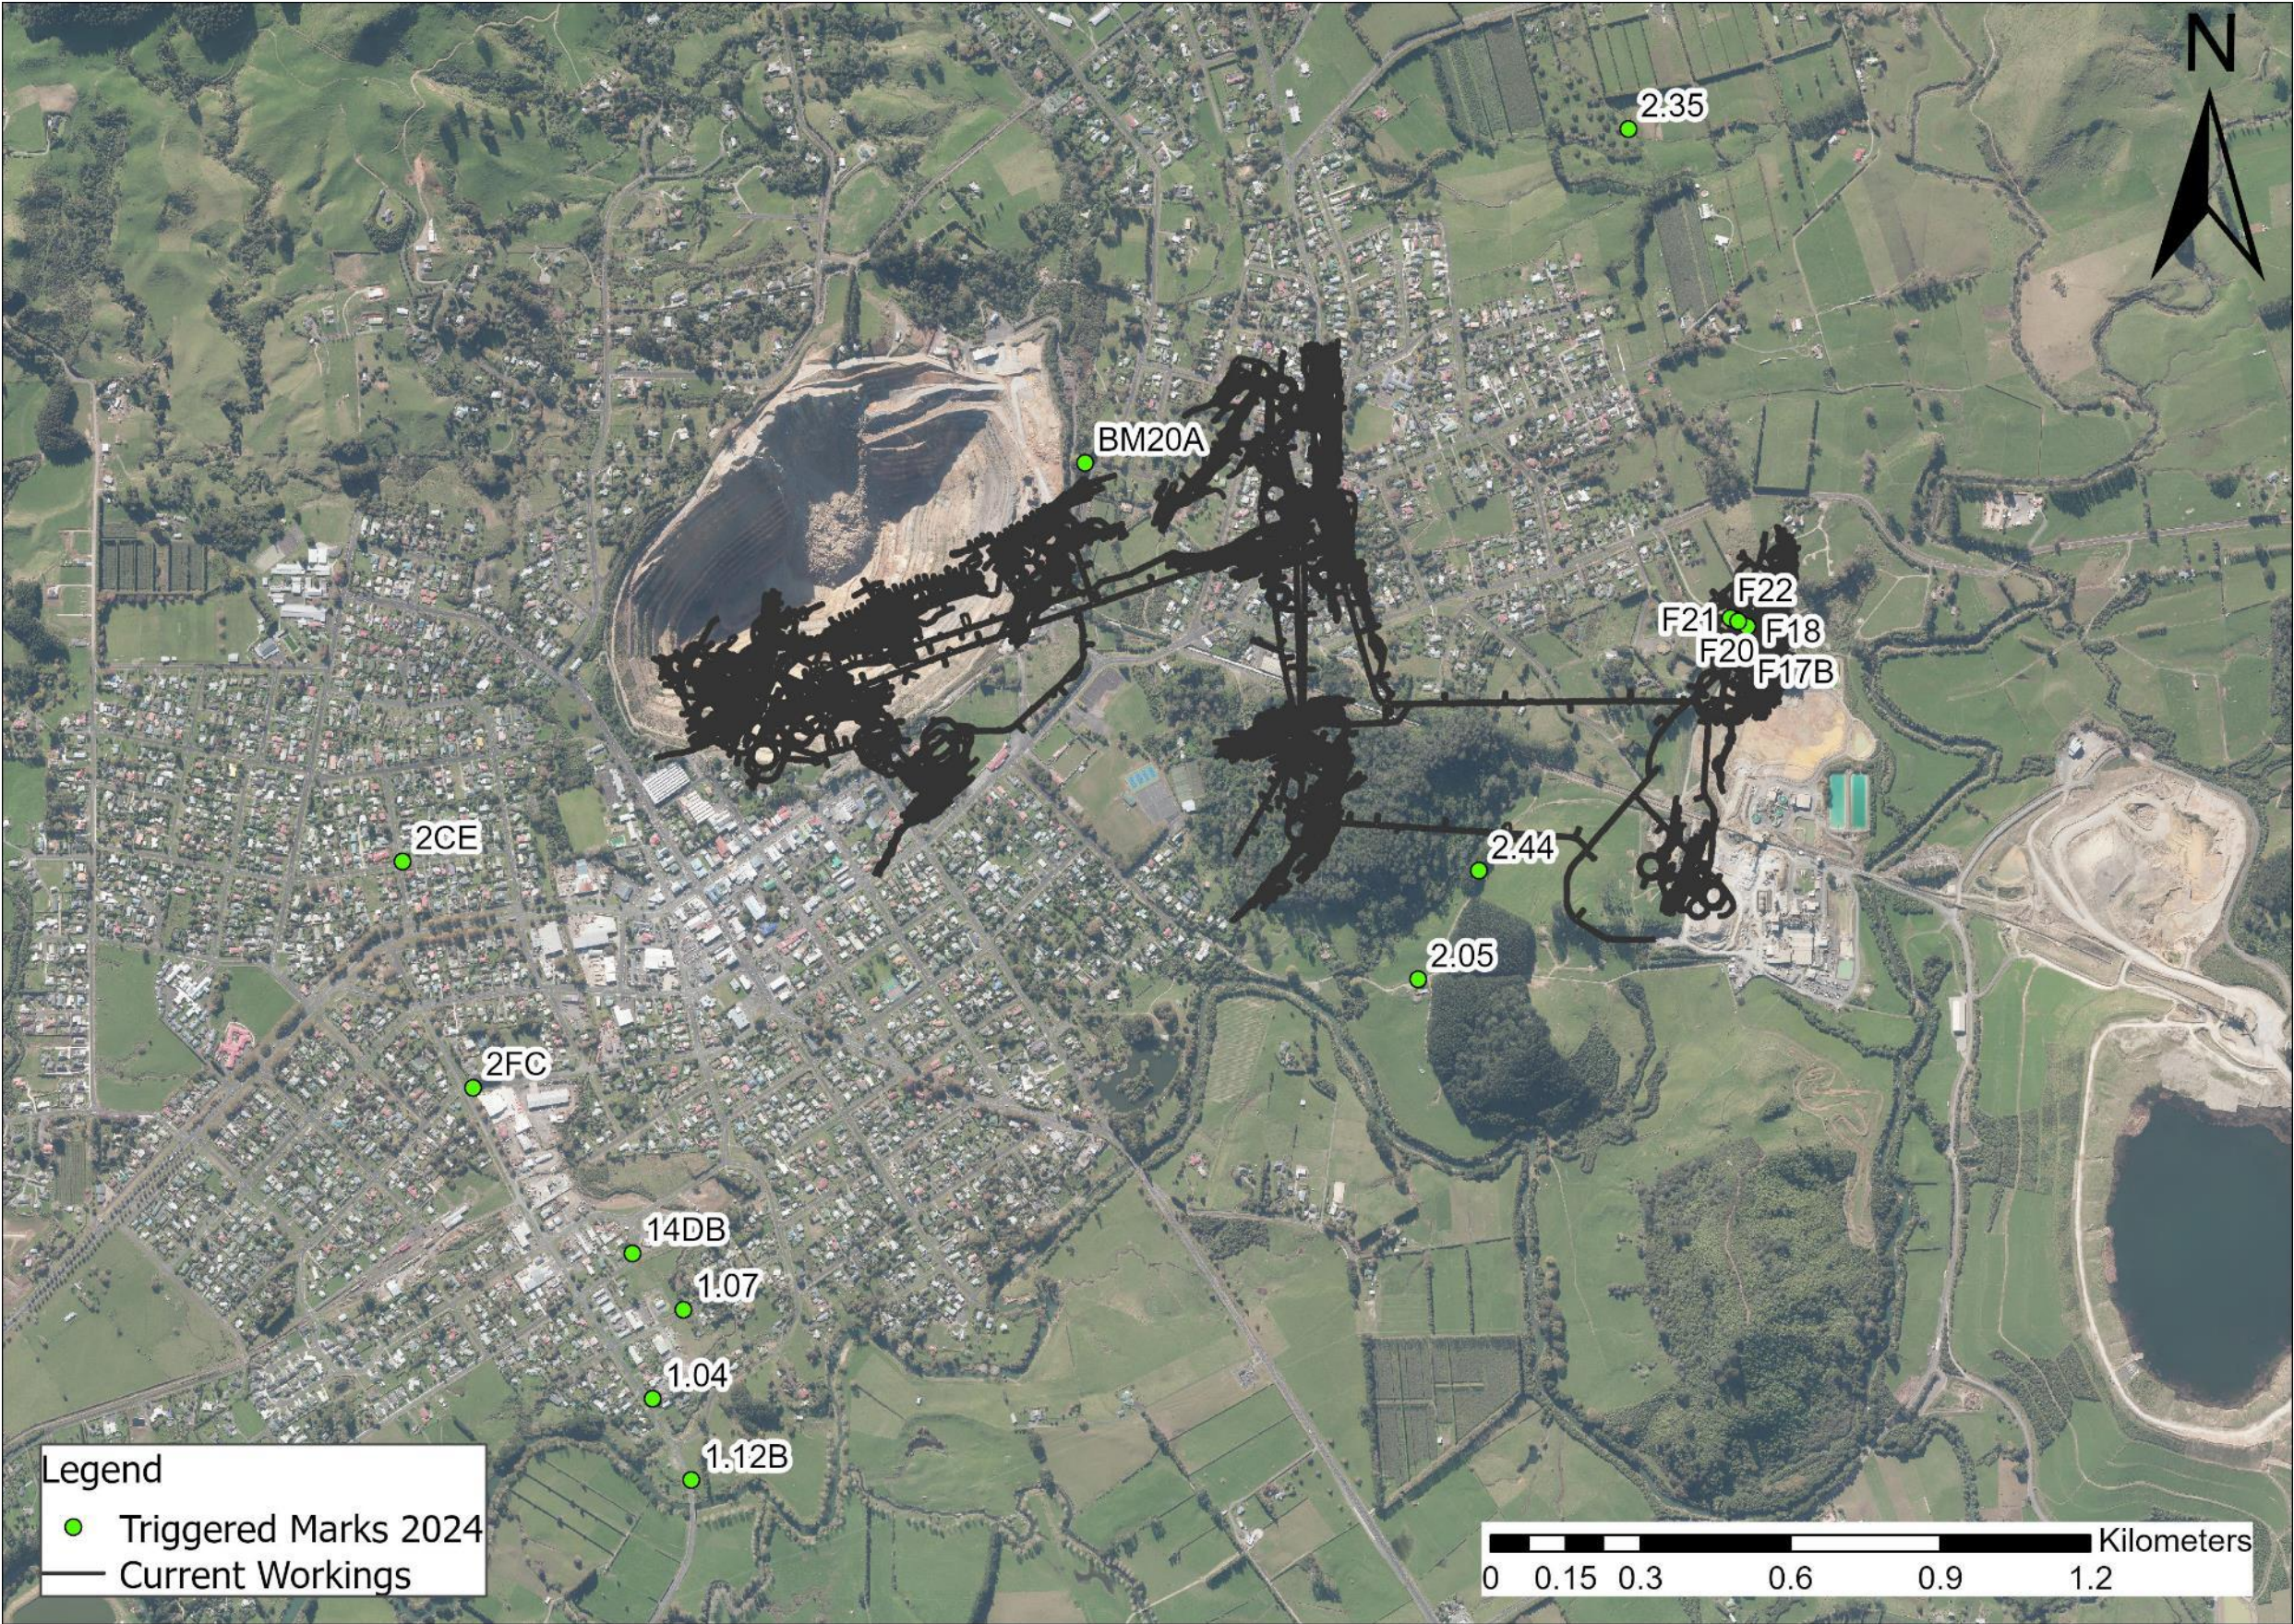
Figure 42. Triggered settlement marks – November 2024.

The remaining ten (10) of the above fifteen (15) triggered marks are located in the wider Waihi area. Generally, no effects were observed at surface near these locations, measured tilts were less than 1 in 1000, and nearby shallow piezometers have not displayed any changes outside of normal seasonal trends.

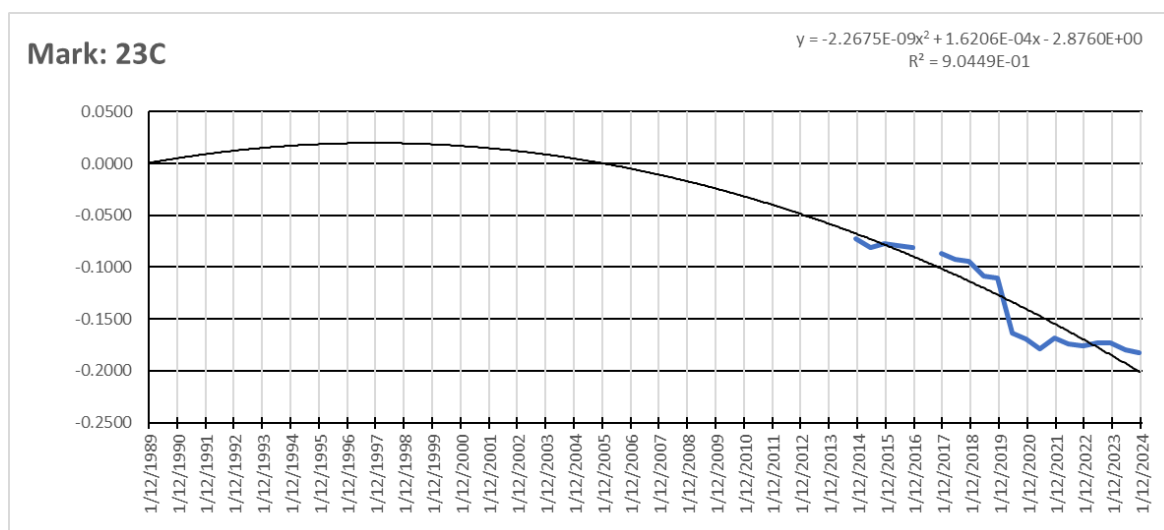
Figure 47. 23C Settlement records prior to correction.

One mark, 23C, showed a sharp increase in settlement during the May 2020 survey. This mark is located near a drain and may have been influenced by drainage works nearby during the 2019/2020 period. No visual evidence of settlement effects on surrounding land have been identified to date and nearby piezometers have not shown any unusual changes. The settlement in all subsequent surveys continued at a steady rate with the other surrounding settlement monitoring marks. Due to the settlement at this location continuing at a rate in line with expected settlement, the large drop in settlement from the May 2020 survey has had a correction applied. As a result, this mark no longer exceeds the settlement trigger. Graphs showing the settlement rate for this mark are shown below prior to corrections being added (Figure 46) and after corrections were applied (Figure 47).

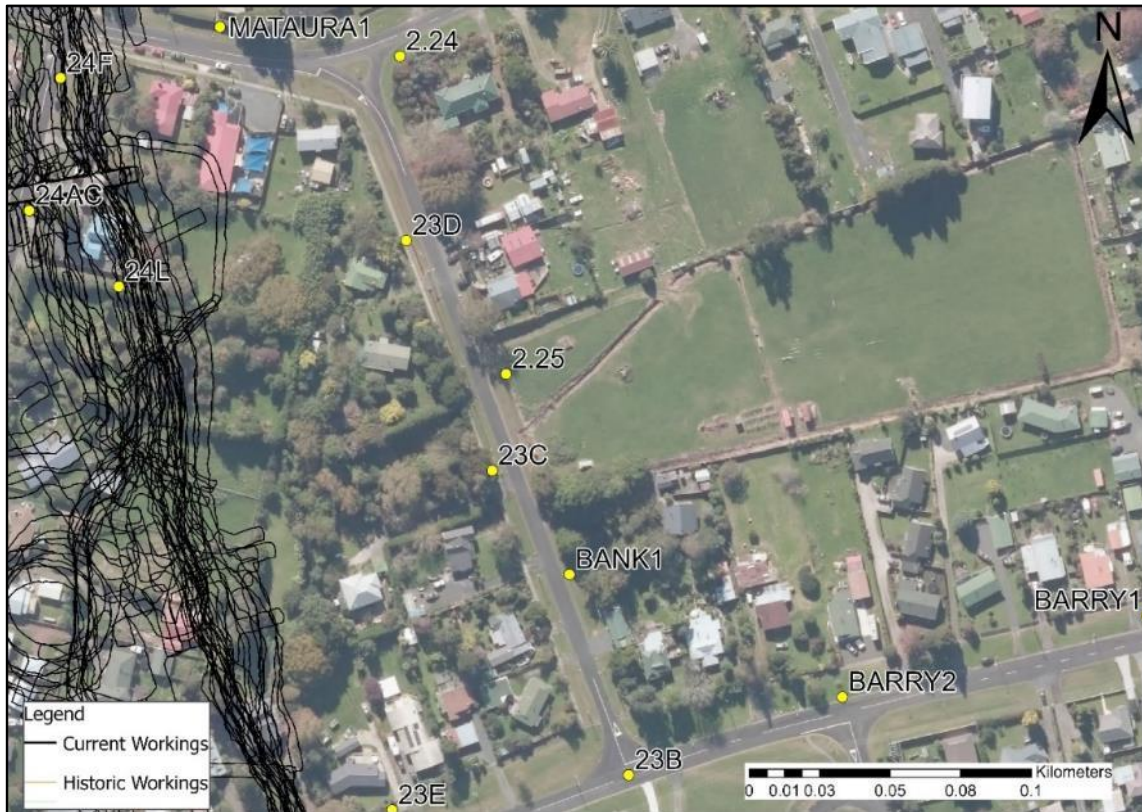
Figure 53. 23C, 2.25 and BANK1 settlement marks and workings.

Tilt greater than 1:1000 was previously identified in the Correnso South area at two locations associated with Mark 23C. As stated in Section 7.2.4 above, due to the potential influence by drainage works, a correction has been applied to this mark. The tilts previously recorded between marks 23C/2.25 and 23C/BANK (Figure 53) are no longer considered to be greater than 1:1000.
