# Trio Stability - 2019 Annual Report

August 2019

The purpose of the OceanaGold NZ Ltd (Waihi Operations) Trio Stability Annual Report is to comply with Condition 16 of Hauraki District Council (HDC) LUC RC-15774 and confirm that appropriate measures are being undertaken to minimise the risk of surface instability.

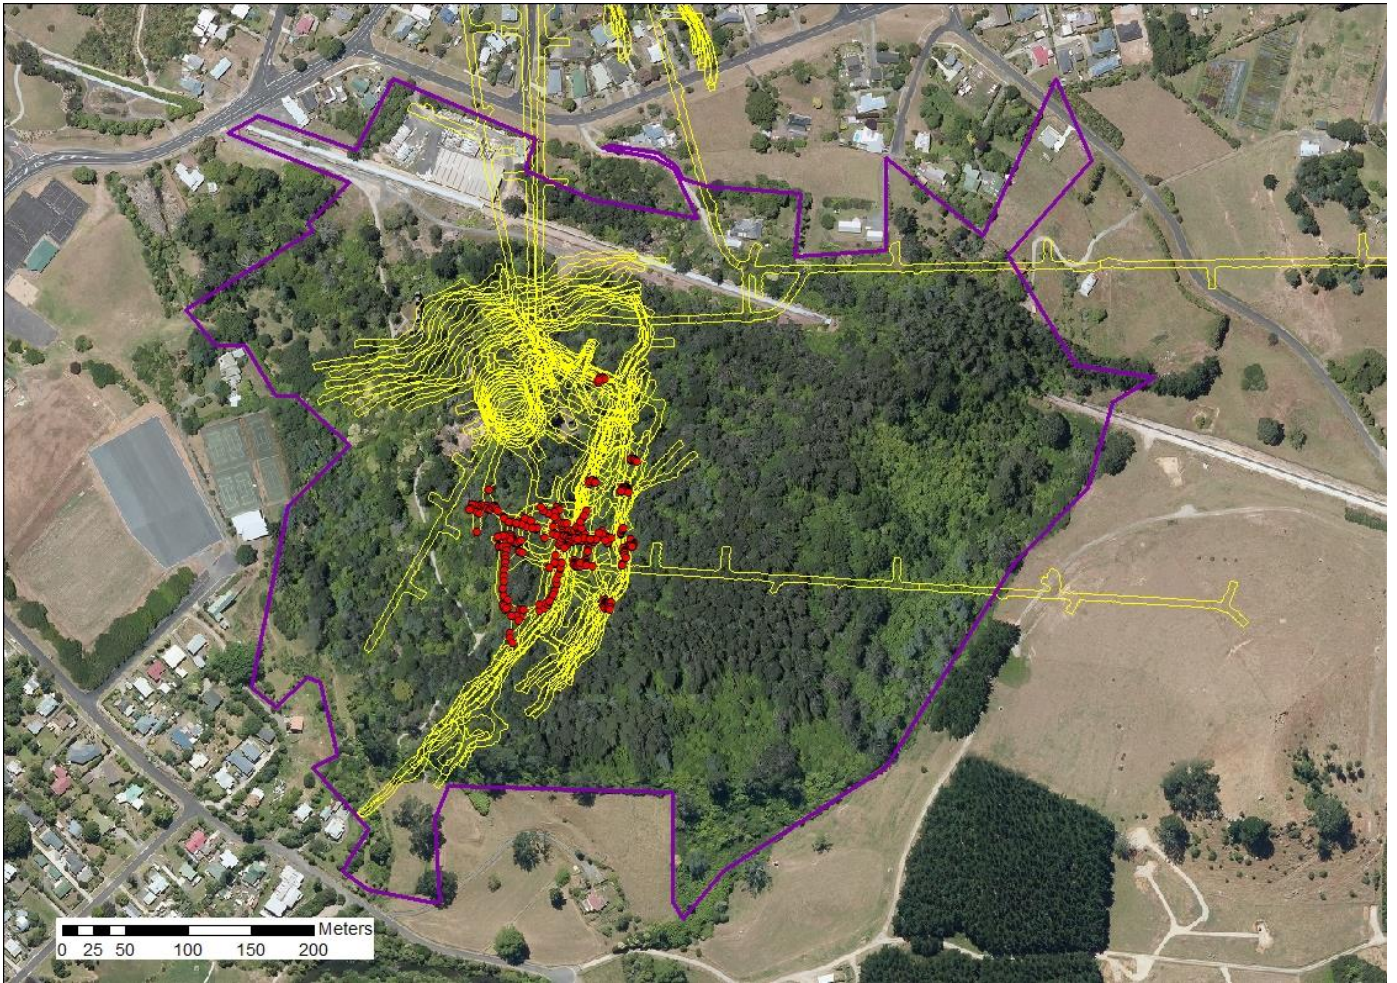
No stoping was undertaken during the reporting period. Development activities during the reporting period consisted of the development of an exploration spiral decline and associated drives underneath the completed Trio works to facilitate access to 'Trio Deeps' (Figures 1 and 2).

Figure 1: 2018-19 Trio Blasting (red dots indicate blast locations)

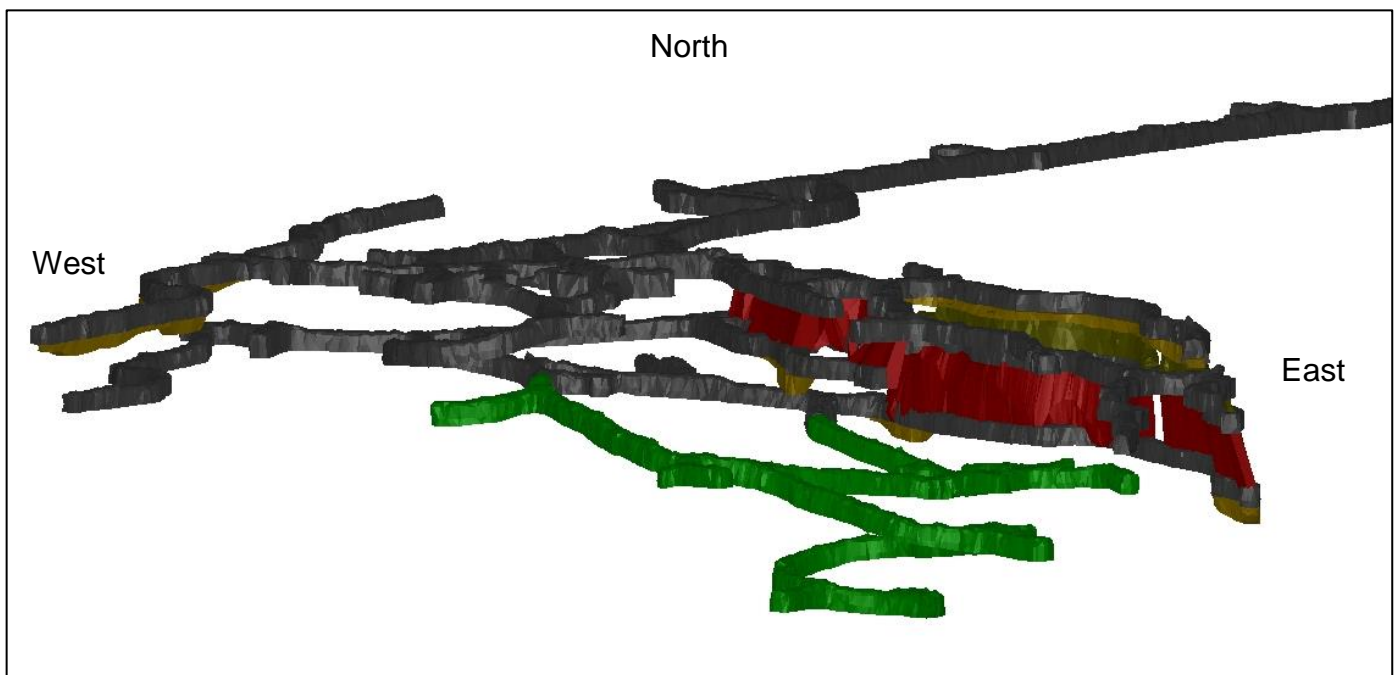
Figure 2: 2019 Oblique view of Trio Deeps Exploration drive (green).

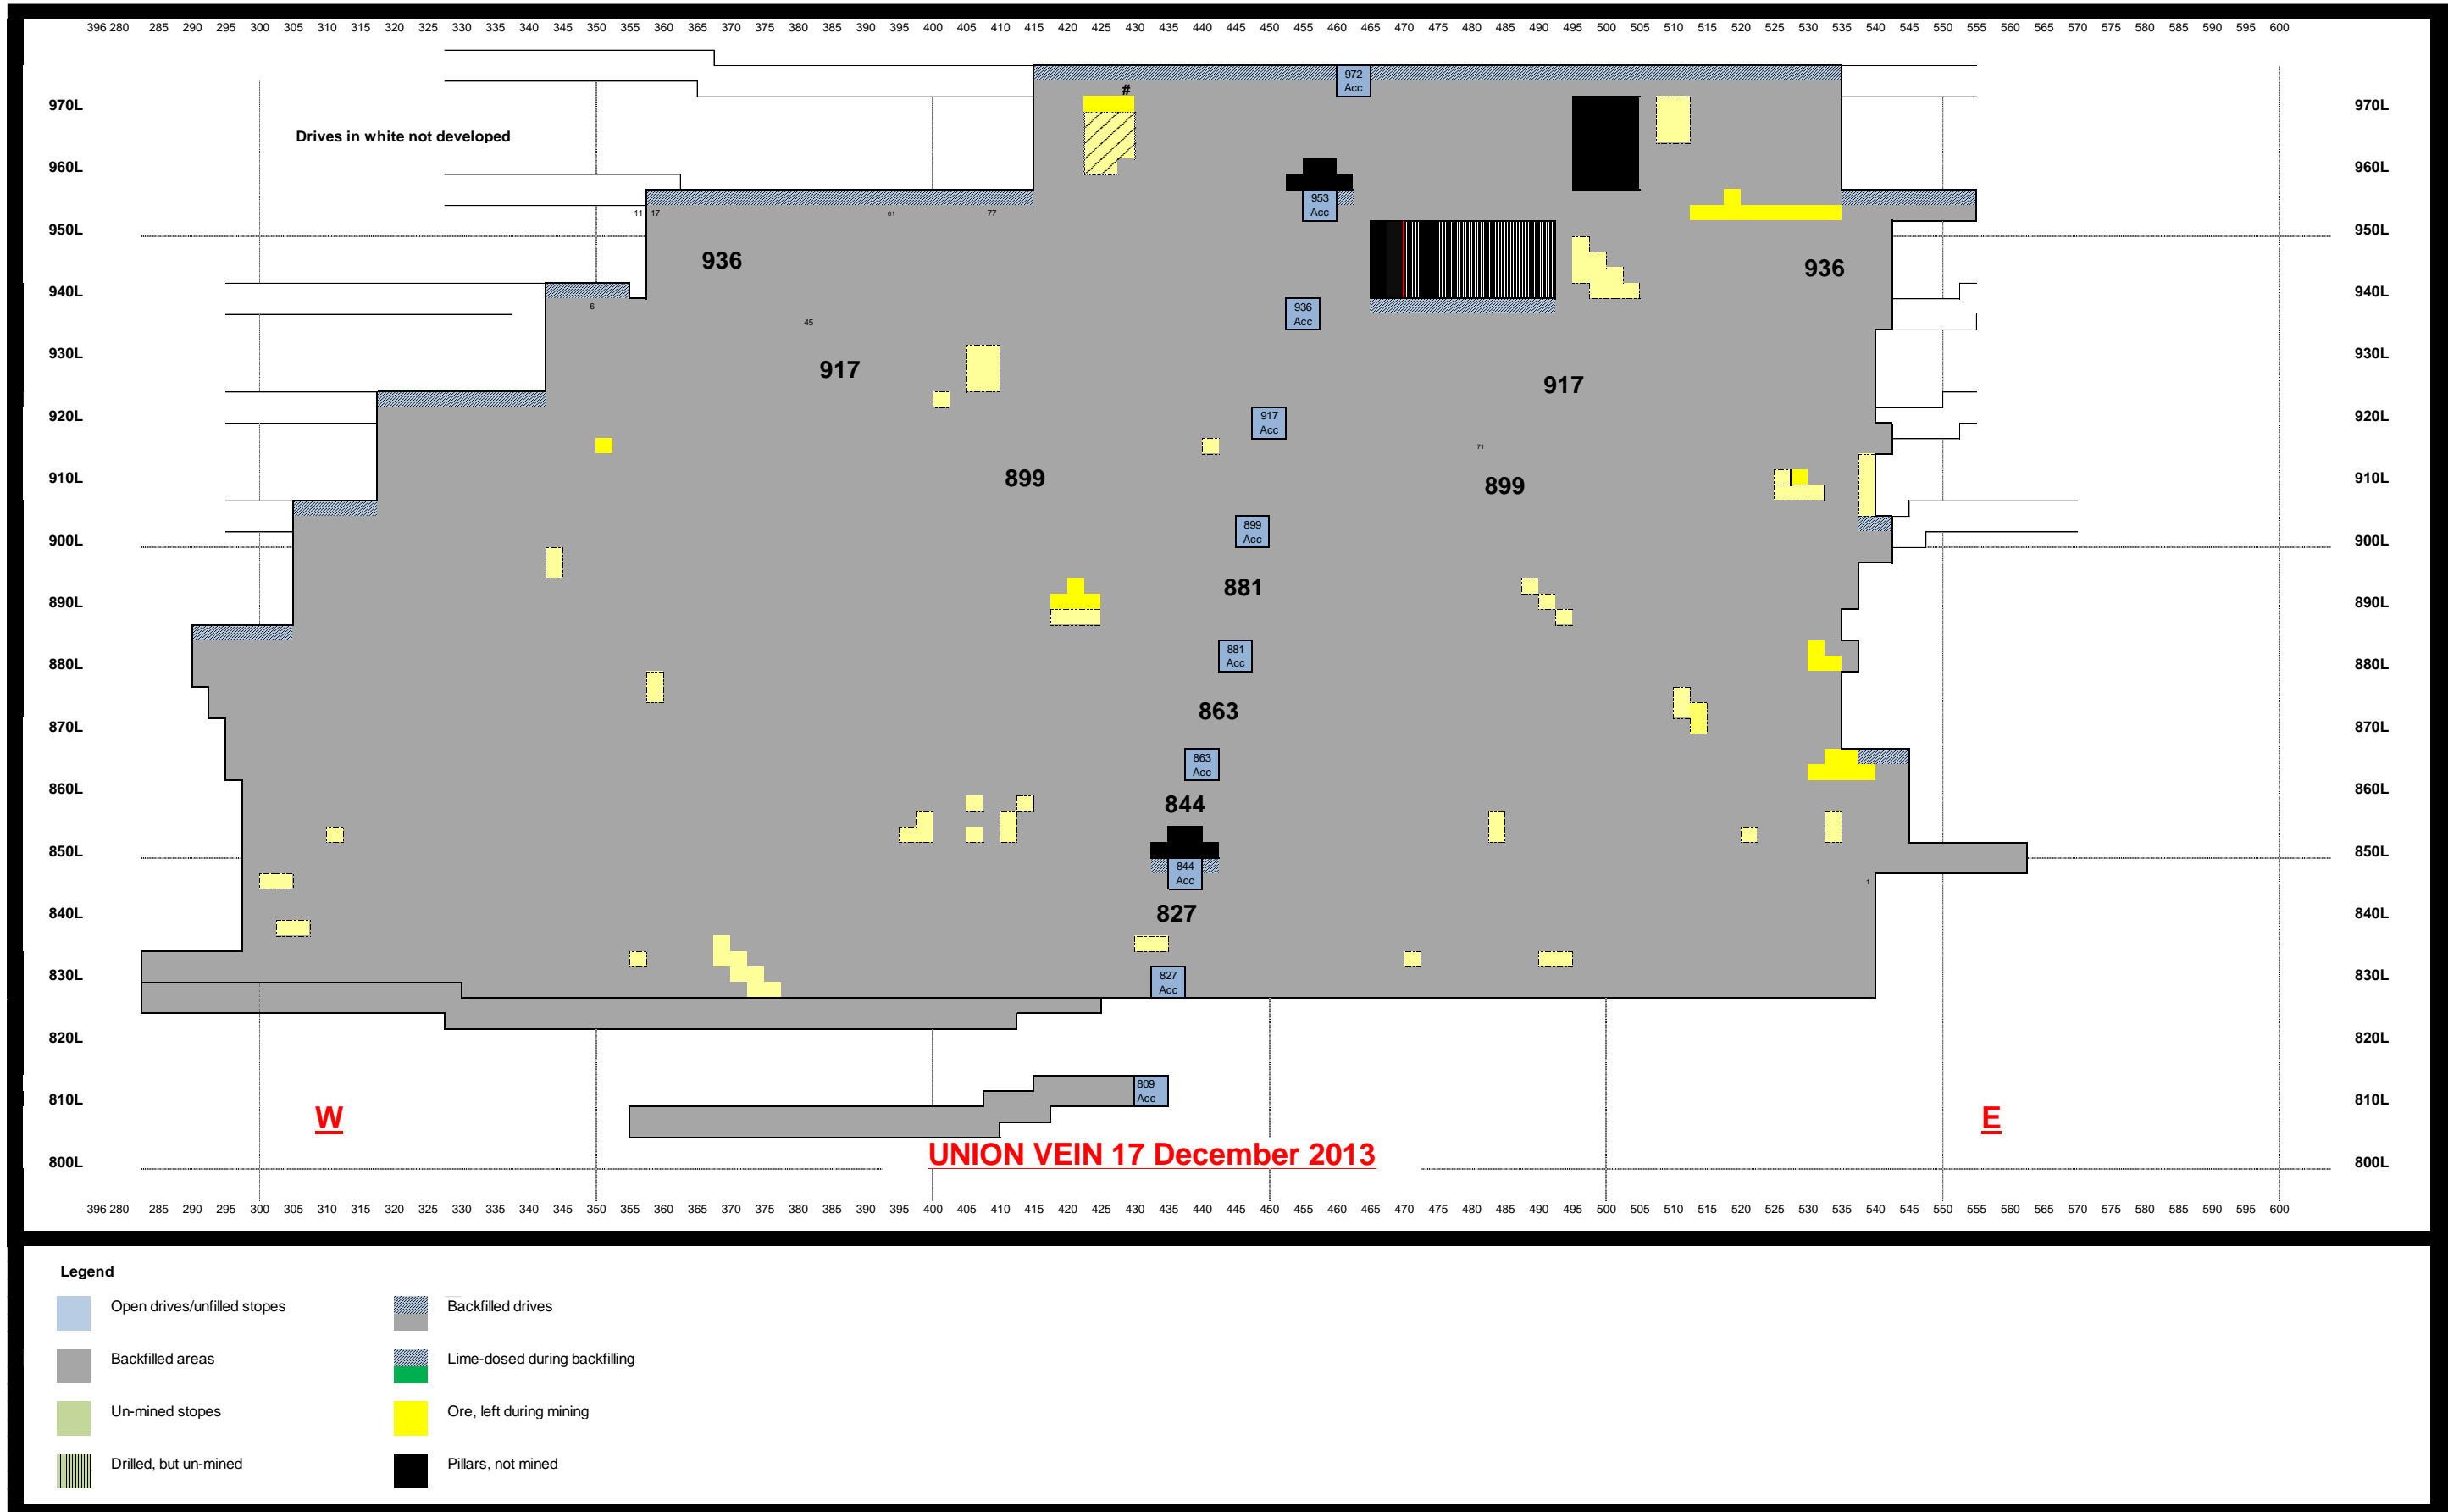
No new backfilling has been required during the reporting period and the schematics for backfilling are unchanged (see figures 3a – 3c). All available stopes were backfilled during earlier reporting periods and no new stoping has been opened up.

Figure 3a: Long view of Union Vein

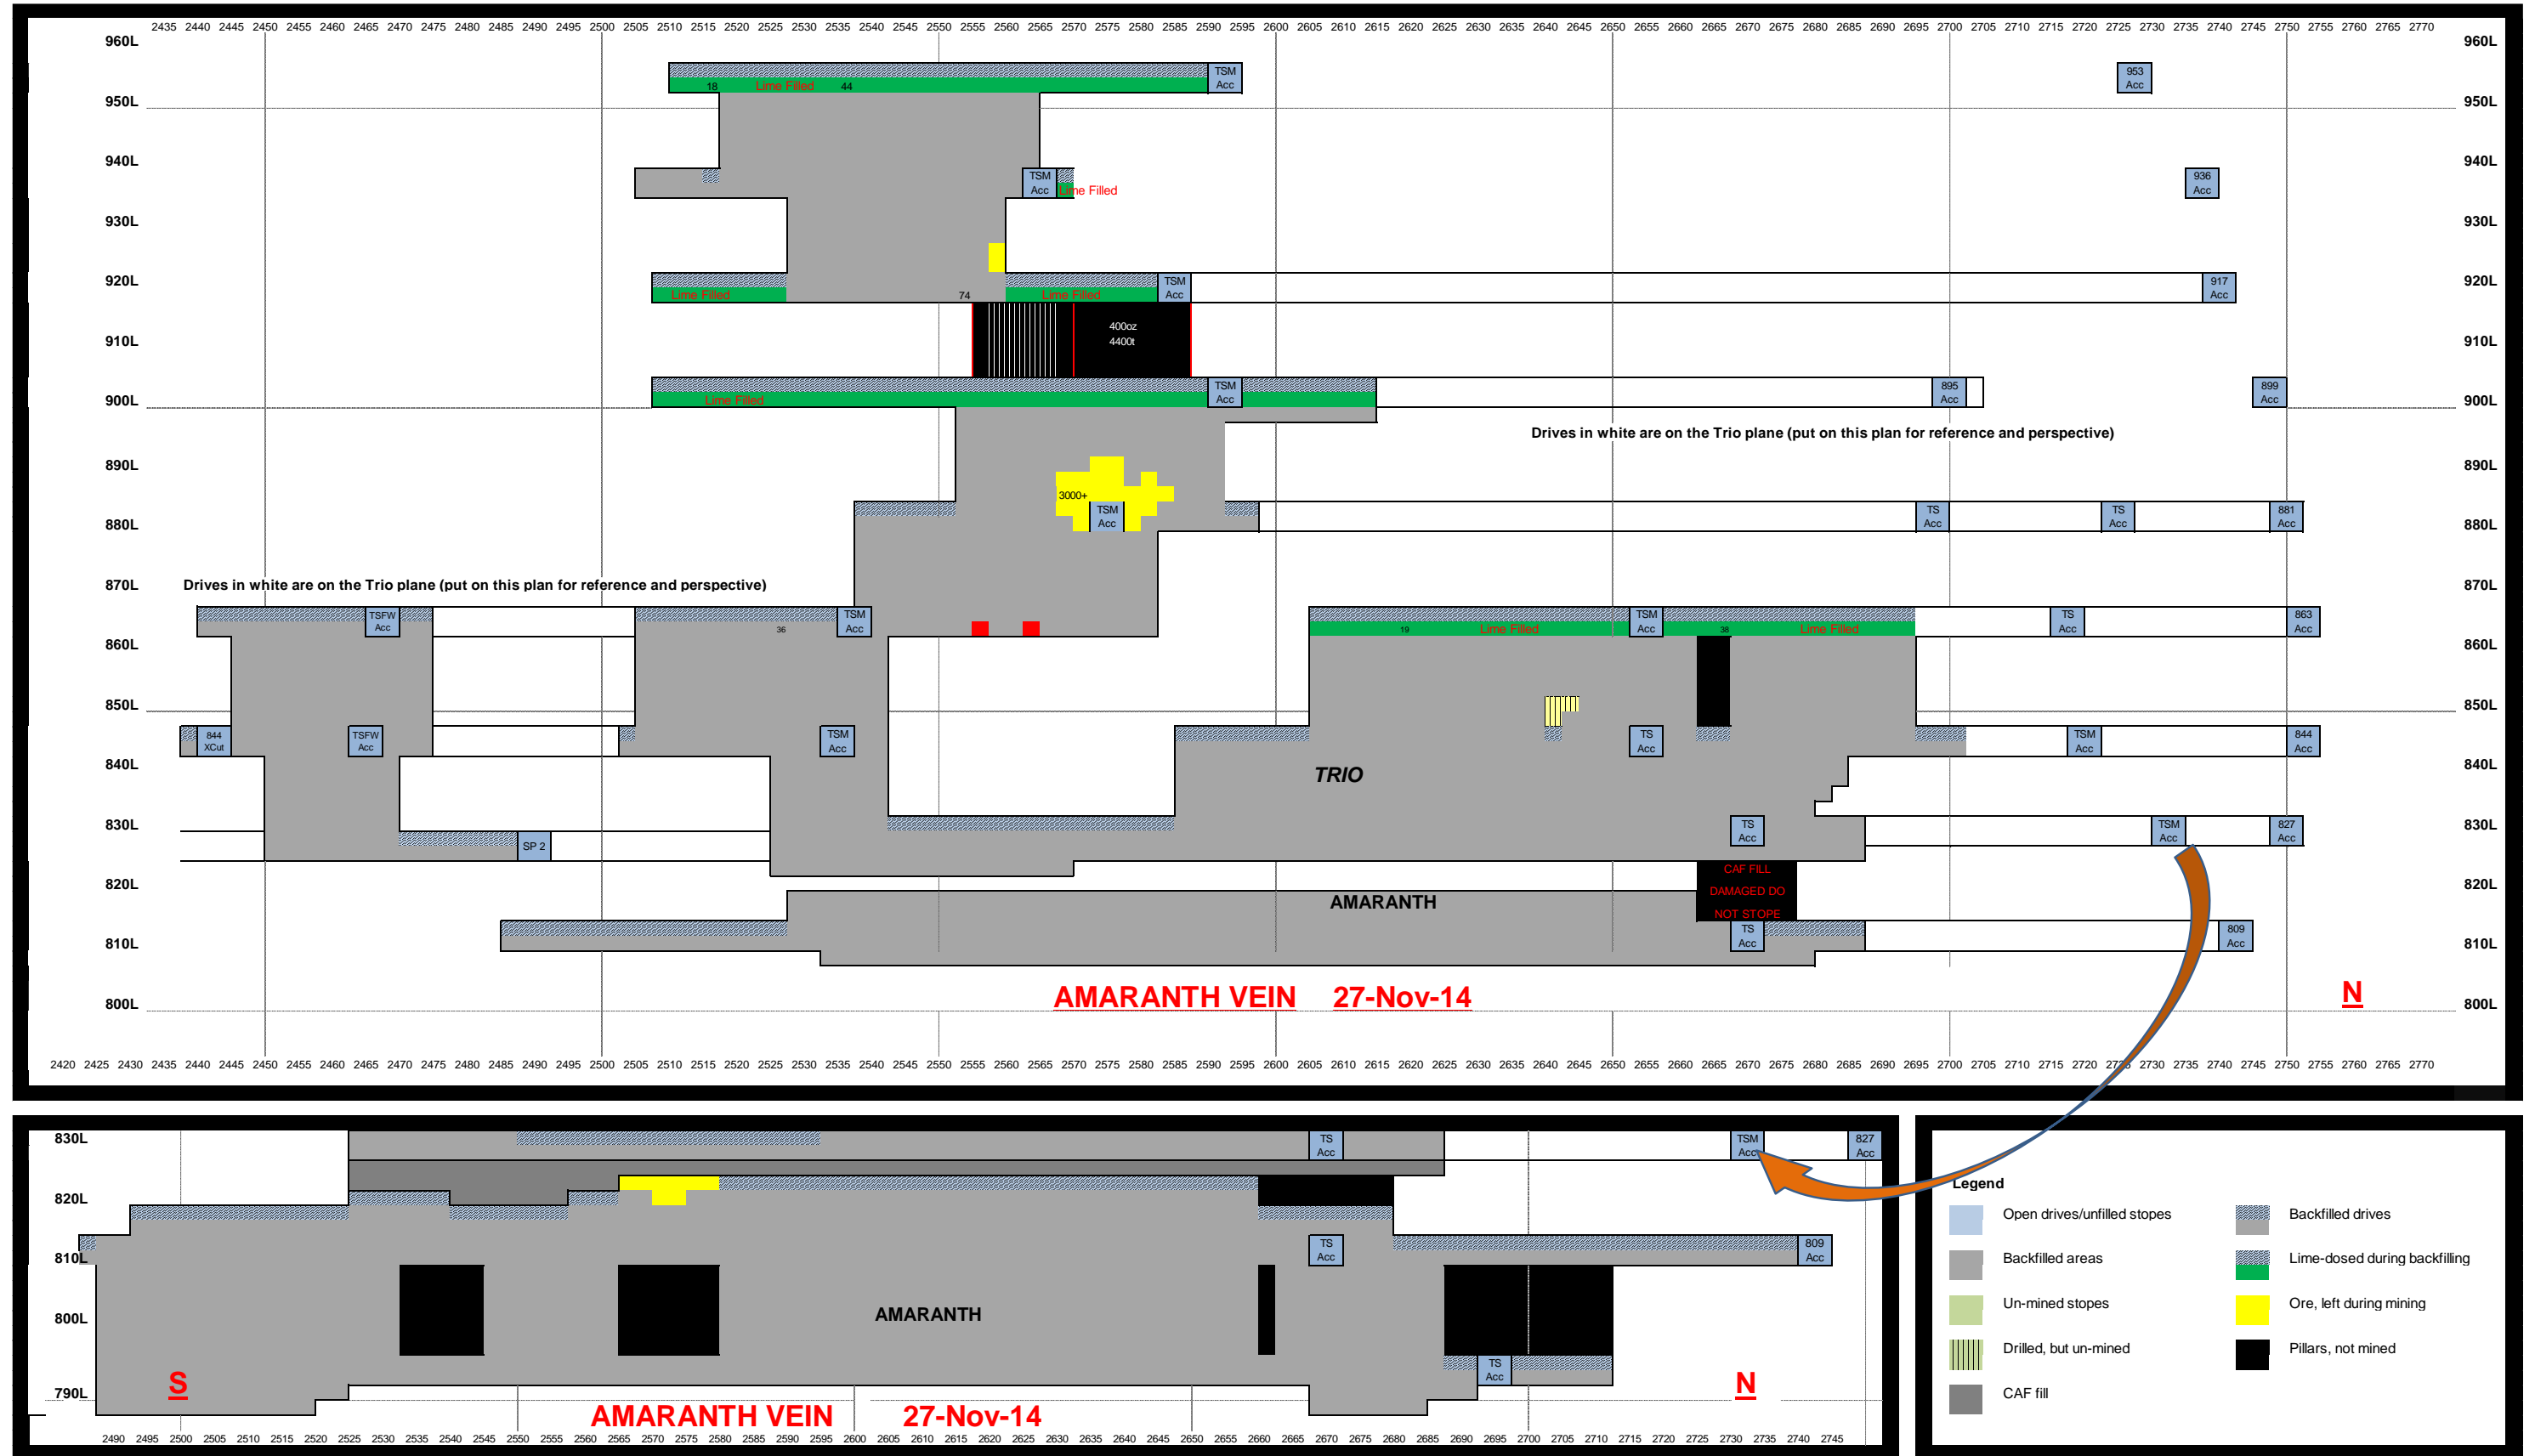
Figure 3b: Long view of Amaranth Vein

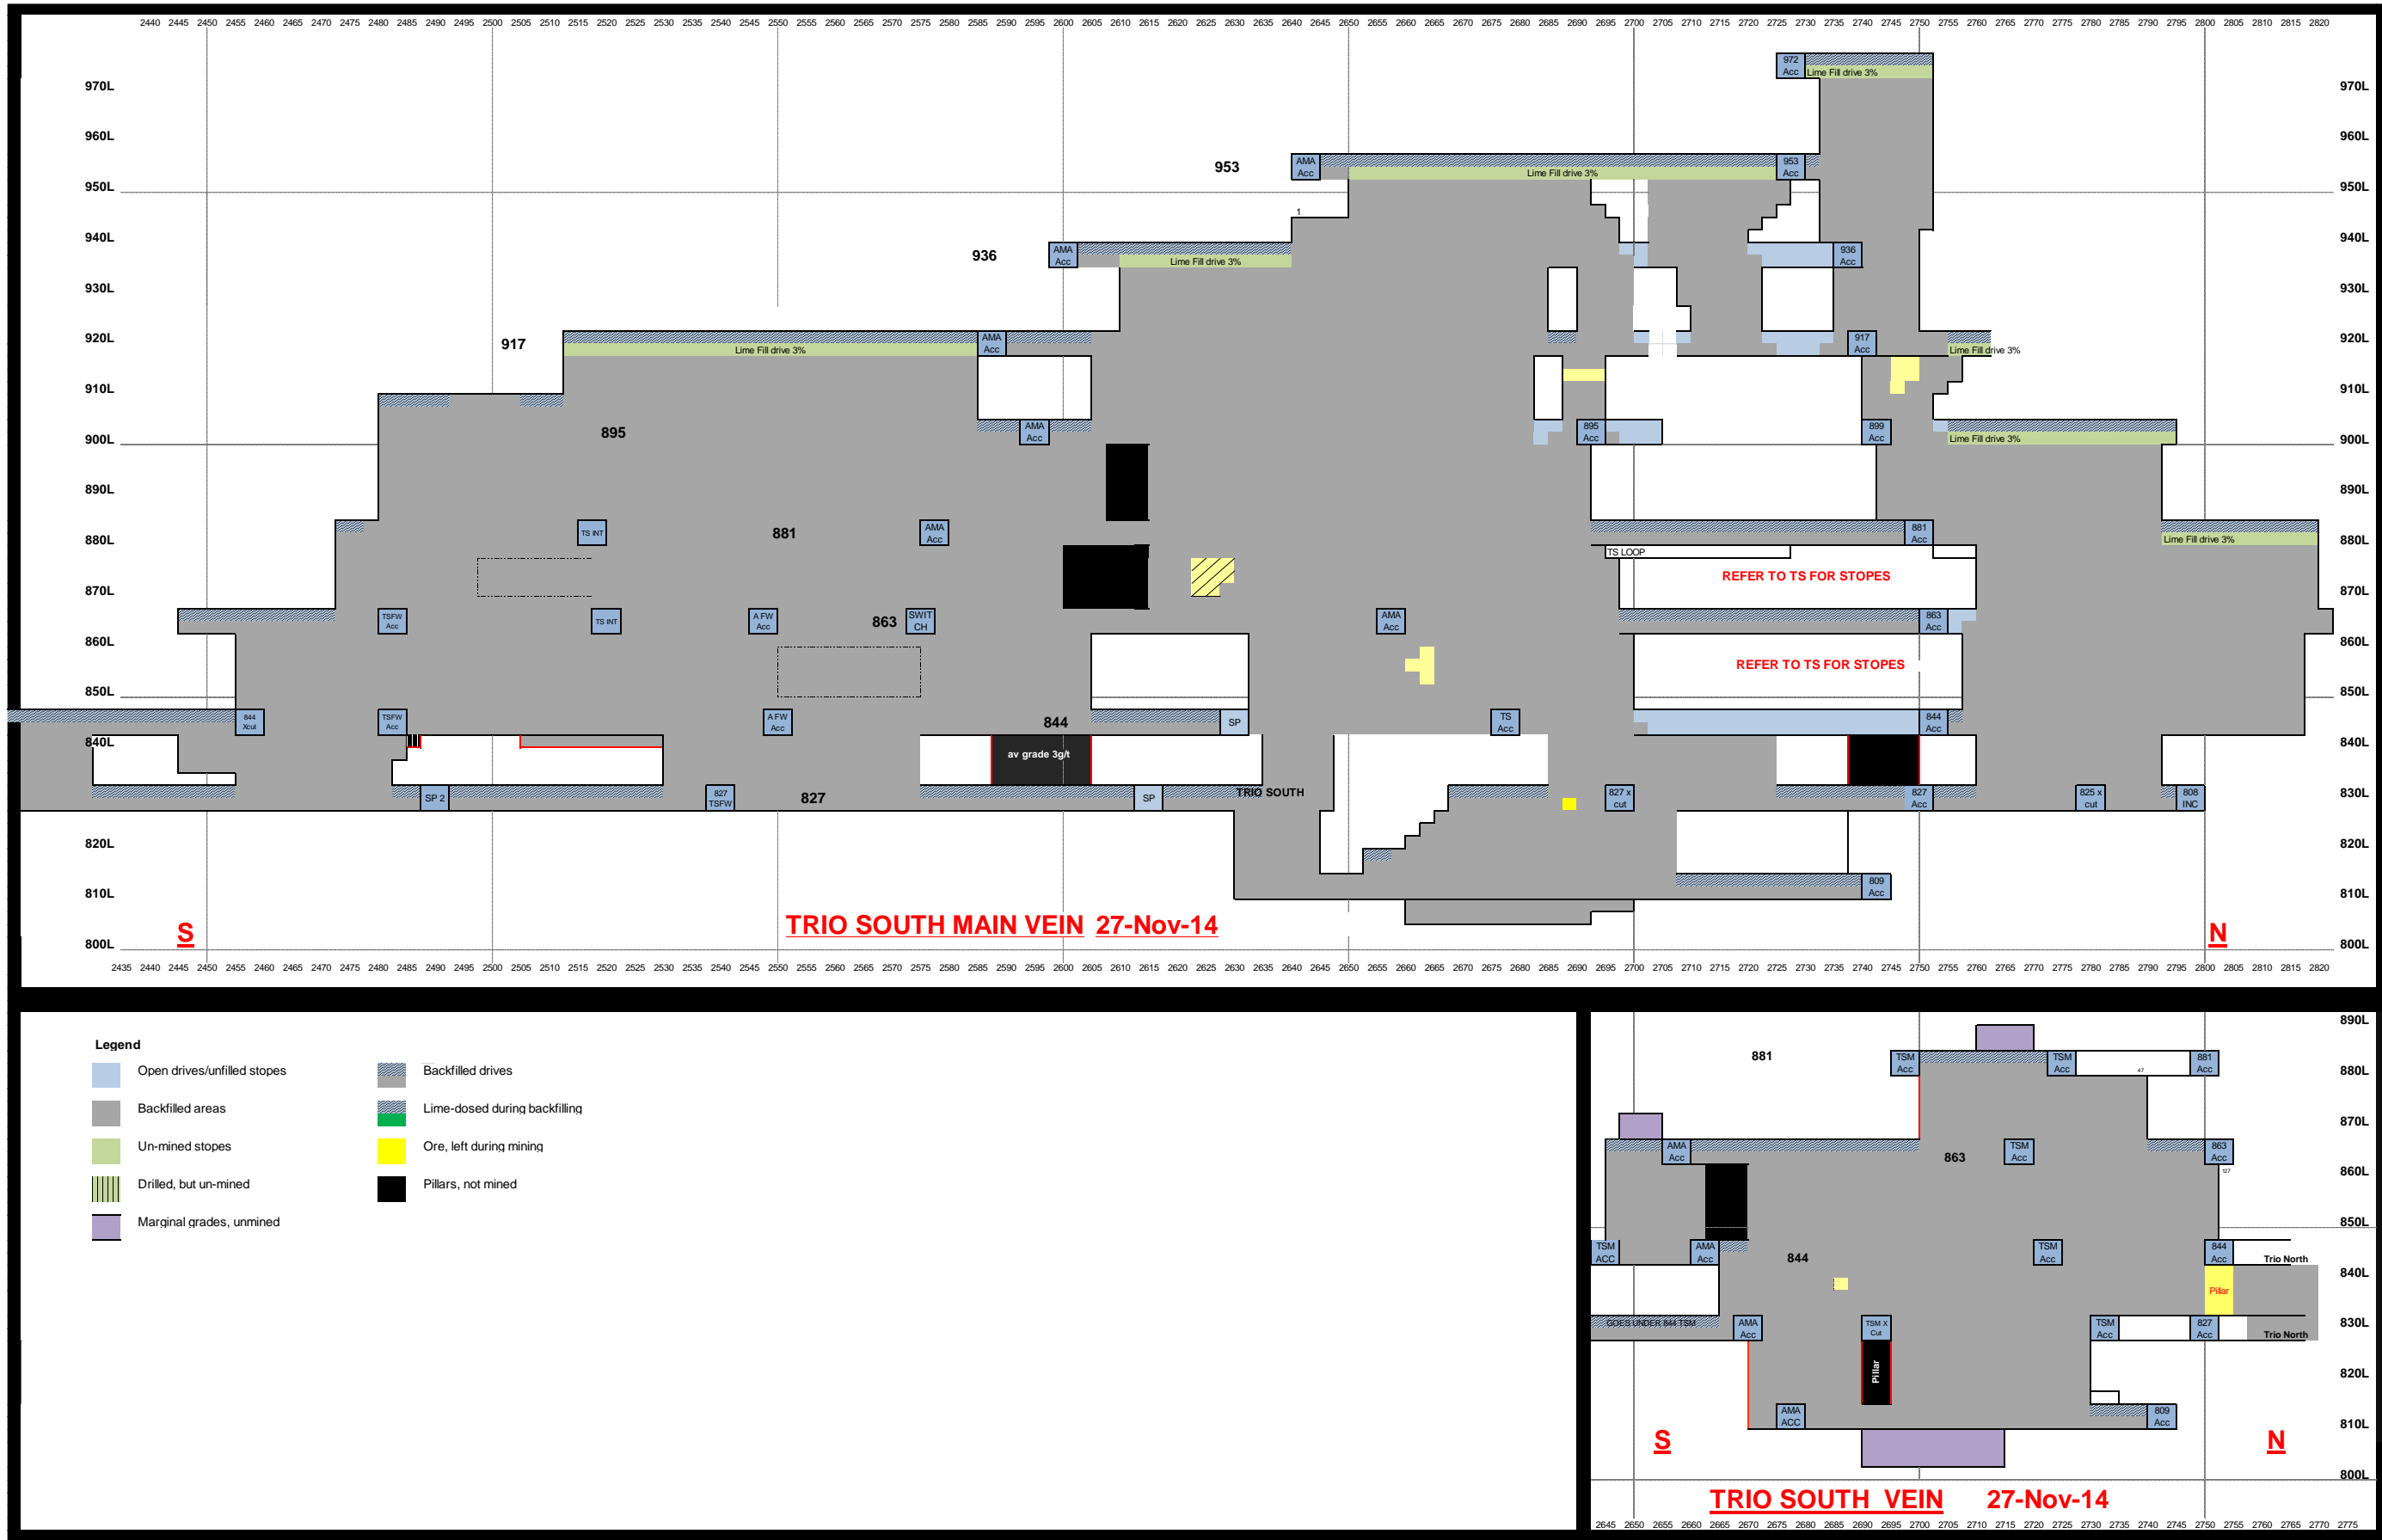
Figure 3c: Long view of Trio Mine
