5 August 2022

Leigh Robcke
Senior Project Planner
Hauraki District Council

Waihi North Transportation Assessment – sec 92 review to determine if further information is required - memo

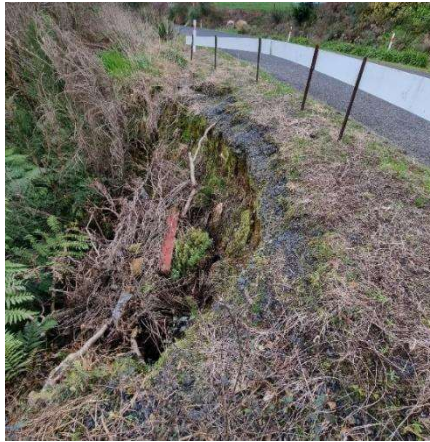
1. At Culvert 65 (appx. Chainage 0.66km), there is a narrow shoulder on the inside of a curve, with a 2m+ drop-off which is around 1m from the edge of seal. Currently this has a sight rail in place, which indicates this has been a safety concern in the past.

Figure 1 – Narrow & steep shoulder at Culvert 65, Chainage 0.66km

The ITA doesn't address the effects of safety or risk of incident relative to the extent and nature of the traffic movements for the above items – or identify measures to manage/mitigate such effects. Please provide an assessment and recommended conditions, for each of the above locations, to address such effects (where identified).

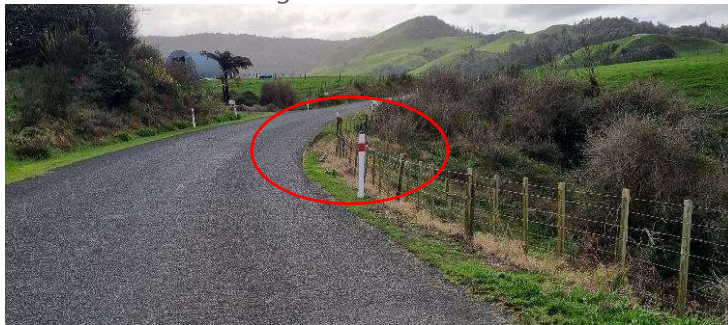
2. Just south of Culvert 65 (apprx. Chainage 0.62km), there is a 3-4m+ drop-off on the inside of a curve, which is within 1m of the edge of seal.

Figure 2 – Narrow & steep shoulder just south of Culvert 65, Chainage 0.62km

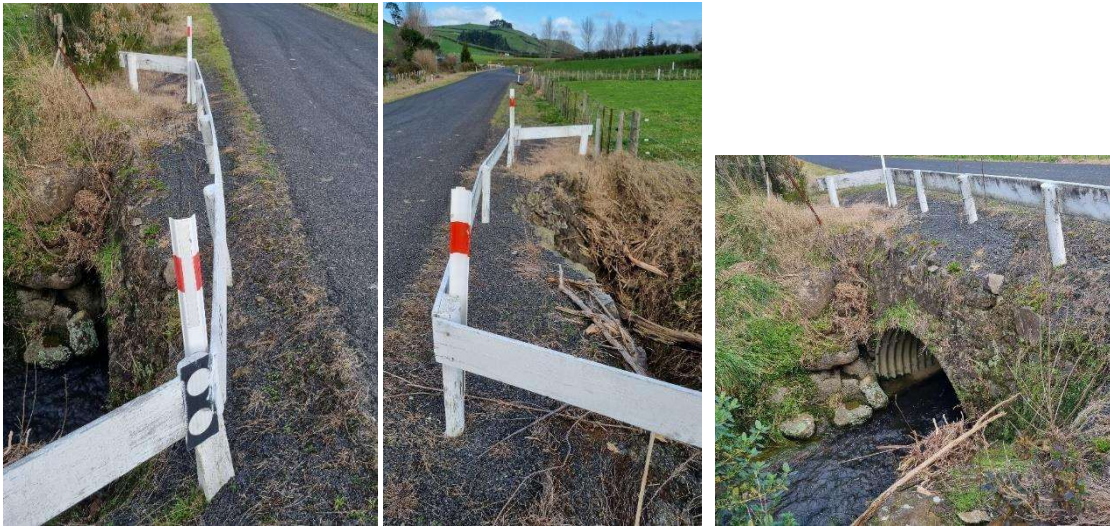
3. At apprx. Chainage 0.37km, there is an approx. 2m dia. Armco culvert crossing under the road (approx. 70m north of Highland Rd). The road shoulders in this location narrow to within 0.5m from edge of seal, with a 2m drop-off, both sides of the road. The road also narrows slightly at this point to 5.5m sealed width. There are currently sight rails in place, which indicates this has been a safety concern in the past.

Figure 3 – Narrow & steep shoulders at Armco Culvert, Chainage 0.37km
