Appendix A – site record form

Site Record Form

NZAA SITE NUMBER: T13/923

SITE TYPE: Mining - gold

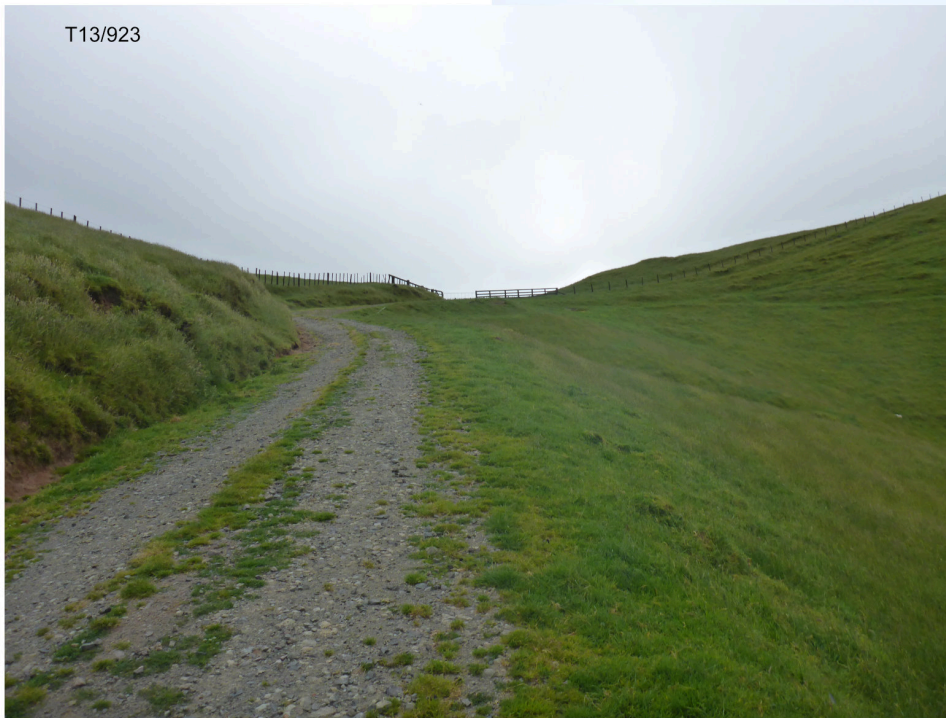
View west from Denize Brothers farm access track across to Adit 2 (T13/923).

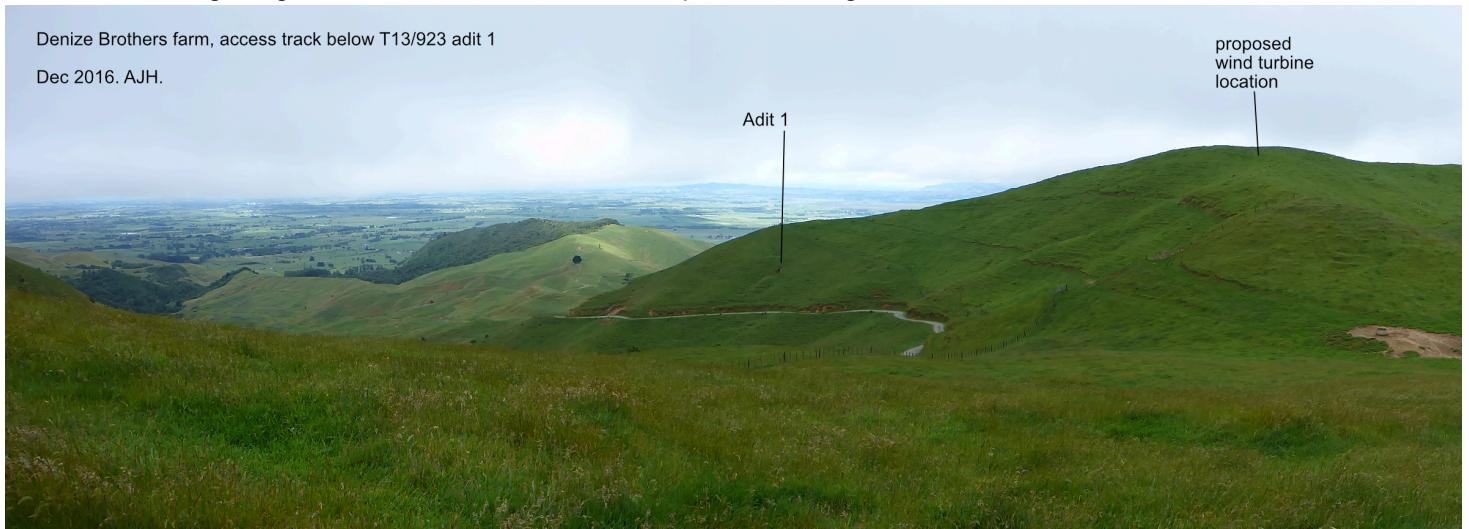
View SW from high ridge across T13/923 adit 1. Hauraki plains in background

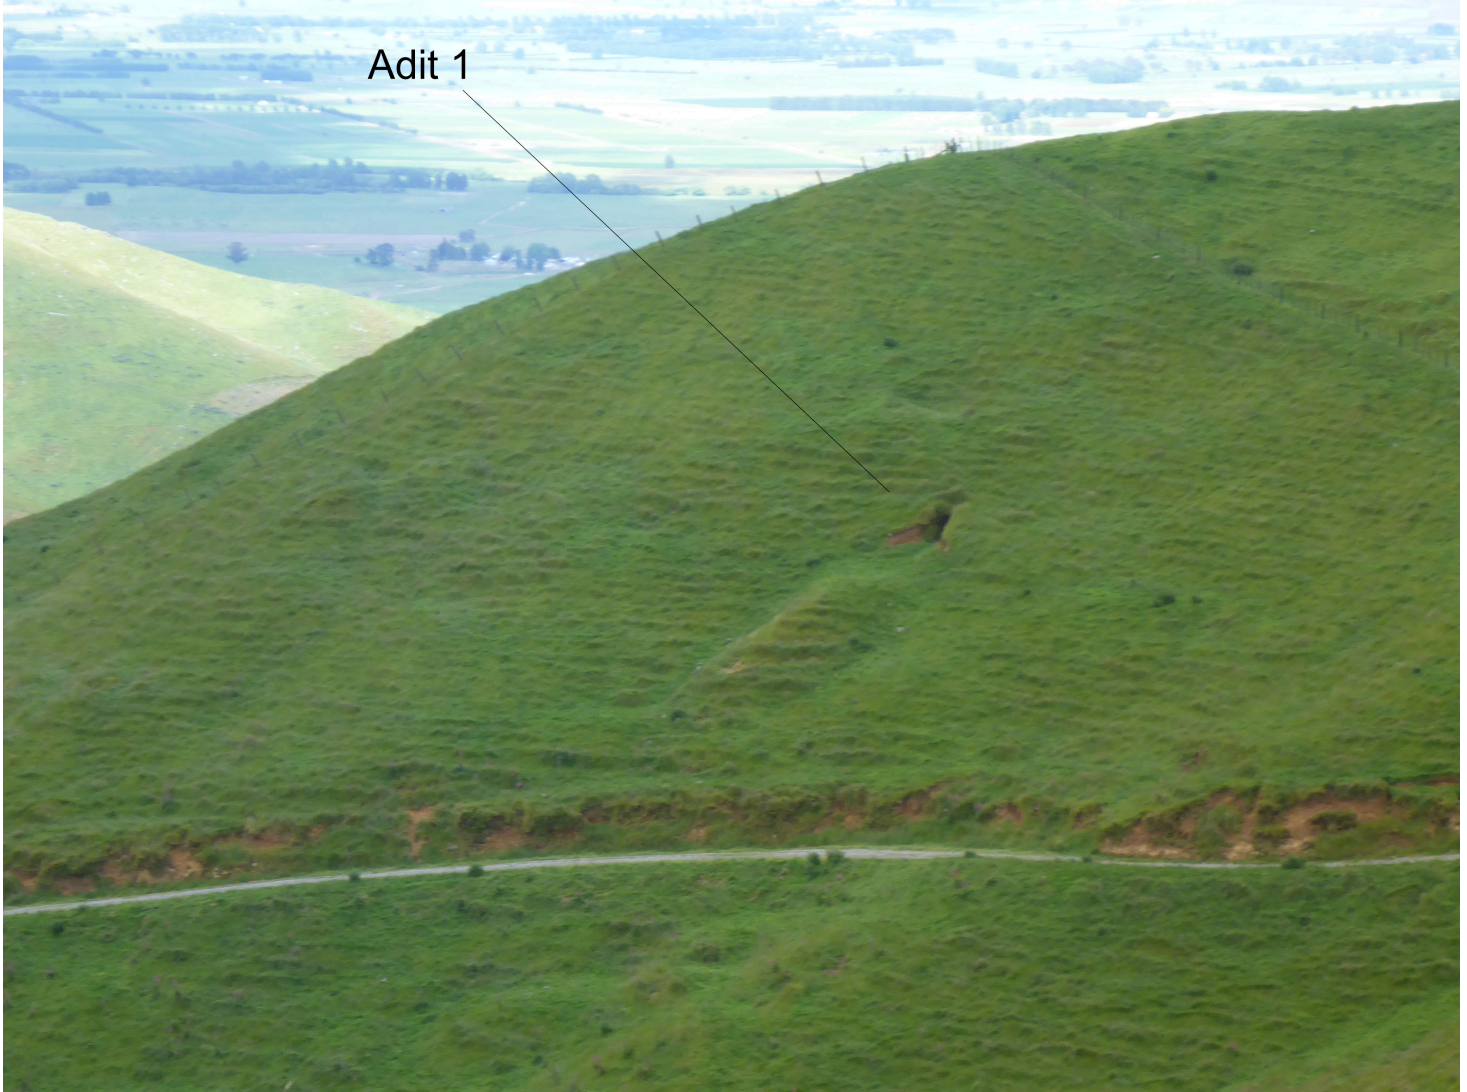
Denize Brothers farm, access track below T13/923 adit 1

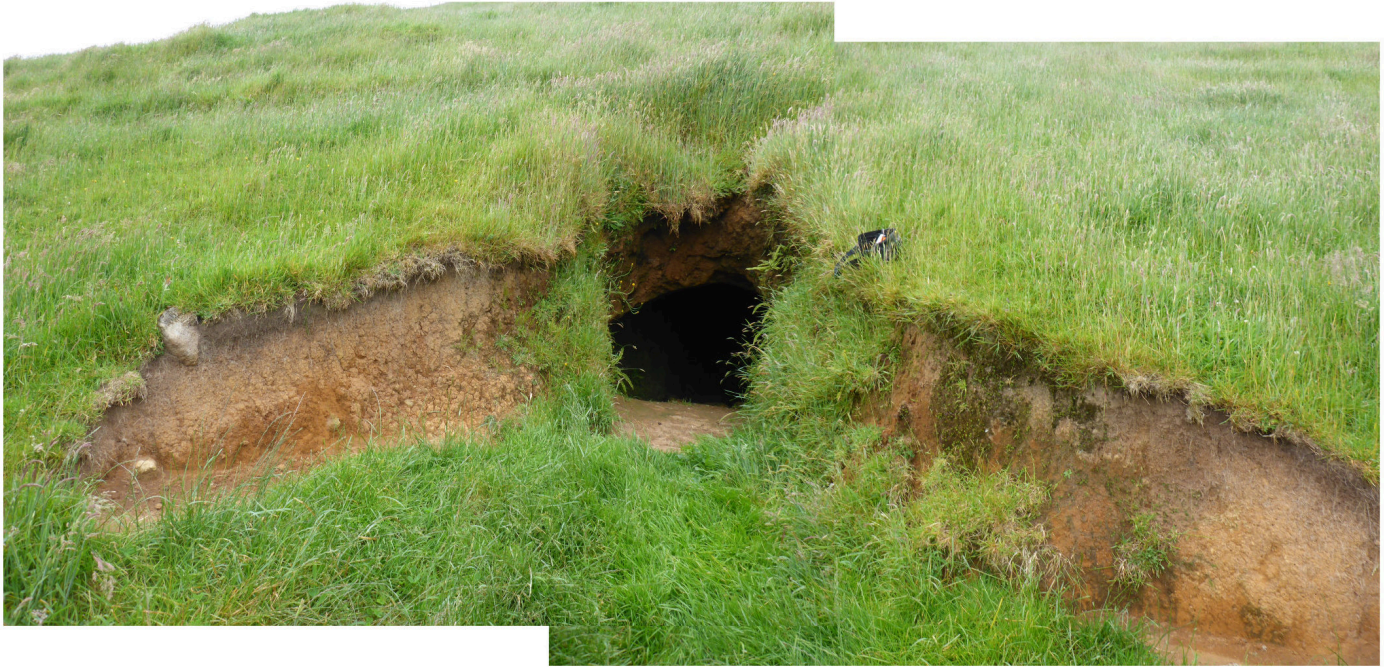
Adit 1 entrance

Adit 1) E1840097/N5851739: prospecting adit, partially collapsed at entrance. Not entered. Mullock heap visible on eastern aspect slope forward of entrance, under grass. Existing benched farm access track is c.30 below entrance, 10 m below lowest point of mullock heap.
