# Kaimai Wind Farm: Supplementary Culvert Assessment Report

Report Number: 1708069-03

Prepared for: Ventus Energy (NZ) Limited

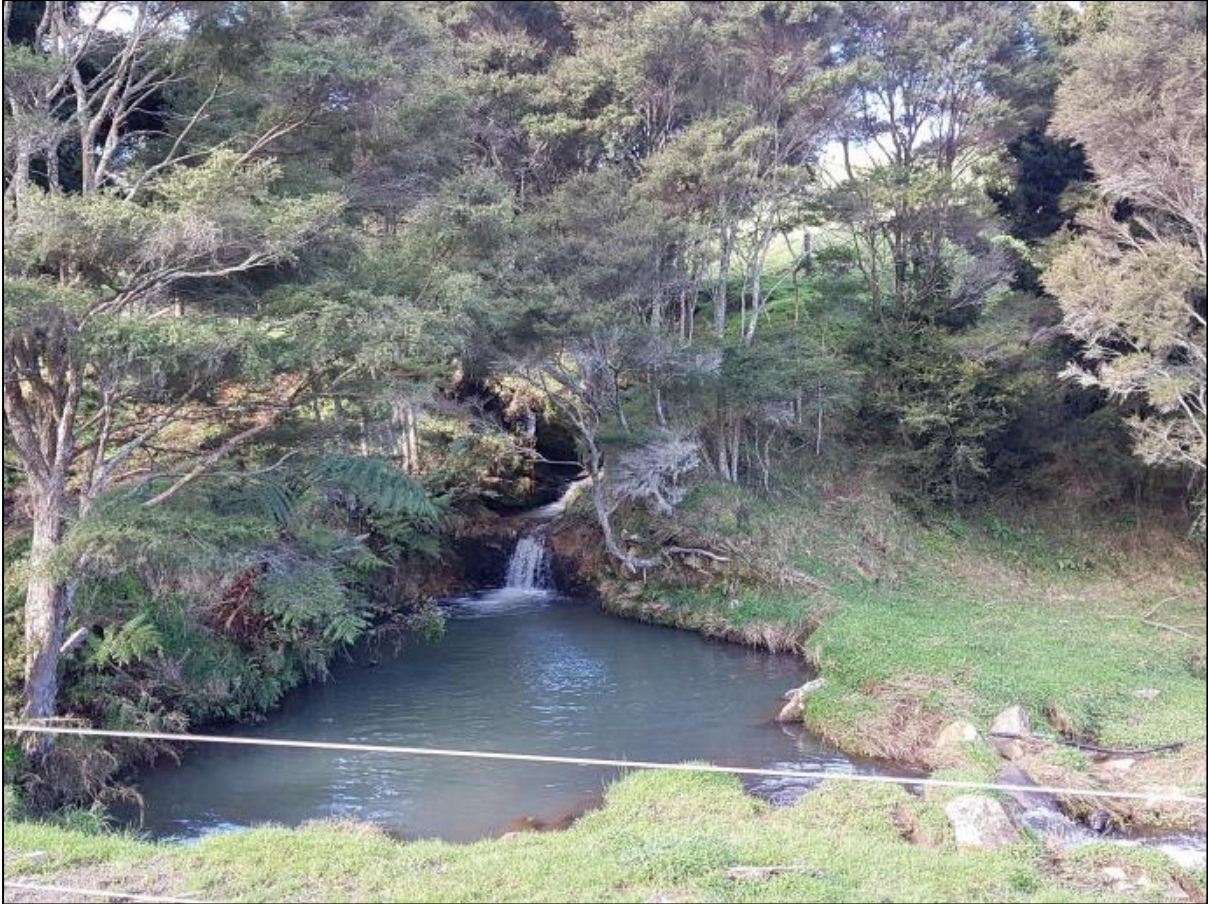
Longfin eel (*Anguilla dieffenbachii*) were noted throughout the catchment in lower numbers compared to shortfin eel (*Anguilla australis*). Individuals caught throughout the reach presented several age classes with a large individual (1.5m) being caught at C7 within a large deep pool system. Shortfin eels were present through the entire catchment with individuals caught throughout the reach presenting a range of age classes with the large individuals recorded around 1 m in length. The presence of both longfin and shortfin eels above the waterfall indicate that this presents no barrier to anguilliformes.

*Plate 1 View of small waterfall identified as a potential barrier to poor climbers*

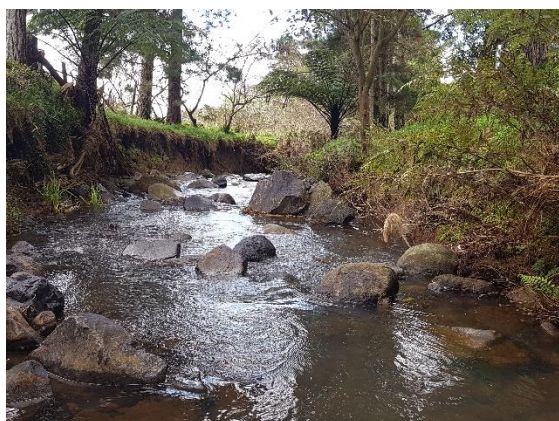
*Plate 2 View of downstream of C1*

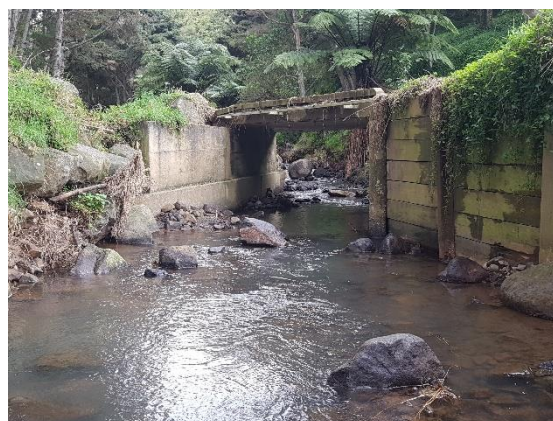
*Plate 3 View of downstream looking up to C1*

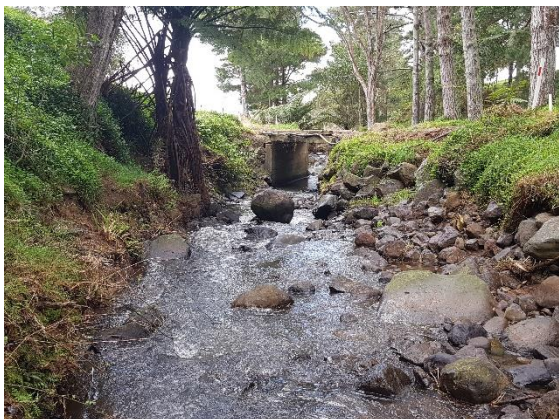
Plate 4 View of upstream looking down to C1

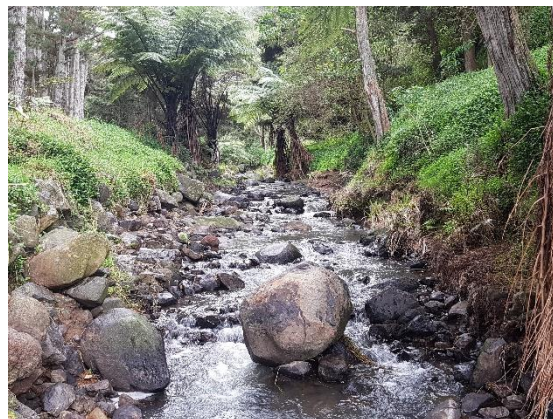
Plate 5 View of upstream of C1

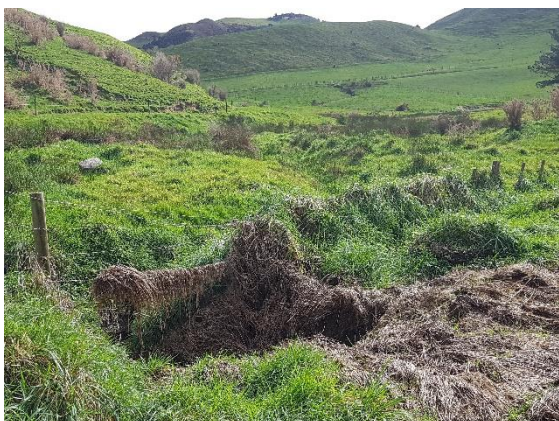
Plate 6 View of upstream wetland stream at C2

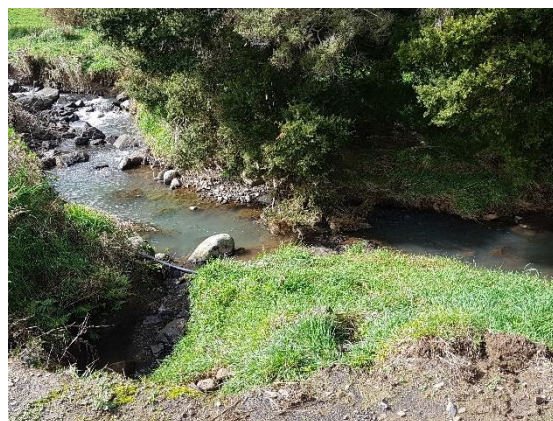
Plate 7 View of downstream of C2 looking at the confluence

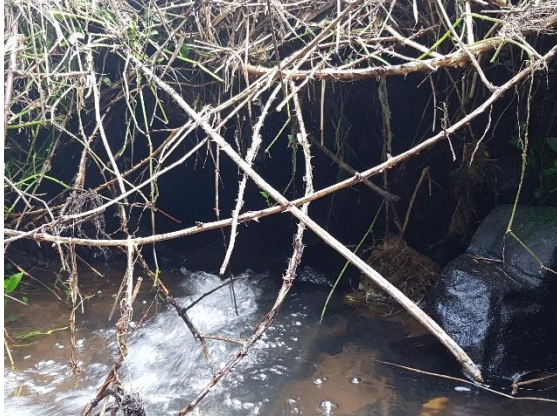
Plate 8 View of C2 discharging into the tributary

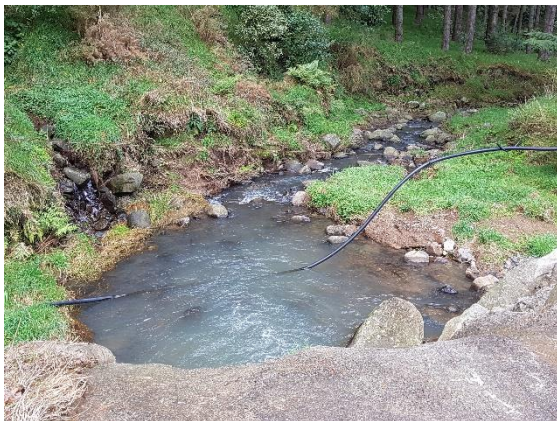
Plate 9 View of downstream of C3 including large pool

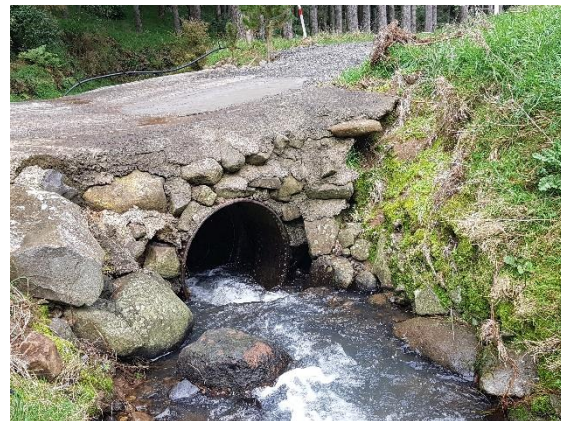
Plate 10 View of upstream looking down on C3

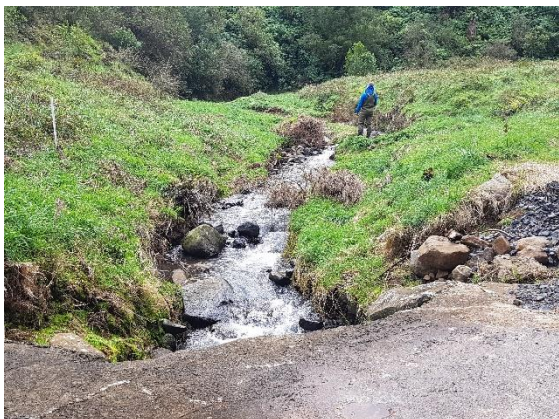
*Plate 11 View of upstream of C3*

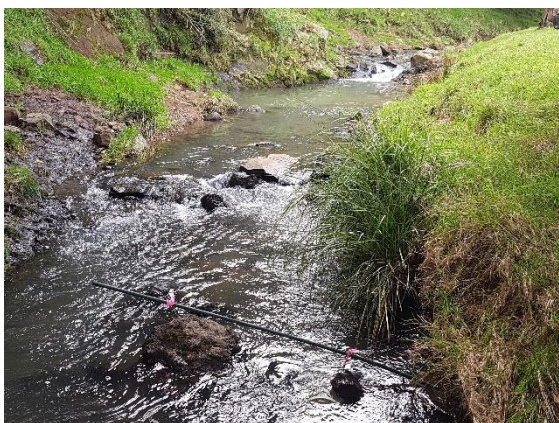
*Plate 12 View of downstream of C4*

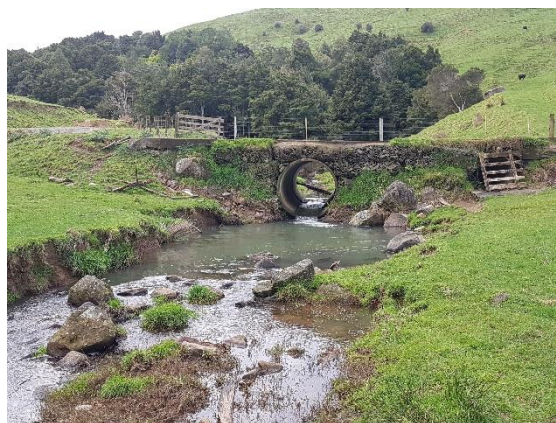
*Plate 13 View of downstream looking up to C4*

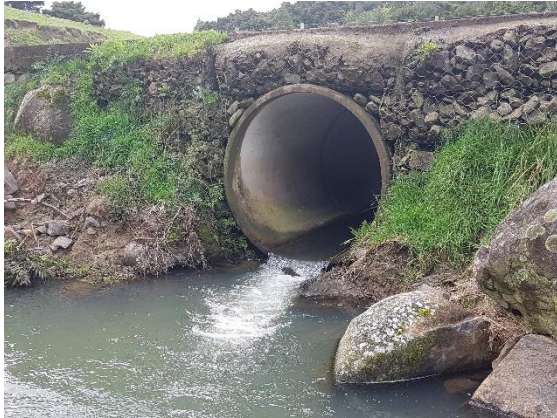
*Plate 14 View of small perch on C4*

To remediate the potential effects of the culvert upgrades, a design that is sensitive to fish passage should be used. For replacement of culverts, it is recommended that culverts be placed well below the level of the current stream bed and material placed in the culvert to replicate the natural stream bed present on site and allow for natural substrate movement. Culverts should be placed at the same gradient and alignment as the stream and the diameter should be equal to or greater than the average stream width (stream width should be determined as the defined stream channel that majority of the flows are contained within) – narrower culverts cause a sudden increase in flow rate which can reduce the ability of fish to move through the culvert. Placement should be such that “perching” of the culvert is avoided – if a culvert is above the water level on the downstream side, then there is a gap between two effective stream beds which prevents fish from migrating past this point. If this situation is unavoidable (for example with those culverts that will remain in place but be extended) the installation of a fish ladder or similar

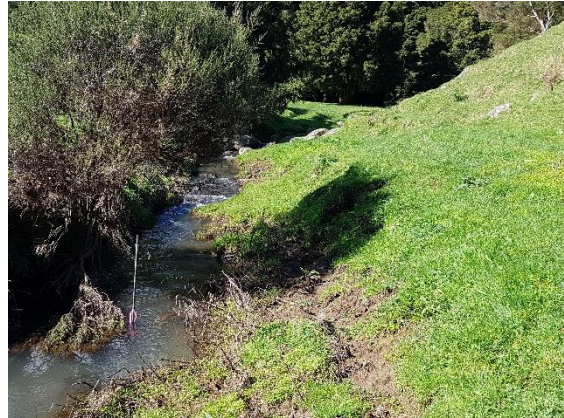
*Plate 15 View of upstream of C4*

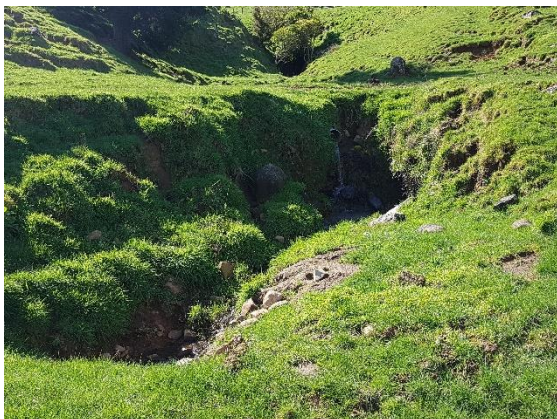
*Plate 16 View of upstream of C5*

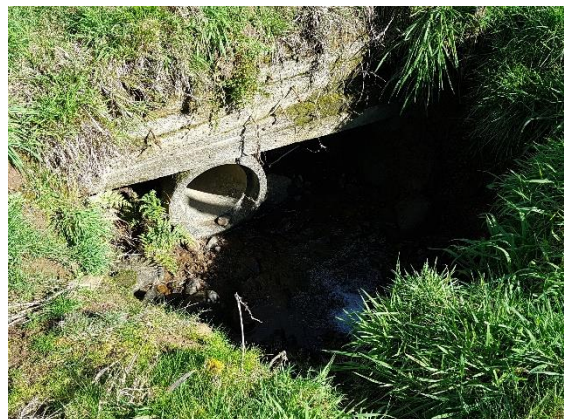
*Plate 17 View of upstream looking at C5*

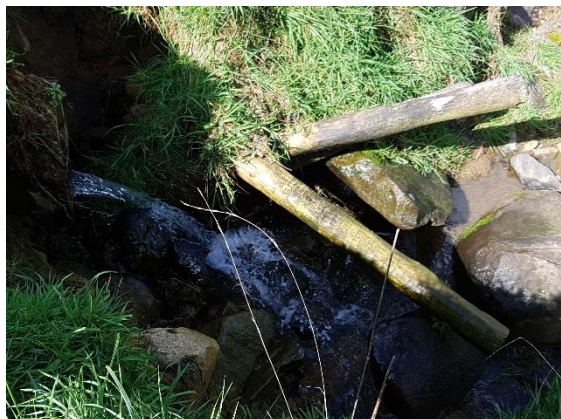
*Plate 18 View of downstream looking at discharge of C5*

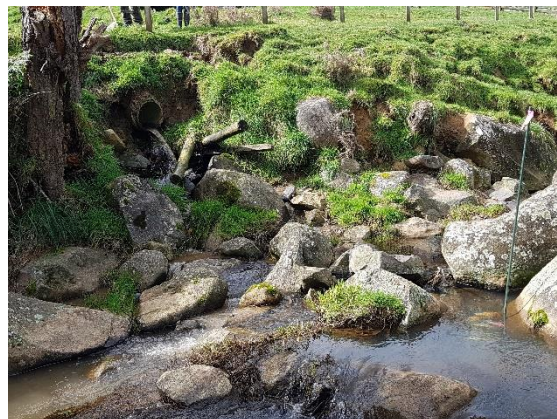
*Plate 19 View of downstream of C5 including Gee Minnow location*

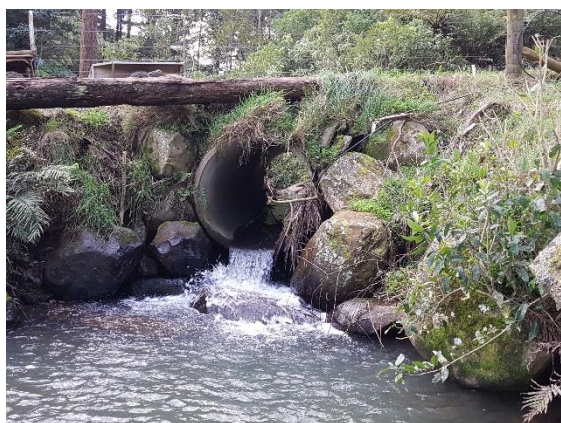
*Plate 20 View of downstream pool of C6*

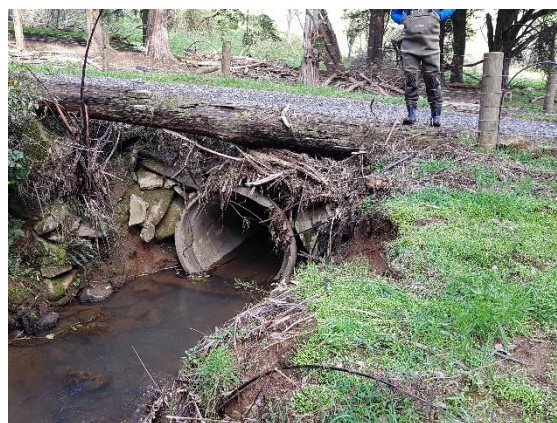
*Plate 21 View of upstream looking at C6*

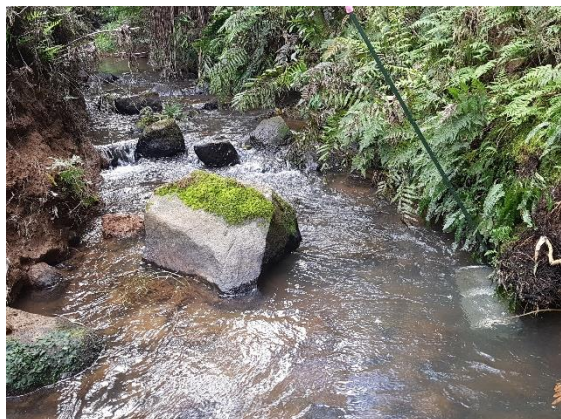
*Plate 22 View of upstream tributary*

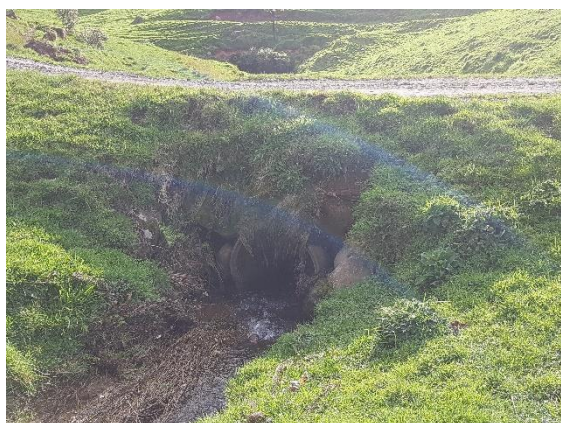
*Plate 23 View of upstream of C7 looking towards C7*

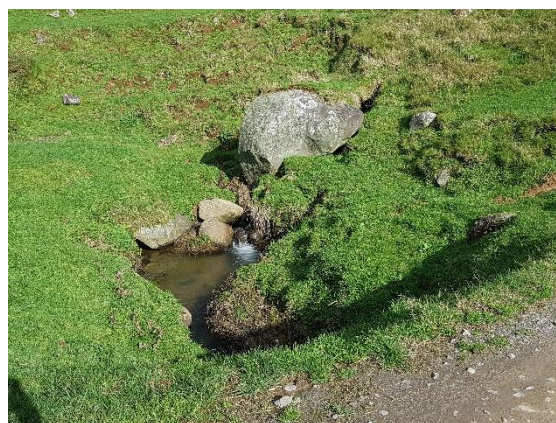
*Plate 24 View of downstream of C7*

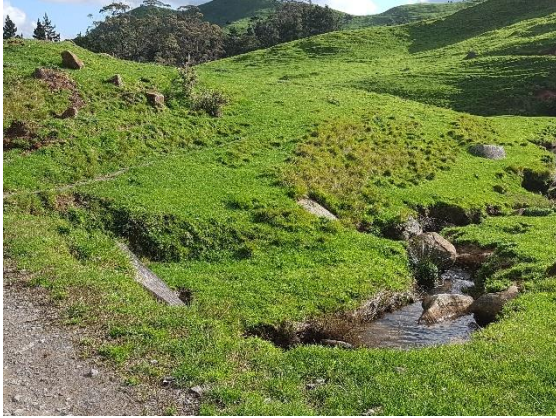
*Plate 25 View of downstream looking at discharge of C8*

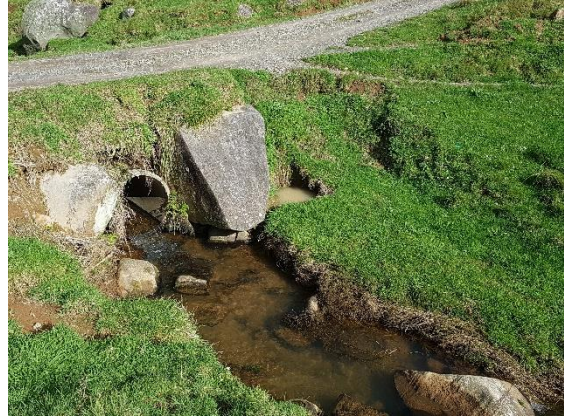
*Plate 26 View of downstream of C8 viewing the small perch*
