Historic Heritage Inventory

Gladstone Battery, Waihi

Number: **HAU245**

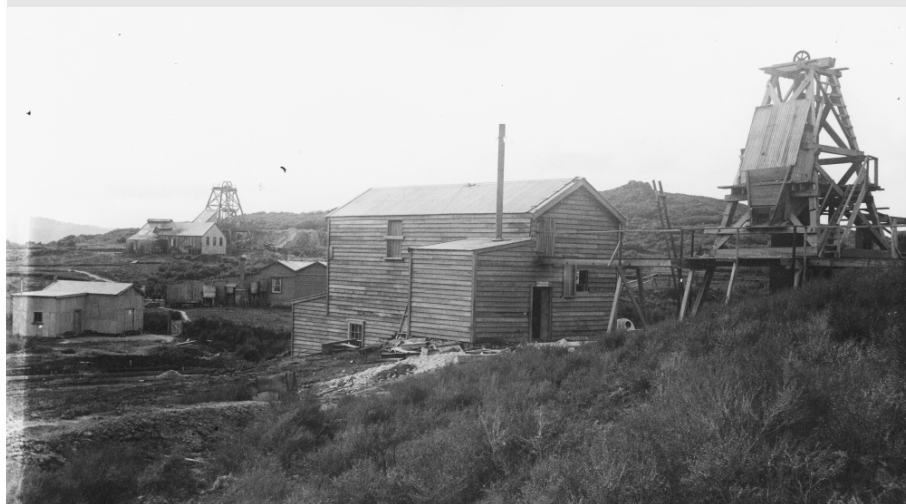
Physical Description: Remains of a 5 stamp battery and the Gladstone shaft.

Photo above shows Gladstone shaft and battery building. The shaft on the right has an ore chute to load trucks which get pushed into the battery building. The small opening in the middle of the end of the building is to allow passage of the cable from winding drum to poppet sheave (for lifting of the shaft cage). The (weather board) battery building suggests three levels (stone breaker near roof, stampers below this, and one or more lower levels for cyaniding), and the chimney from the lean-to suggests a small boiler (for the Tangye engine). Work ceased at this shaft circa 1902 (E. Lens).
