Kaimai Wind Farm: Supplementary Ecology Report

Report Number: 1708069-02

Prepared for: Ventus Energy (NZ) Limited

14 June 2018

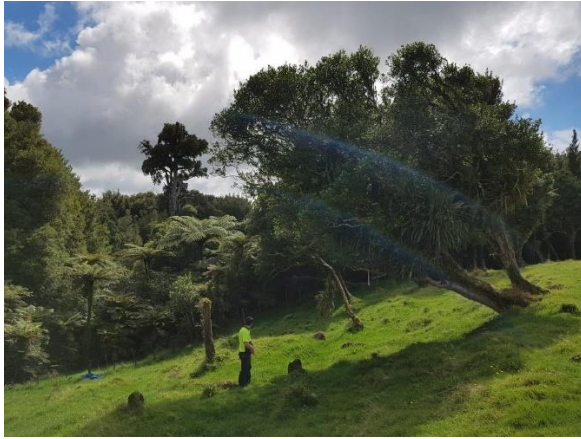
Figure 3: Representative photo of ABM 03 site

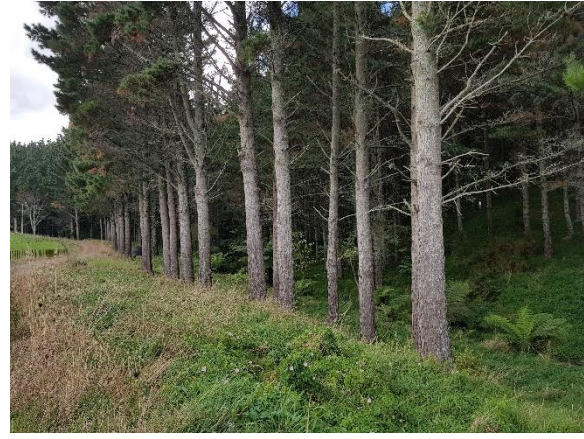
Figure 4: Representative photo of ABM 18 site

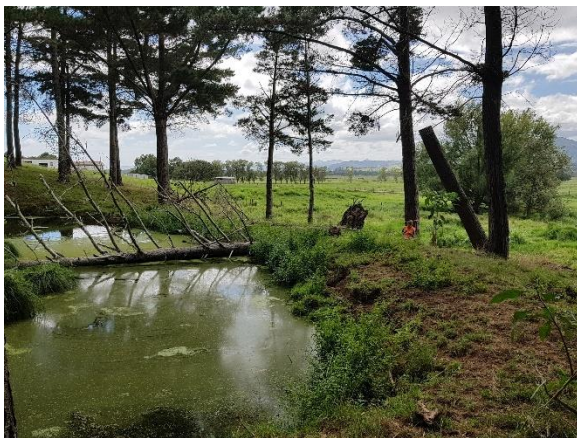
Figure 5: Representative photo of ABM 11 site

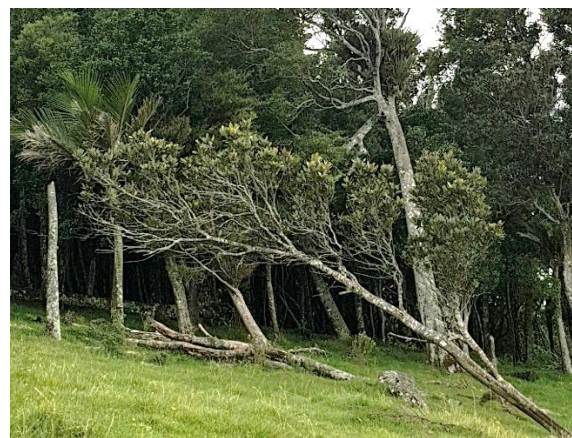
Figure 6: Representative photo of ABM 16 site
