8888-6B

14 June 2018

**GEOTECHNICAL ENGINEERING INVESTIGATION
PROPOSED WINDFARM
ROTOKOHU ROAD
PAEROA**

Geotechnical Engineering Investigation
Proposed Windfarm
Rotokohu Road
Paeroa

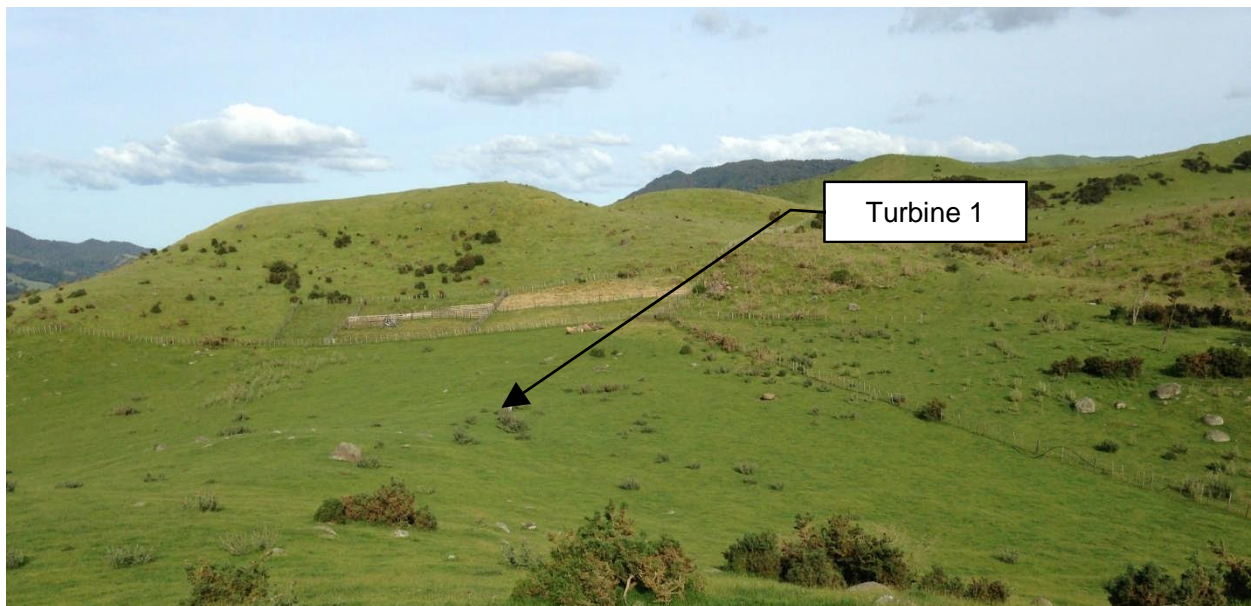
Turbine 1

- Gently sloping ridge line falling to northeast and southwest, on a saddle between hilltops.
- Ground conditions expected to comprise very stiff to hard clay and silt soils within depth of turbine footing excavation.
- No geotechnical concerns for this site.

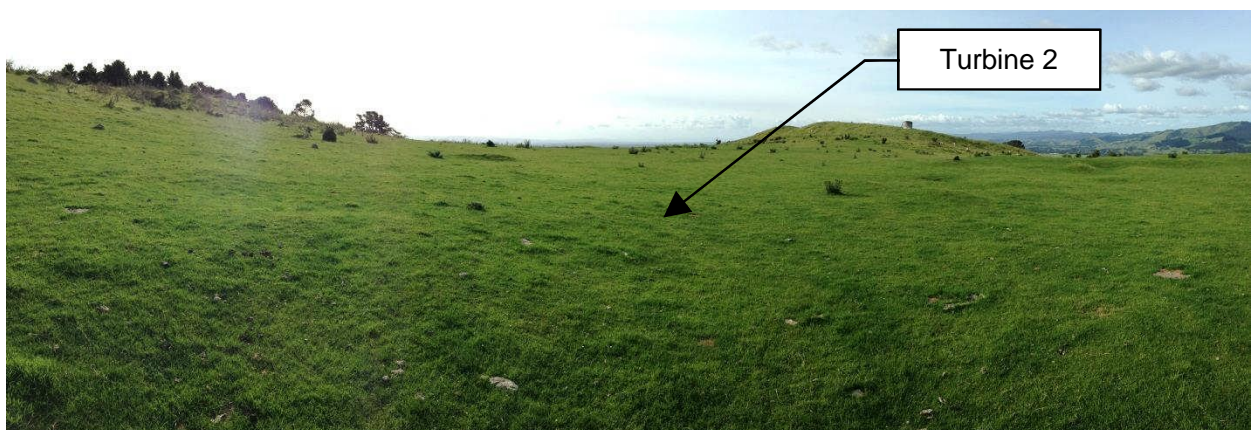
Turbine 2

- Near level ridge line.
- Ground conditions expected to comprise very stiff to hard clay and silt soils within depths of turbine footing excavation.
- No geotechnical concerns for this site.

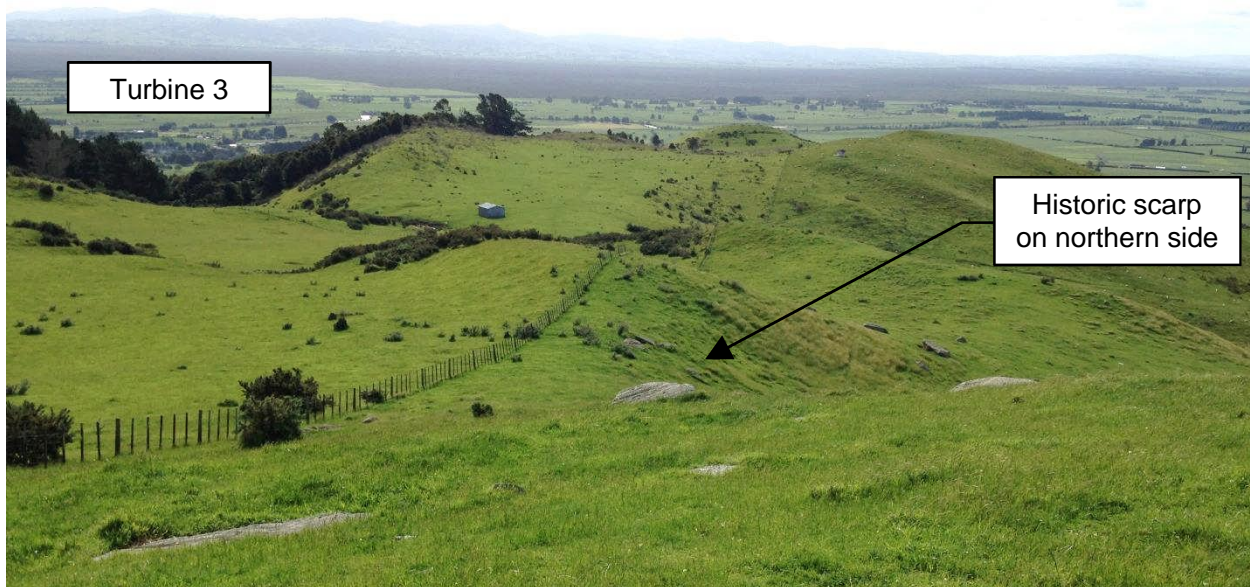
Turbine 3

- Narrow hilltop with moderately sloping side slopes.
- Back scarp identified on northern slope with the slope falling at approximately 25°. The feature is smooth in appearance and is suspected to be historical.
- Ground conditions expected to comprise very stiff to hard clay and silt soils.
- The hilltop is narrower than the foundation base of a turbine and will need to be lowered.
- The ground conditions are expected to get harder with depth and depending on the depth of excavation required for the turbine platform, it is possible that rock will be encountered within the excavation depth.

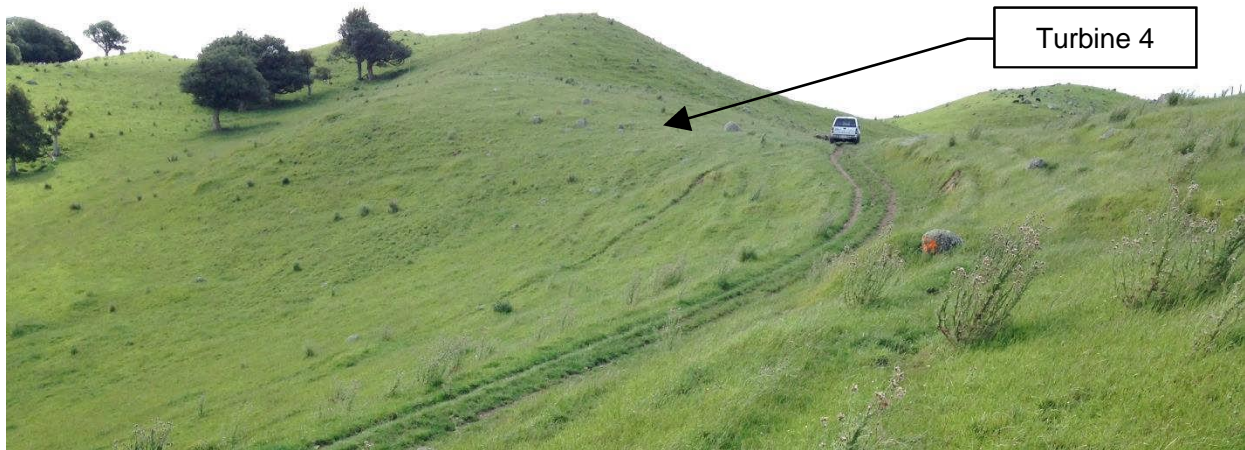
Turbine 4

- Ridgeline, with broad top, approximately 35m wide.
- Side slopes are moderately sloping.
- Ground conditions comprise hard CGVD to approximately 5.5m depth.
- The ridgeline will need to be lowered to form a level platform for the turbine and crane. The ground was found to be hard and rock is likely to be encountered at approximately 5m to 6m depth. Boulders may be encountered within the soil at shallower depths.
- As part of foundation design slope stability should be considered, as per Section 9.

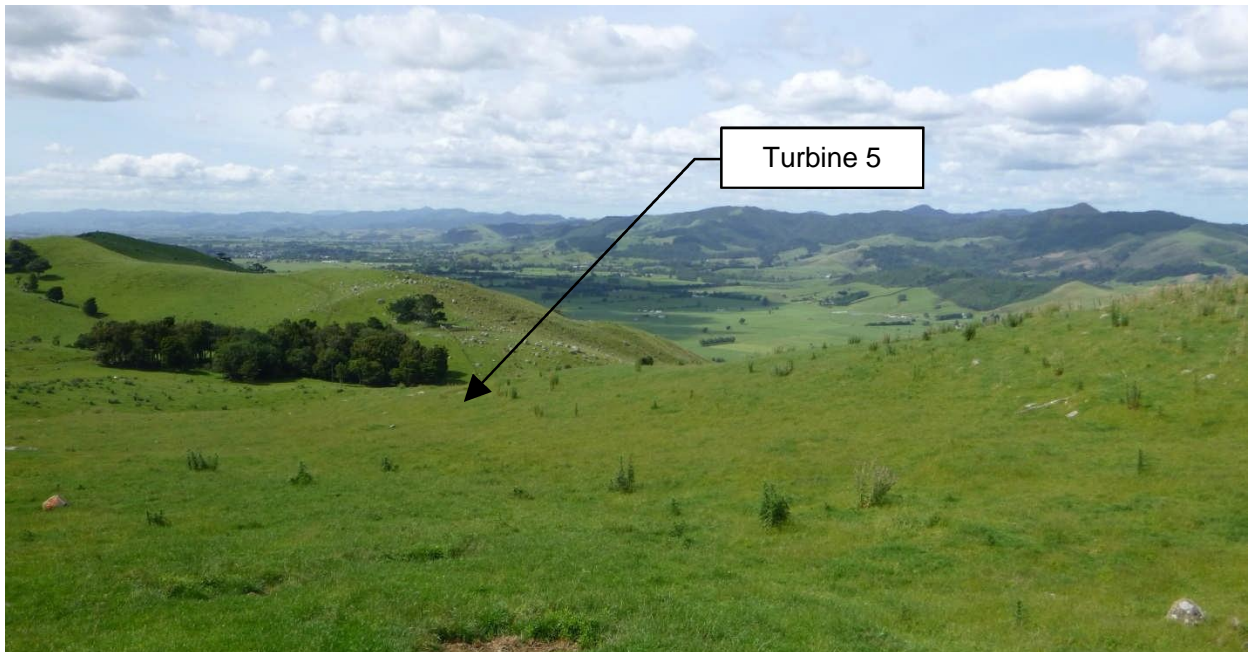
Turbine 5

- Gently to moderately sloping, north facing slope falling at up to approximately 16° at the turbine site.
- The ground surface of the site and surrounding area is hummocky in appearance with curved surface features located upslope of the turbine site indicating past slope movement and presence of colluvium lobes. The features are smoothed suggesting historical movement.

- The ground conditions identified suspected colluvium, which is consistent with our observations of past slope movement. Very stiff to hard soils were encountered to approximately 6m depth. Intermixed sand was encountered from approximately 3m depth.

- Groundwater was encountered at approximately 3.4m depth and the material was described as wet.
- We recommend that the turbine platform be formed by excavation only. To reduce potential excavation, we suggest that as part of the micro siting of the turbine, the ground profile in the general area be considered as excavation will reduce where slopes are gentler.

- Excavation may also be required for the crane platform.

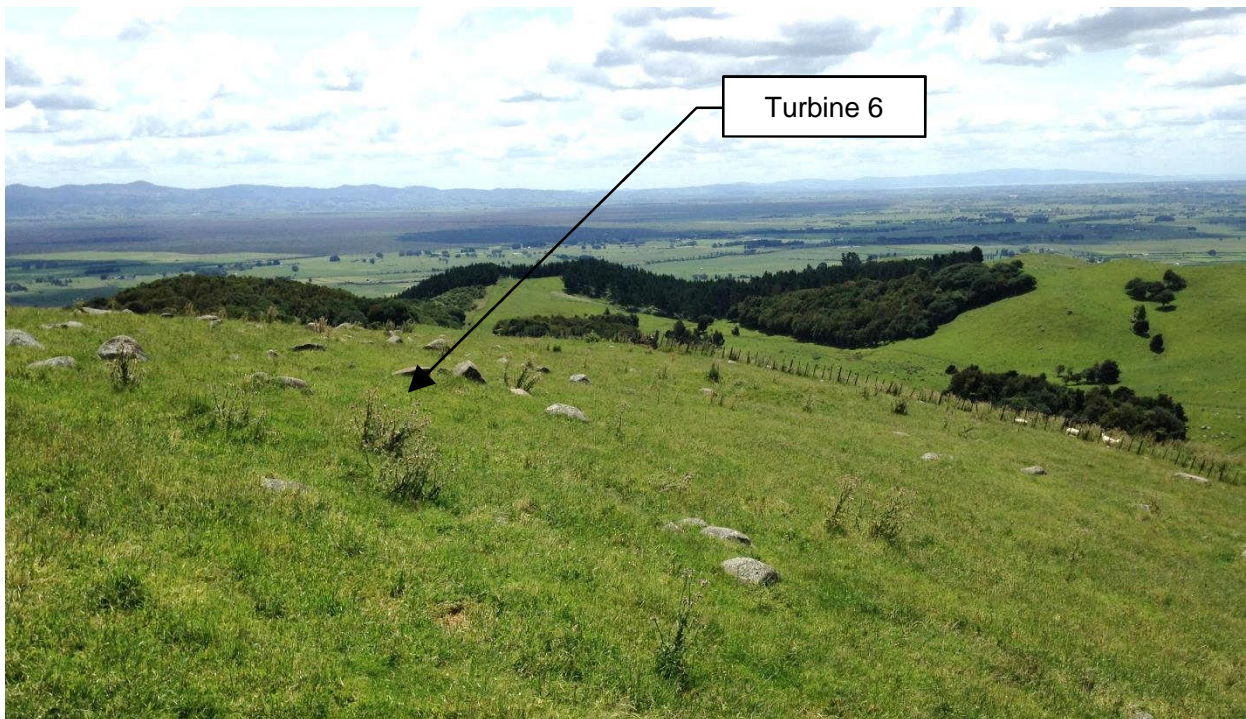
Turbine 6

- Broad ridgeline, falling to the north, with steep side slopes to the east and west at up to approximately 30°.
- Ground conditions are expected to comprise very stiff to hard clay and silt soils.
- It is likely that excavation will be necessary to form the level turbine platform. The ground conditions are expected to get harder with depth and depending on the depth of excavation required, it is possible that rock will be encountered within the excavation depth.
- As part of foundation design slope stability should be considered, as per Section 9.

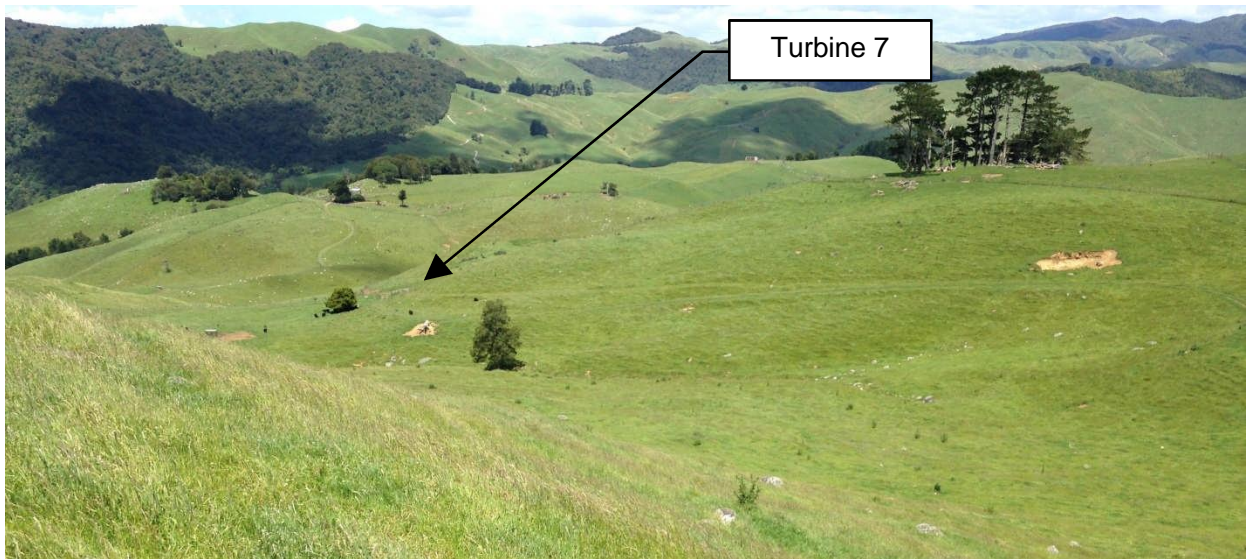
Turbine 7

- Gently sloping ridge line, that falls steeply to the east and west.
- Ground conditions are expected to comprise very stiff to hard clay and silt soils.
- It is likely that excavation will be necessary to form the level turbine platform. The ground conditions are expected to get harder with depth and depending on the depth of excavation required, it is possible that rock will be encountered within the excavation depth.
- Slope stability should be considered when final siting of the turbine is known.

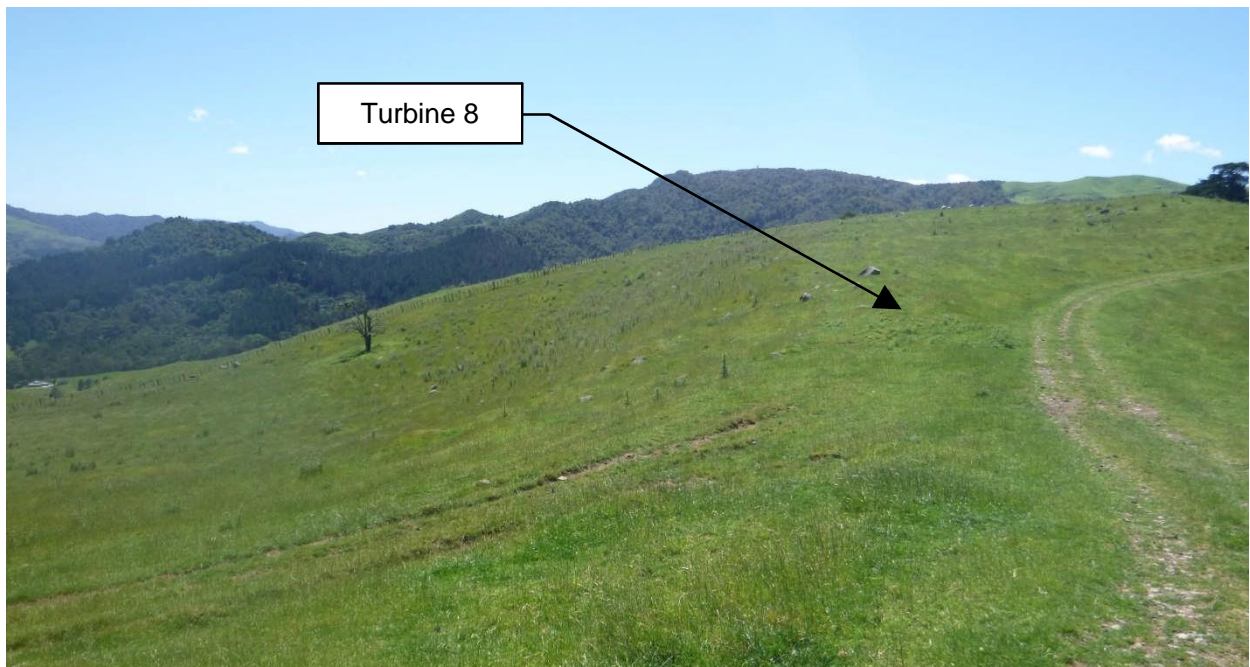
Turbine 8

- Turbine located on the northern side of a saddle along the ridgeline on a gently to moderate slope. The saddle is the high point, separating two gullies, which fall to the north and south.
- Ground conditions comprise hard CGVD soils, with shallow rock expected to be encountered at approximately 2m to 3m depth.
- The turbine site is located on sloping ground and excavation will be required to form a level base. It is possible that rock will be encountered within the excavation depth. To minimise excavation, locate the turbine on the more gently sloping ground in the general area.
- As part of foundation design slope stability should be considered, as per Section 9.

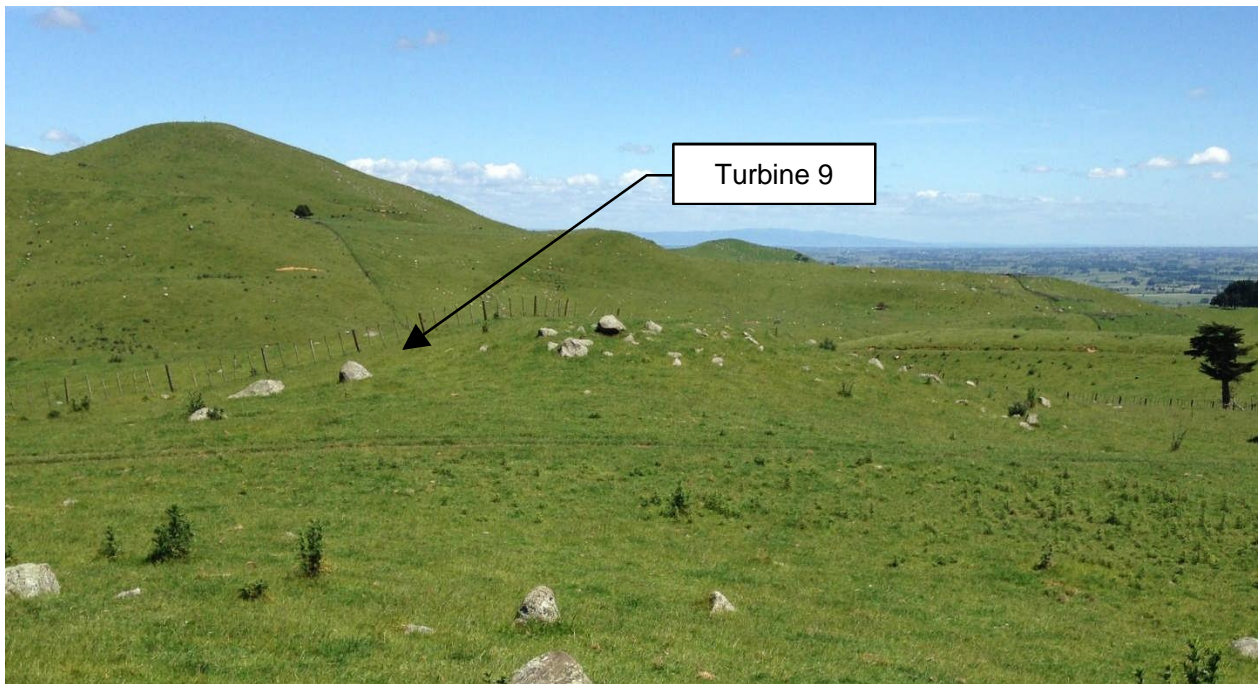
Turbine 9

- Gently sloping, east facing slope, that becomes moderately sloping further downslope.
- Ground conditions expected to comprise very stiff to hard CGVS soils with rock expected to be encountered between approximately 2m and 3m depth.
- Rock will likely be encountered within the excavation for the level platform.
- No geotechnical concerns for this site.

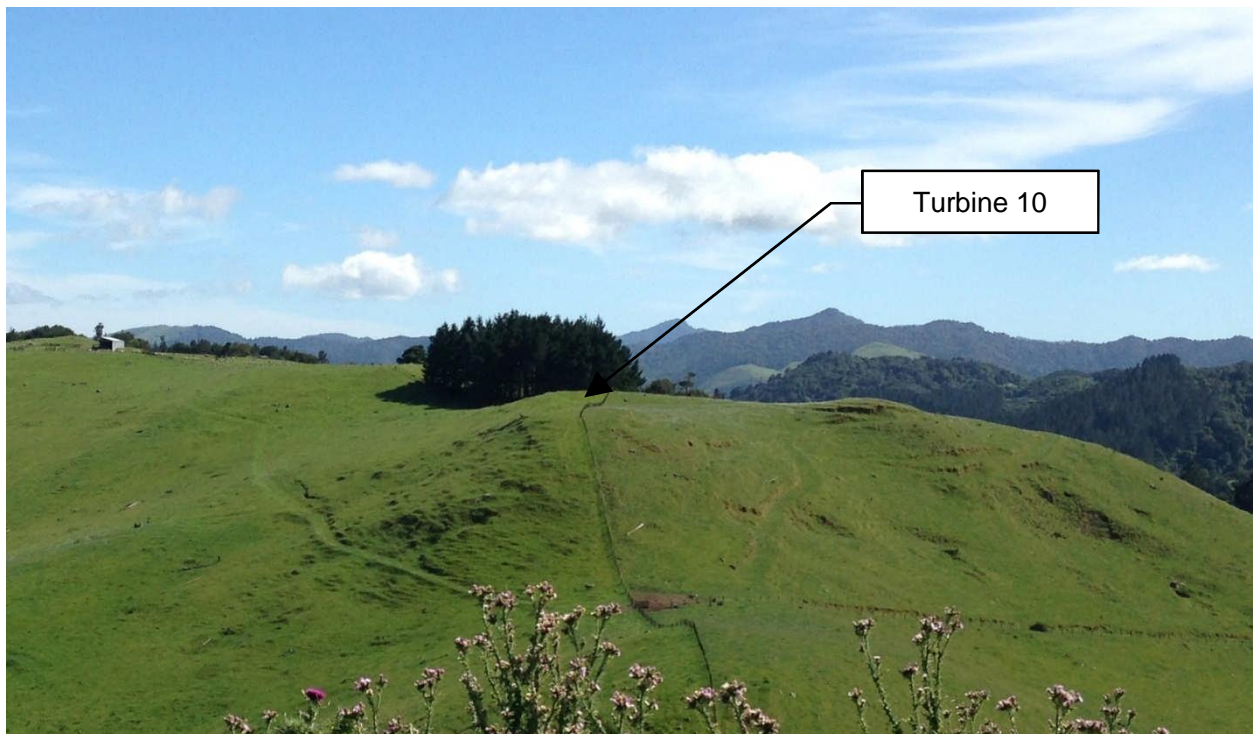
Turbine 10

- Gently sloping ridge. Side slopes to the west, south and southwest become moderately to steeply sloping.
- Ground conditions expected to comprise very stiff to hard CGVS soils with rock at approximately 3m depth.
- A level platform should be formed by excavation and it is likely that rock will be encountered within the depth of excavation.
- As part of foundation design slope stability should be considered, as per Section 9.

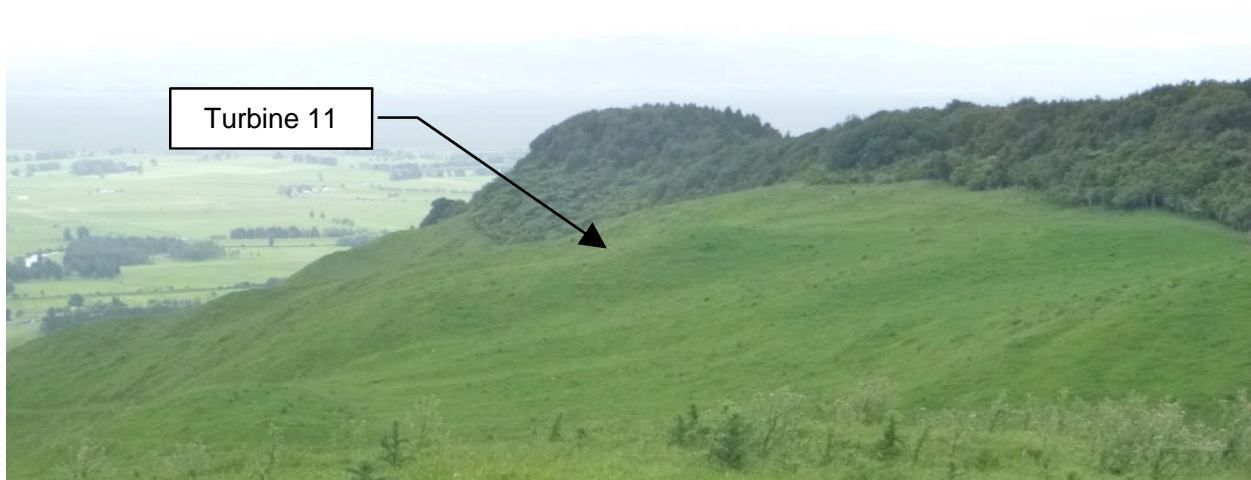
Turbine 11

- Moderately to steeply sloping, south facing slope.
- The ground surface of the site and surrounding area is hummocky in appearance with curved surface features indicating past slope movement. The features are smoothed suggesting historical movement.

- Very stiff to hard CGVD soils were encountered to approximately 2.2m depth, indicating shallow rock in this area. Rock bluffs were observed on the lower portion of the slope.

- We recommend that the turbine platform be formed by excavation only to provide a uniform subgrade. To minimise excavation, we suggest that as part of the micro siting of the turbine, it be located in the more gently sloping part of the general area. It is likely that rock will be encountered if excavation is greater than approximately 2.5m depth.

- Excavation may be required to form a platform for the crane.
- As part of foundation design slope stability should be considered, as per Section 9.

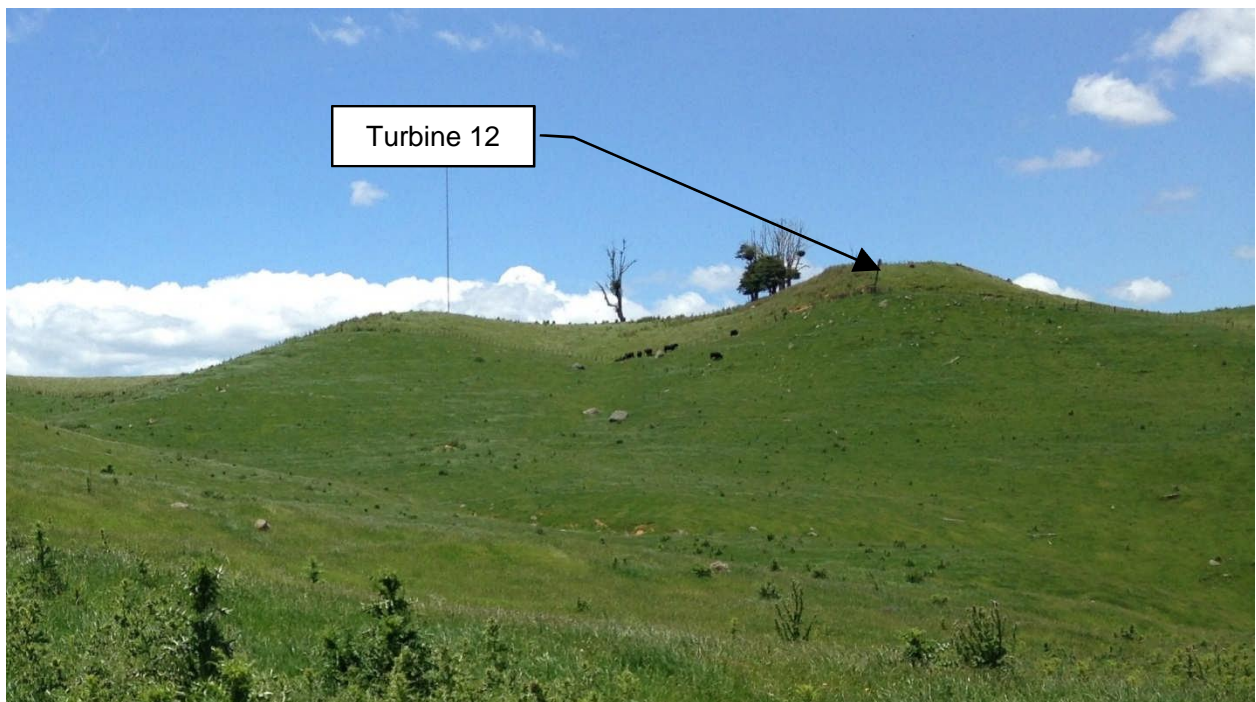
Turbine 12

- Narrow, spur ridge with steep side slopes.
- Surface creep observed on the side slopes.
- Ground conditions expected to comprise very stiff to hard CGVD soils to a depth in the order of 2m, based on results from nearby boreholes.
- Excavation will be necessary to form the level turbine platform. The ground conditions are expected to get harder with depth and depending on the depth of excavation required, it is possible that rock will be encountered within the excavation depth.
- The ridge line is gently sloping, but narrow, and some excavation may be required to form a platform for the crane.
- As part of foundation design slope stability should be considered, as per Section 9.

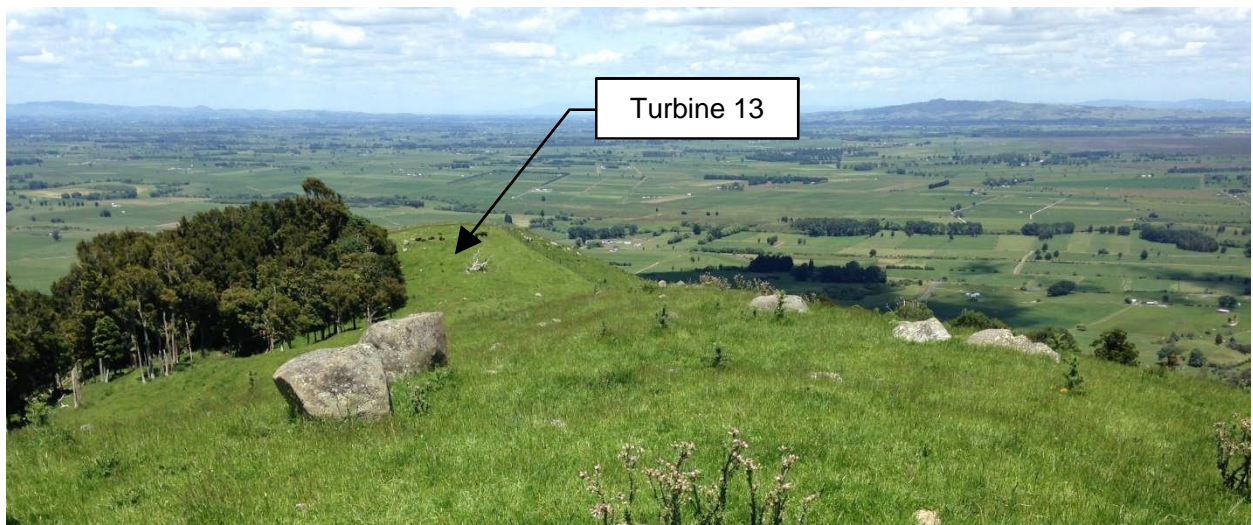
Turbine 13

- Spur ridge line with broad top and moderately sloping side slopes to the east and west.
- Ground conditions comprise hard CGVD soils, with shallow rock expected to be encountered at approximately 1m to 2m depth.
- Rock will likely be encountered with the excavation for the level platform.
- Slope stability and foundation design should be considered when final siting of the turbine is known.

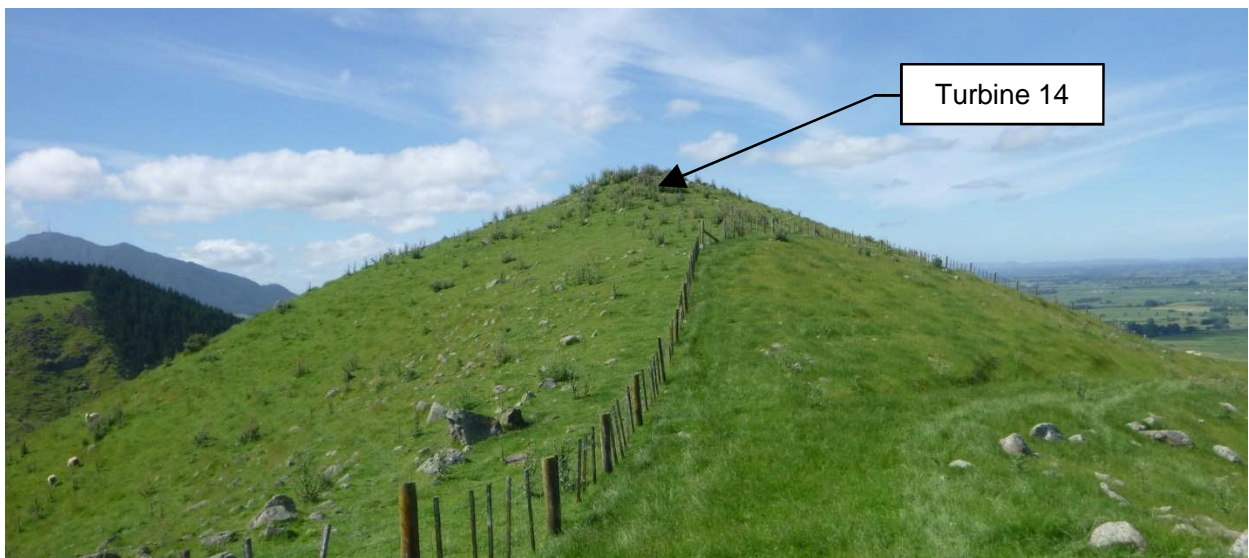
Turbine 14

- Located on a hilltop approximately 10m to 15m wide, along a narrow spur ridge. Side slopes are steep, falling at approximately 30° to 40°. The site is at the end of the spur ridge and several hill tops are present along its length.
- Ground conditions expected to comprise very stiff to hard CGVS soils with rock expected to be encountered between approximately 2m and 3m depth.
- The hilltop will need to be lowered significantly to form a level platform for the turbine and crane platform.
- As part of foundation design, slope stability should be considered, as per Section 9.
- Access to this area would involve either the lowering of the hilltops along the spur ridge, or cutting the access road into the side slopes which would form steep cut faces that will either require retaining or battering. Access road formation is discussed in Section 13.

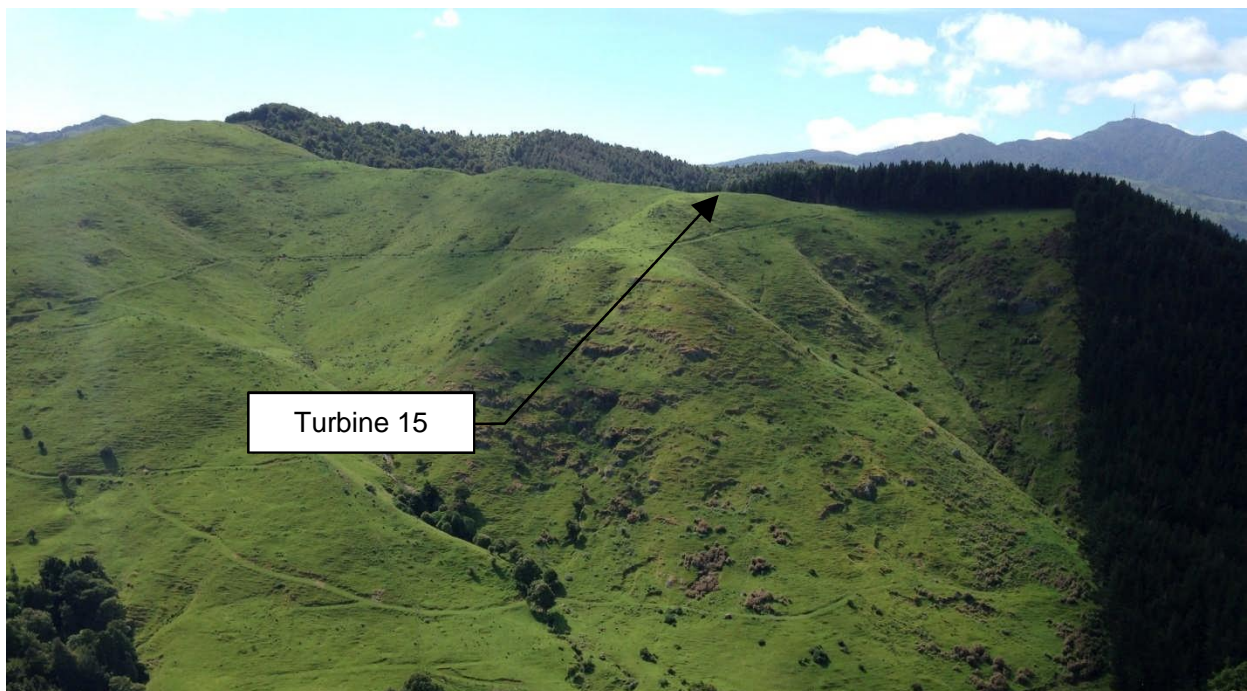
Turbine 15

- Located on gently sloping ridge line with moderate to steep side slopes.
- Ground conditions expected to comprise very stiff to hard CGVS soils with rock in excess of 5m depth.
- Curved features were observed downslope of the turbine site as well as downslope of the ridgeline to access the site. The features are smooth in appearance, indicating historic slope movement. Surface creep was also observed.
- We recommend that the turbine site be located as centrally on the ridge line as possible to increase distance to the steep side slopes.
- Some excavation will be required to form a level platform for the crane and turbine, however, there are no significant geotechnical concerns for this site.
- Slope stability and foundation design should be considered once exact turbine site is known.

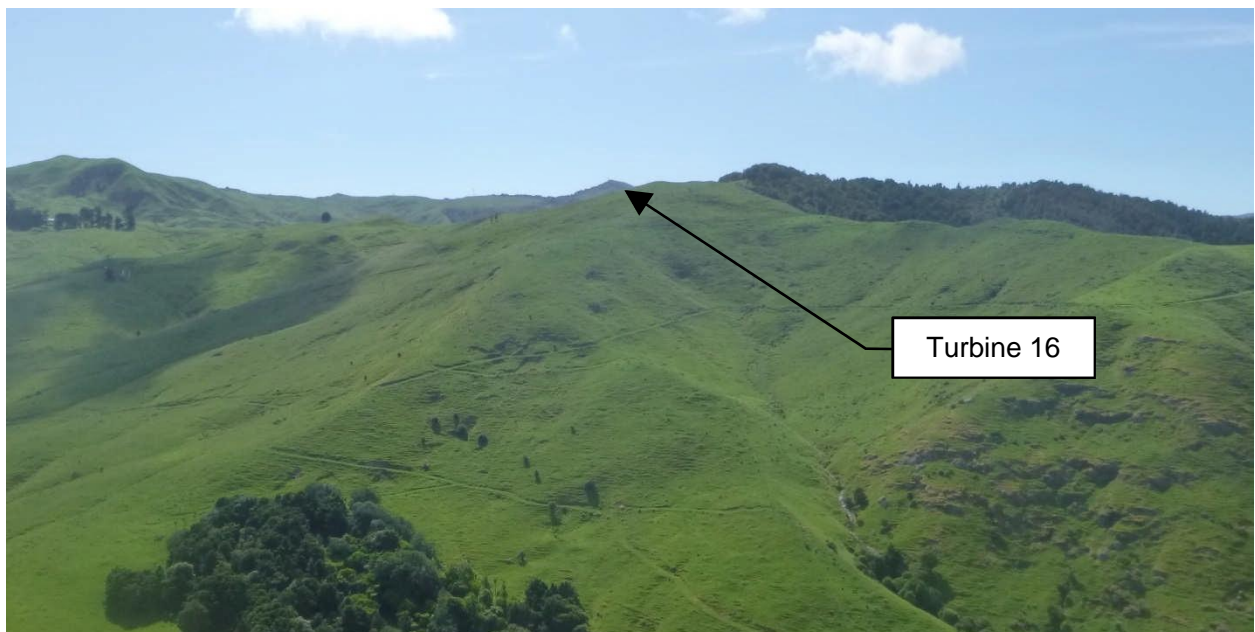
Turbine 16

- Located on upper, steeply sloping side slopes of the ridge line.
- Ground conditions expected to comprise very stiff to hard CGVS soils with rock expected to be encountered in excess of 5m depth.
- Curved features were observed in the vicinity of the turbine site as well as on the side slopes of the ridgeline to access the site. The features are smooth in appearance, indicating historic slope movement. Surface creep was also observed.
- Significant excavation will be required to form a level platform for the turbine and crane due to the steepness of the site, and rock may be encountered in the excavation depth.
- To minimise excavation depth, it may be prudent to locate the turbine on the more gently sloping ridge line.
- As part of foundation design, slope stability should be considered, as per Section 9.

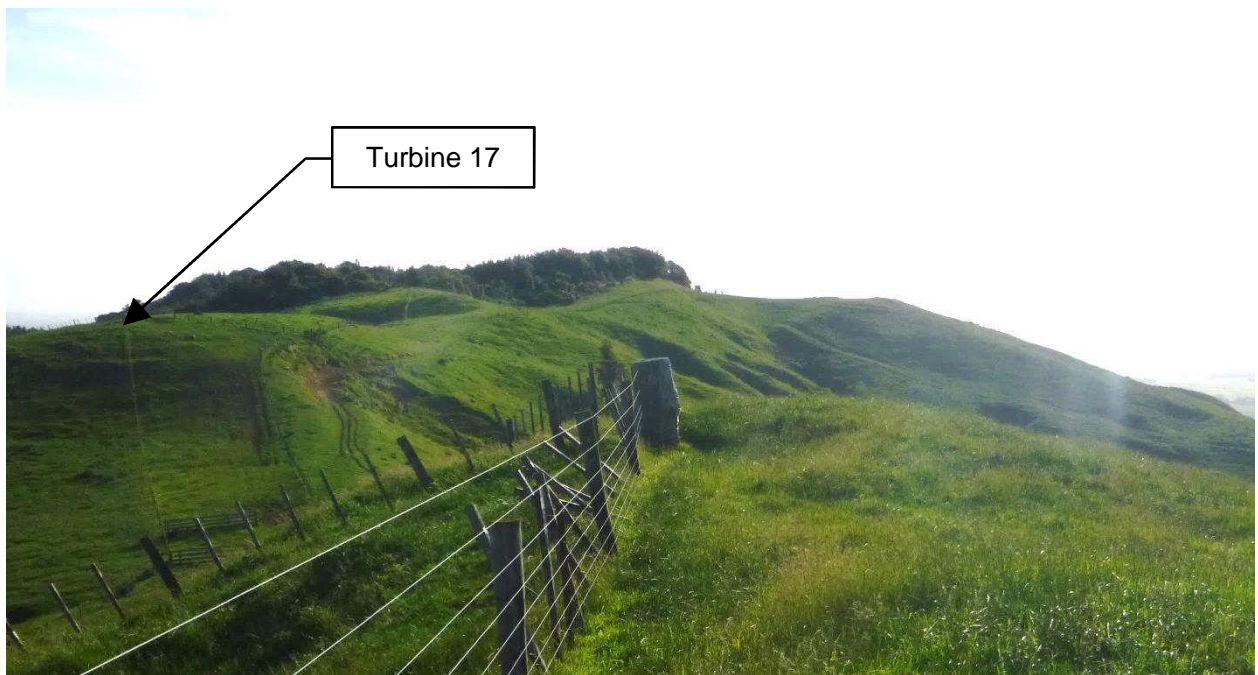
Turbine 17

- Broad ridge line with moderate to steep side slopes.
- Arcuate features located on the northern and southern sides of ridge line indicating past slope movement. The features are smooth in appearance, indicating the movements are historic.
- Ground conditions expected to comprise very stiff to hard CGVS soils with rock expected to be encountered in excess of 5m depth.
- If excavation for turbine base is more than approximately 5m depth, rock may be encountered in the excavation for the level platform.
- Provided the turbine is sited centrally on the ridge line, there are no significant geotechnical concerns for this site.
- Slope stability will have to be considered once exact siting is known.

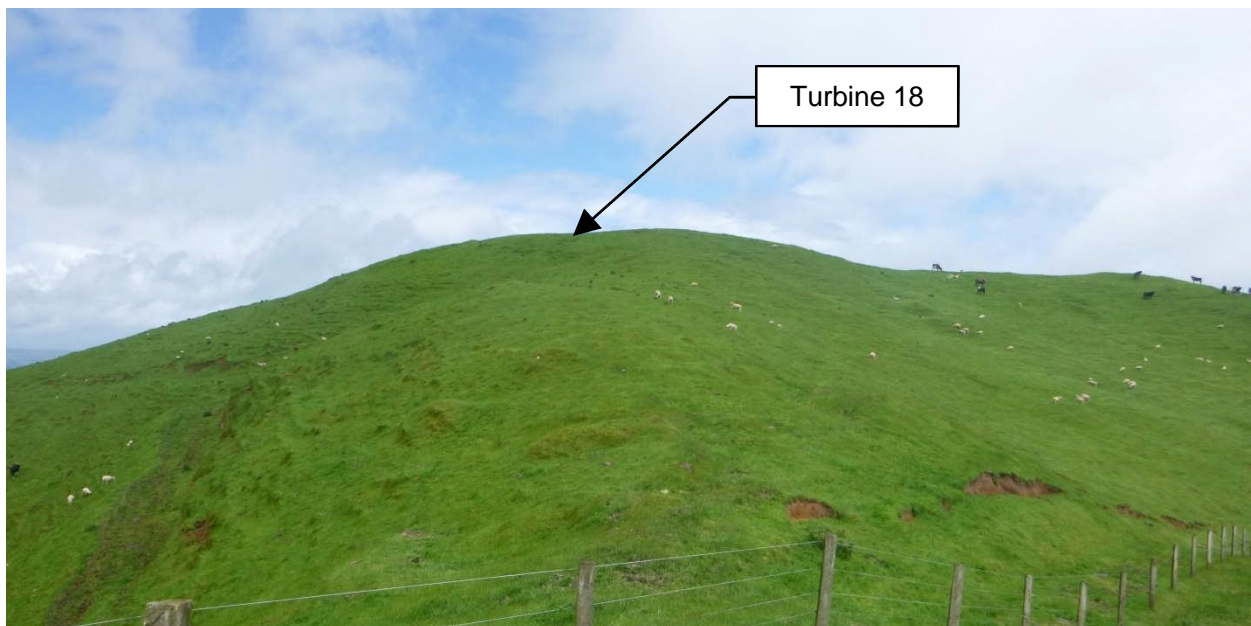
Turbine 18

- Narrow hilltop along ridge line, with steep side slopes falling at approximately 30°.
- Slumping was observed on both sides of ridge. Features are smoothed and appear to be historical. Surface creep was also observed.
- Ground conditions comprise very stiff to hard CGVS soils. Scala penetrometer testing shows soil strength increasing with depth and material approaching rock in consistency expected to be encountered at approximately 5m depth.
- Excavation will be required on the ridge line to form a level platform for the turbine and crane. It is possible that rock will be encountered within the depth of excavation.
- Depending on the final location of the turbine, following excavation for the platform, the turbine may be close to steep side slopes.
- As part of foundation design, slope stability should be considered, as per Section 9.

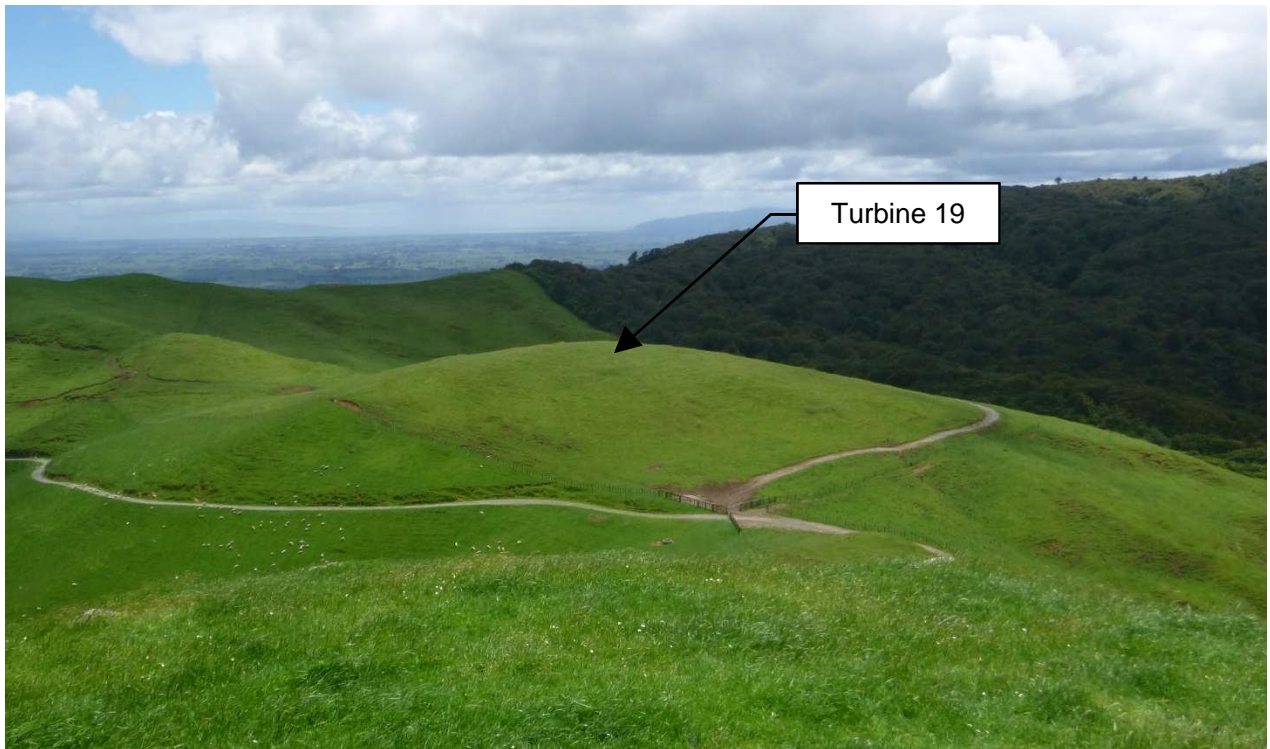
Turbine 19

- Broad hilltop along ridge line, approximately 30m across. Side slopes are moderately sloping with some surface creep observed.
- Ground conditions are expected to comprise very stiff to hard CGVS soils with material approaching rock in consistency expected to be encountered at approximately 5m depth.
- Excavation will be required on the ridge line to form a level platform for the turbine and crane. It is possible that rock will be encountered within the depth of excavation.
- There are no geotechnical concerns for this site.

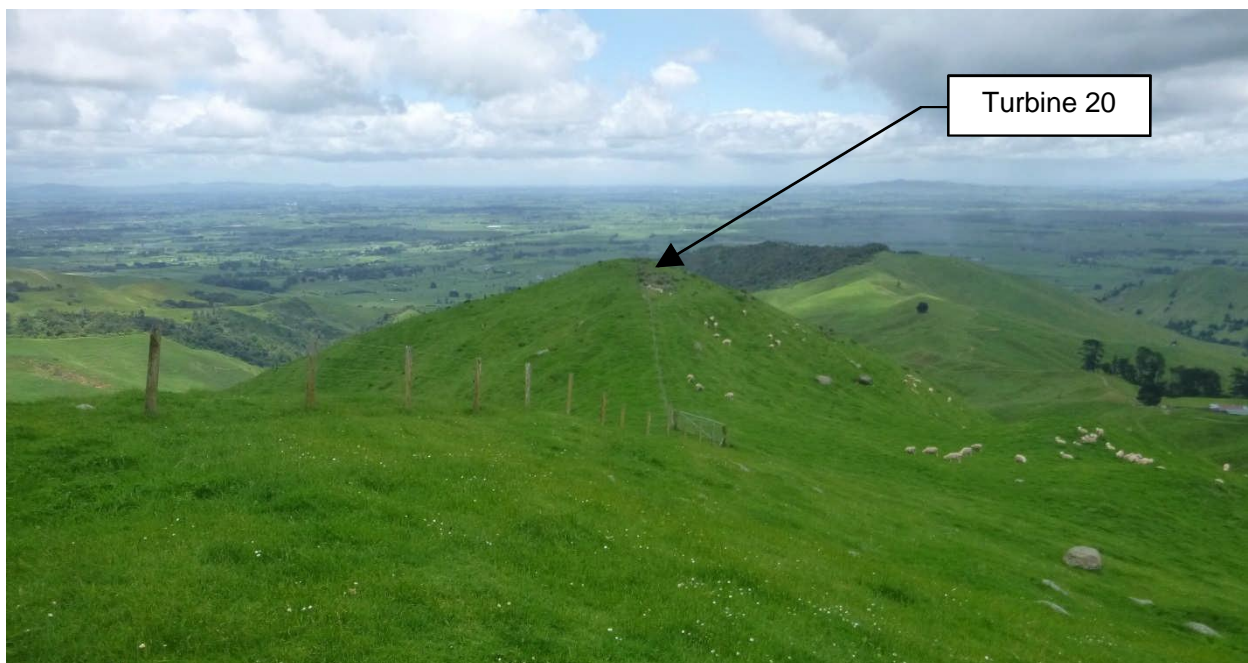
Turbine 20

- Narrow ridgeline, approximately 15m across with steep side slopes.
- Ground conditions are expected to comprise very stiff to hard CGVS soils with material approaching rock in consistency expected to be encountered at approximately 5m depth.
- Excavation will be required on the ridge line to form a level platform for the turbine and crane. It is possible that rock will be encountered within the depth of excavation.
- As part of foundation design, slope stability should be considered, as per Section 9.

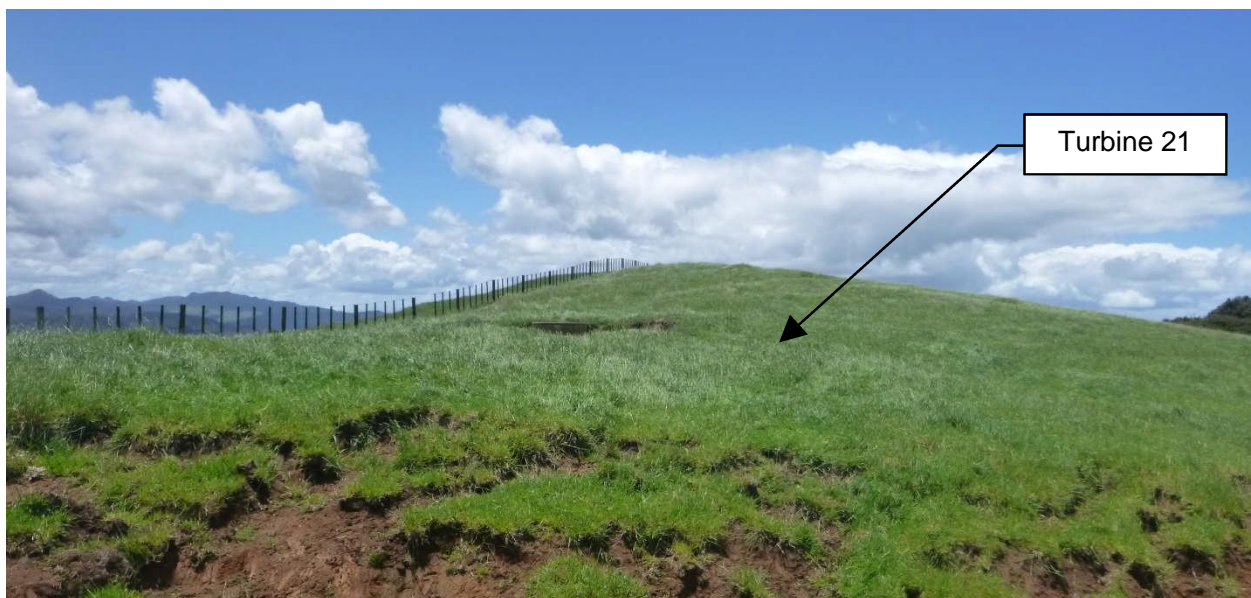
Turbine 21

- Broad ridge line, with gentle to moderately sloping side slopes.
- Ground conditions comprised very stiff to hard CGVS soils with material approaching rock in consistency expected to be encountered at approximately 4m to 5m depth.
- Excavation will be required to form a level platform for the turbine and crane. Rock may be encountered within the depth of excavation.
- There are no geotechnical concerns for this site.

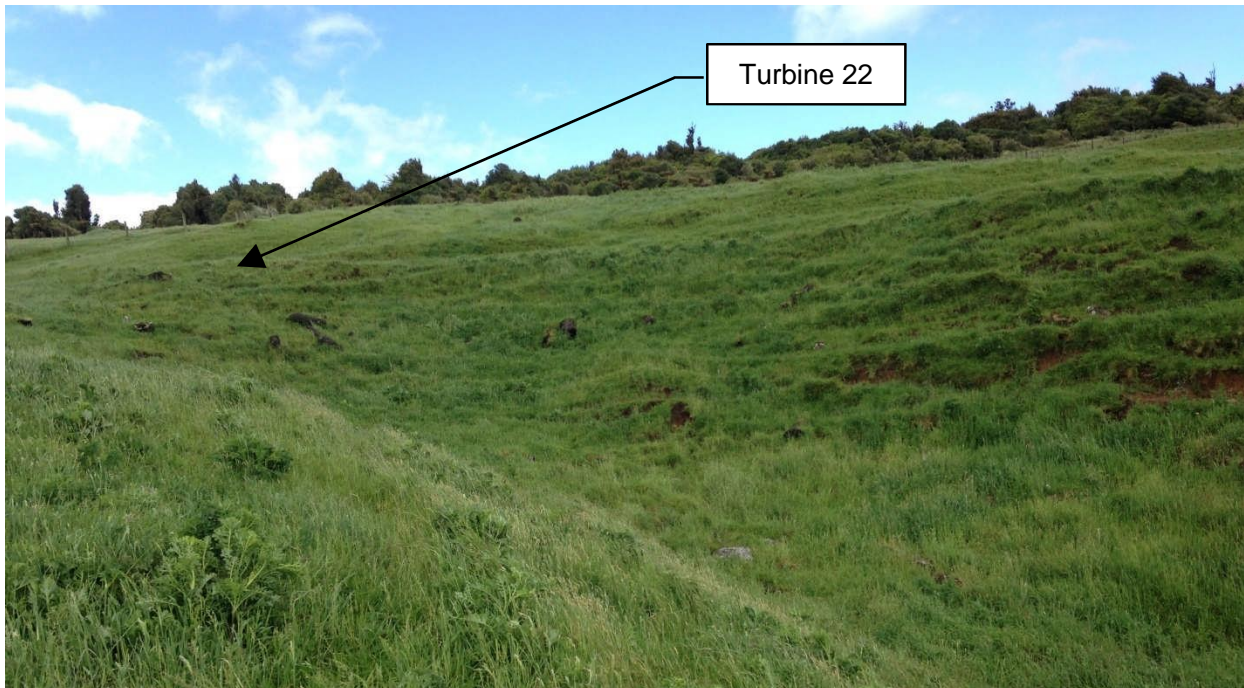
Turbine 22

- The site of the turbine is gently sloping but immediately upslope of a tributary gully that shows evidence of recent regression, such as side slope creep, slumping and gully inwash.

- The tributary is approximately 3m deep with a broad base.
- Ground conditions comprised very stiff to hard CGVS soils with material approaching rock in consistency expected to be encountered at approximately 6m to 7m depth.

- We recommend that the turbine be sited as far upslope and to the side of the tributary gully as practicable. This applies to the tributary gully immediately downslope of the turbine site as well as other tributary gullies in the vicinity of the site. This will reduce the risk of on-going regression affecting the turbine site over its design life.

- Excavation will be required to form a level platform for the turbine and crane. Based on the depth to rock and the gently sloping nature of the site, rock is not expected to be encountered within the depth of excavation.

- As part of foundation design, slope stability should be considered, as per Section 9.

Turbines 3, 11, 14, 15 to 18, 20, 22 to 24 are located in areas of historic instability, with more active regression of tributary gullies observed near Turbines 22 and 23. Where practicable, turbines should be located centrally on ridge lines and as far from the side slopes as possible. Where potential instability features cannot be avoided, they can be remediated by standard engineering works such as retaining or specific foundation recommendations.

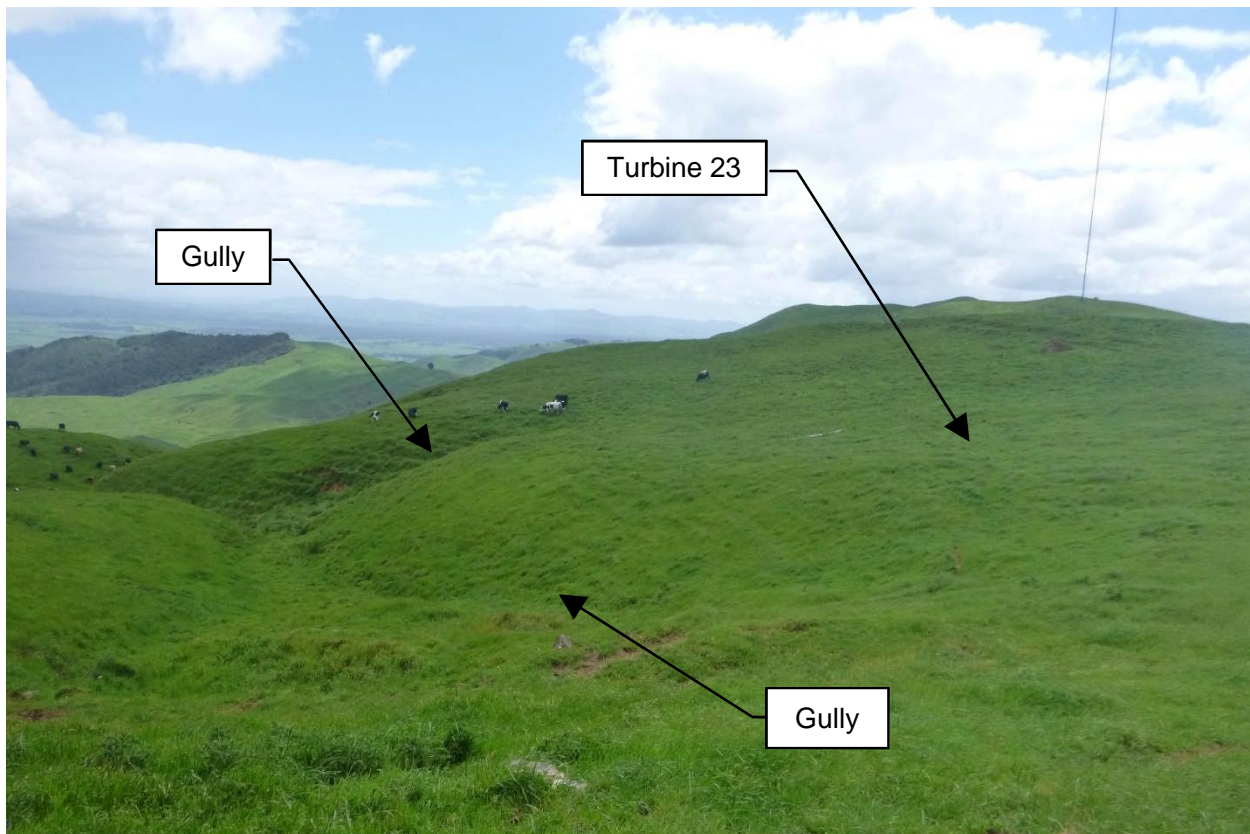
Turbine 23

- The site of the turbine is gently to moderately sloping to the southwest. The gully to the south is approximately 3m deep with a broad base.
- Gullies have developed downslope of the turbine site which show significant creep and surface slumping, indicating active regression.

- Ground conditions expected to comprise very stiff to hard CGVS soils with material approaching rock in consistency expected to be encountered at approximately 6m to 7m depth.

- We recommend that the turbine be sited as far upslope and away from the gully features as practicable. This will reduce the risk of on-going regression affecting the turbine site over its design life.

- Excavation will be required to form a level platform for the turbine and crane. Based on the depth to rock and the gently sloping nature of the site, rock is not expected to be encountered within the depth of excavation.

- As part of foundation design, slope stability should be considered, as per Section 9.
