8888-6B

14 June 2018

**GEOTECHNICAL ENGINEERING INVESTIGATION
PROPOSED WINDFARM
ROTOKOHU ROAD
PAEROA**

Geotechnical Engineering Investigation
Proposed Windfarm
Rotokohu Road
Paeroa

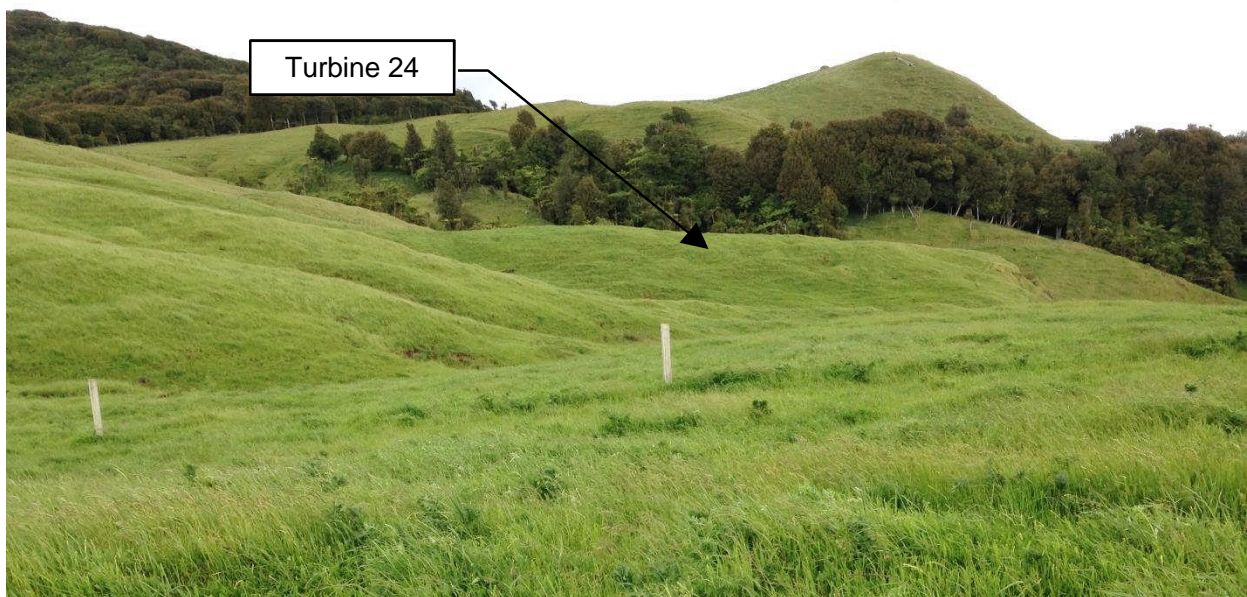
Turbine 24

- Broad, gently sloping ridgeline with steep side slopes that fall into gullies to the northern and southern sides of the ridge.
- There is evidence of instability on the gully side slopes.
- Ground conditions comprised very stiff to hard CGVS soils with material approaching rock in consistency expected to be encountered at approximately 6m to 7m depth.
- We recommend that the turbine be sited centrally on the ridge line to maximise distance to the steeper side slopes.
- Excavation will be required to form a level platform for the turbine and crane and rock. Based on the depth to rock and the gently sloping nature of the site, rock is not expected to be encountered within the depth of excavation.
- As part of foundation design, slope stability should be considered, as per Section 9.

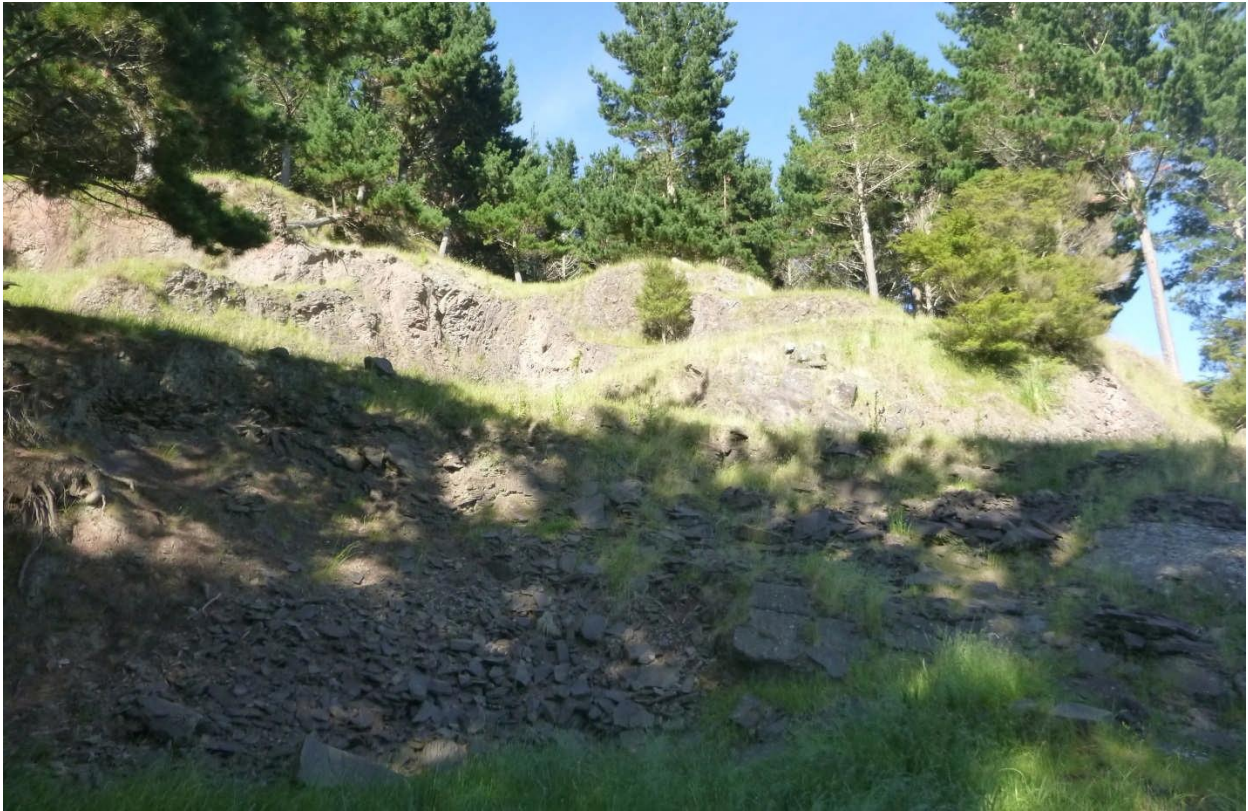
Farm Quarry on 604 Rotokohu Road

A farm quarry has been formed on 604 Rotokohu Road, as the approximate location shown on the Site Plan and shown in the photo below. A limited source of aggregate material is available in this area with only shallow overburden observed. To determine the extent of possible aggregate in this area, further geotechnical input will be required.
