## ATTACHMENT 2

Site Plans

**PRELIMINARY SITE  
INVESTIGATION  
780 AND 874 WANI ROAD  
NETHERTON**

**PREPARED FOR:  
AGRIGHT NEW ZEALAND  
OPCO 3 LIMITED**

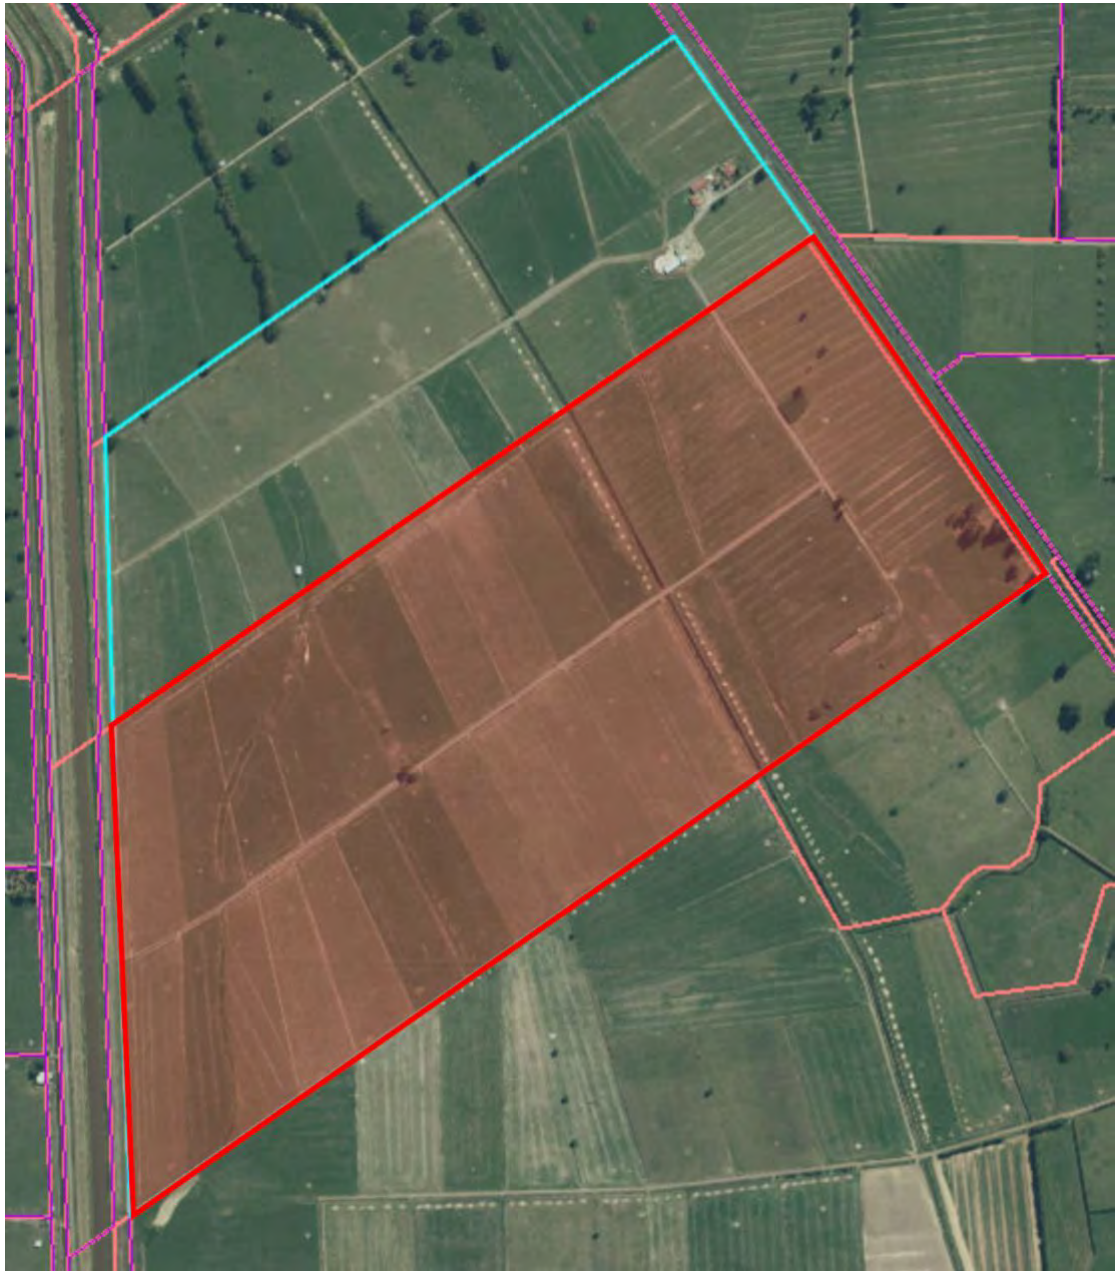
| | FIGURE 2 |

| <b>CSI</b><br><b>Contaminated Site Investigations</b><br><b>34 Brookfield Street</b><br><b>Hamilton</b> | 874 WANI ROAD, NETHERTON |

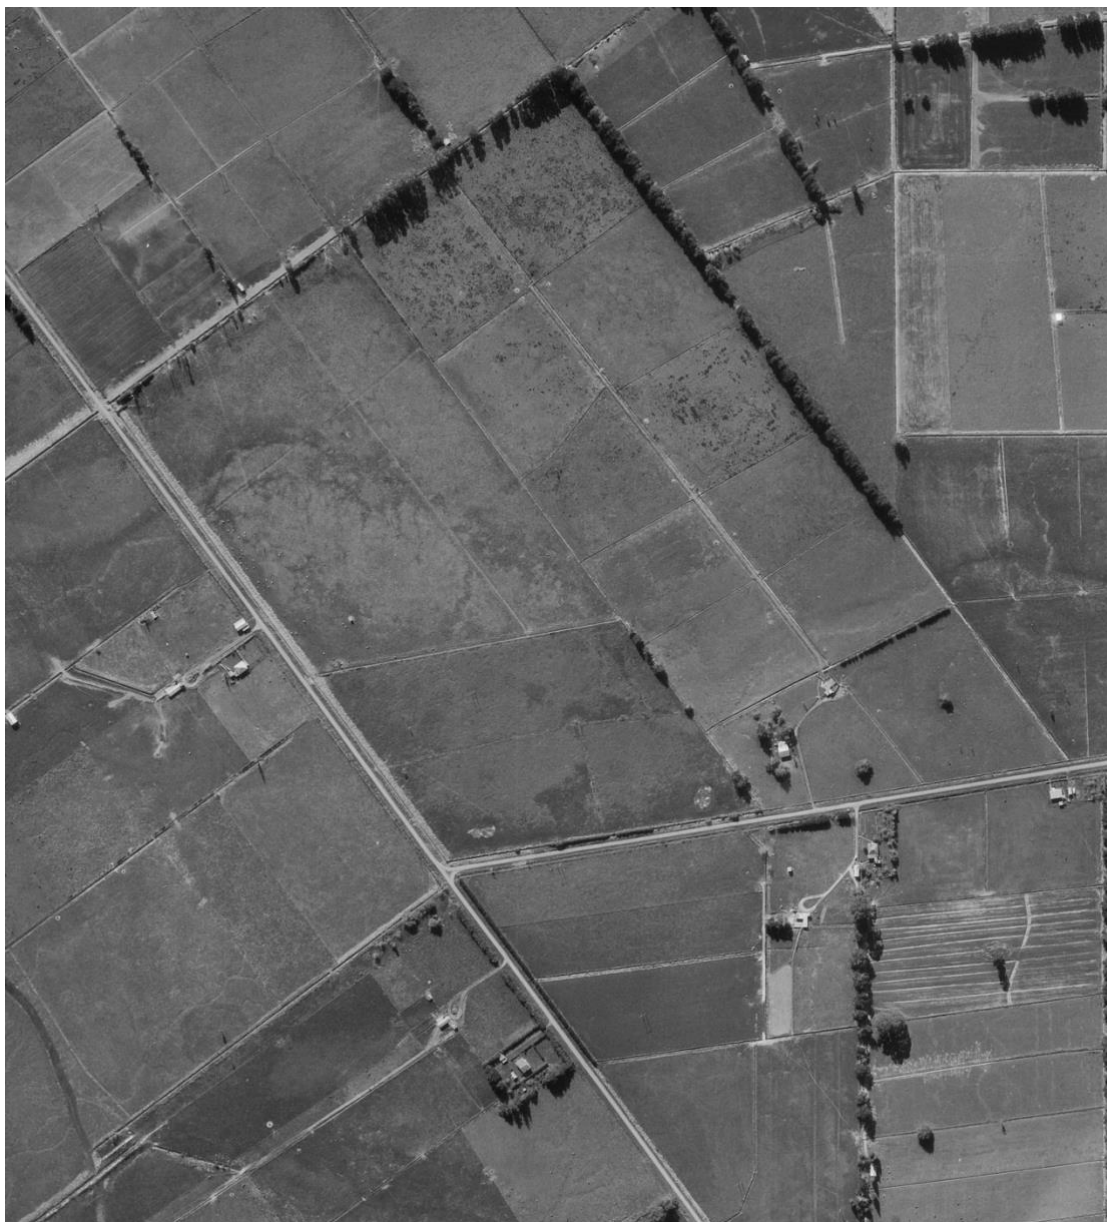
| | SK02 |

- 3.1.2.2 The 1963 reproduction (SK02) shows similar conditions on site to the 1942 reproduction. Site boundaries and immediate adjacent land shows similar conditions to the 1942 reproduction.

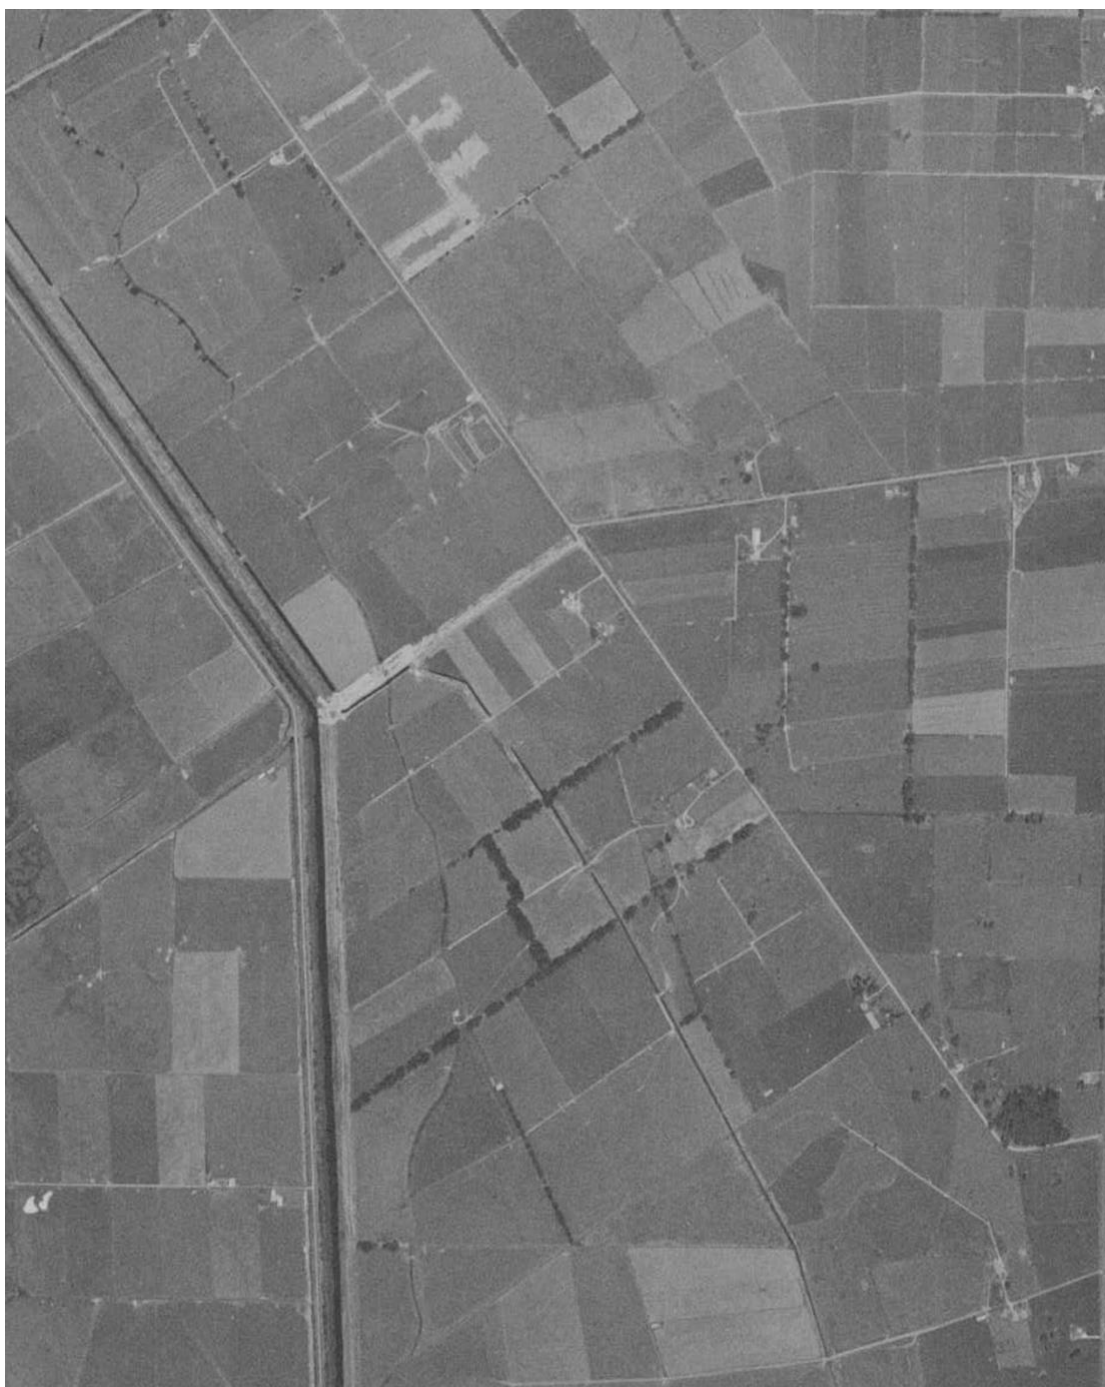
| | SK03 |

- 3.1.2.3 The 1969 reproduction (SK03) shows similar conditions on site to the 1963 reproduction except a series of in some of the paddocks. These lines are considered to be drainage channels. Site boundaries and immediate adjacent land shows similar conditions to the previous reproduction.

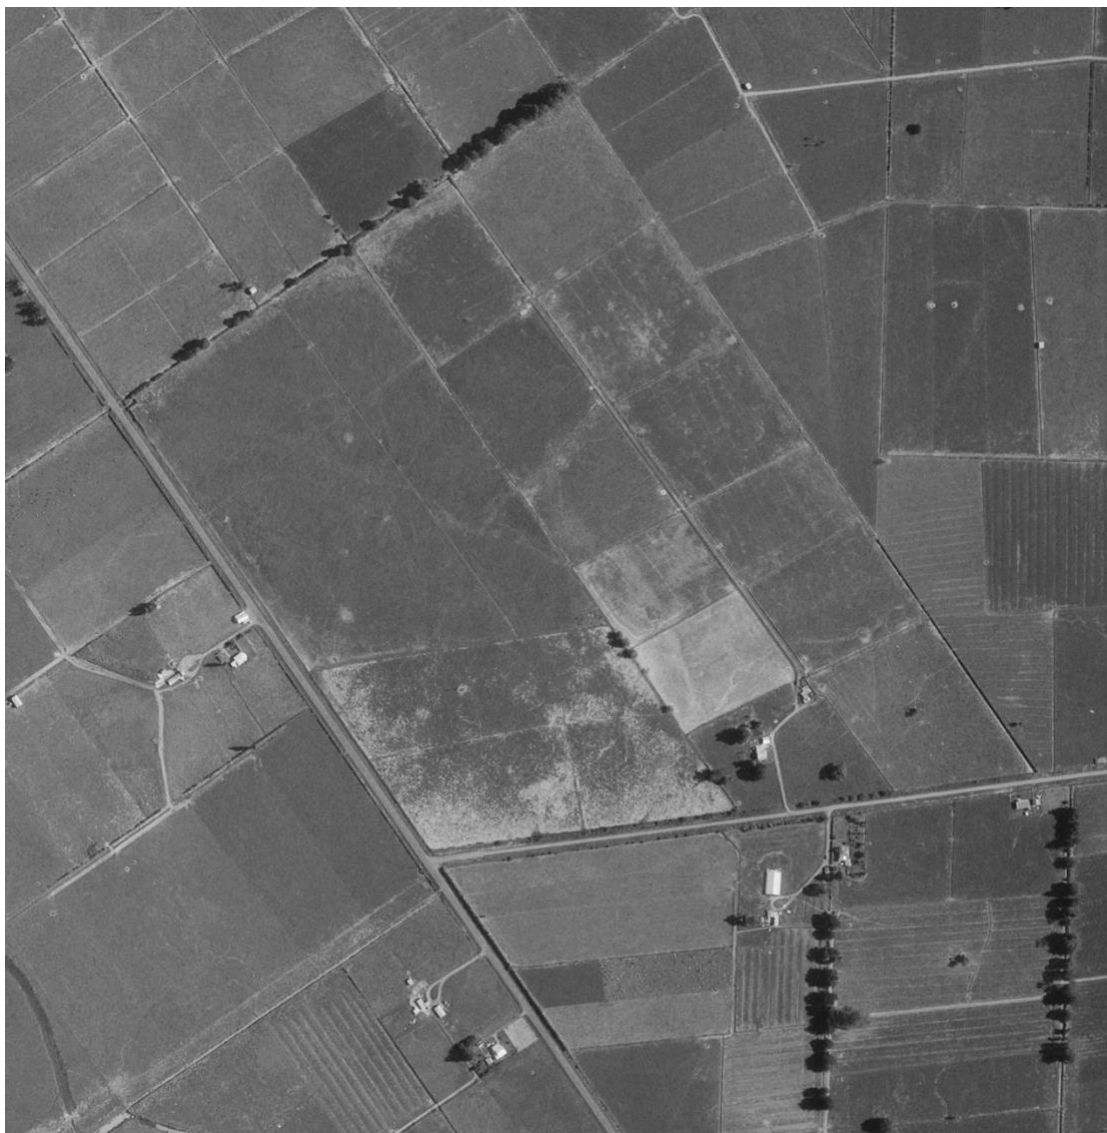
| | SK04 |

- 3.1.2.4 The 1975 reproduction (SK04) shows similar conditions on site to the previous reproductions except the small square structure in the central west is no longer present. Site boundaries and immediate adjacent land shows similar conditions to the previous reproduction.

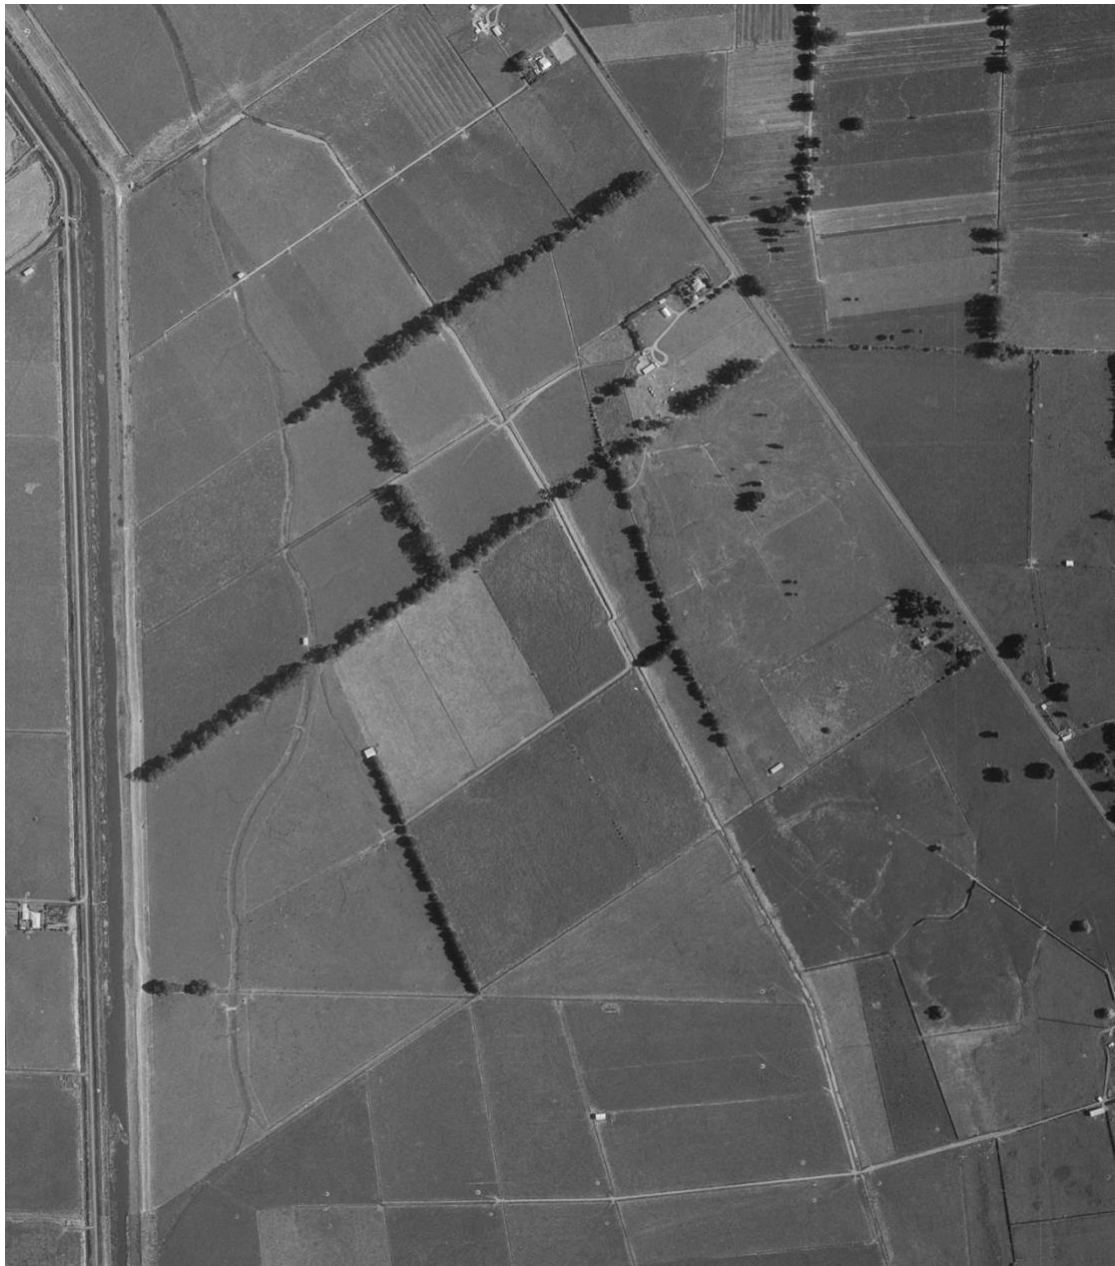
| | SK04 |

- 3.1.3.4 The 1975 reproduction (SK04) shows similar conditions on site to the 1969 reproduction. Site boundaries and immediate adjacent land shows similar conditions to the 1969 reproduction.

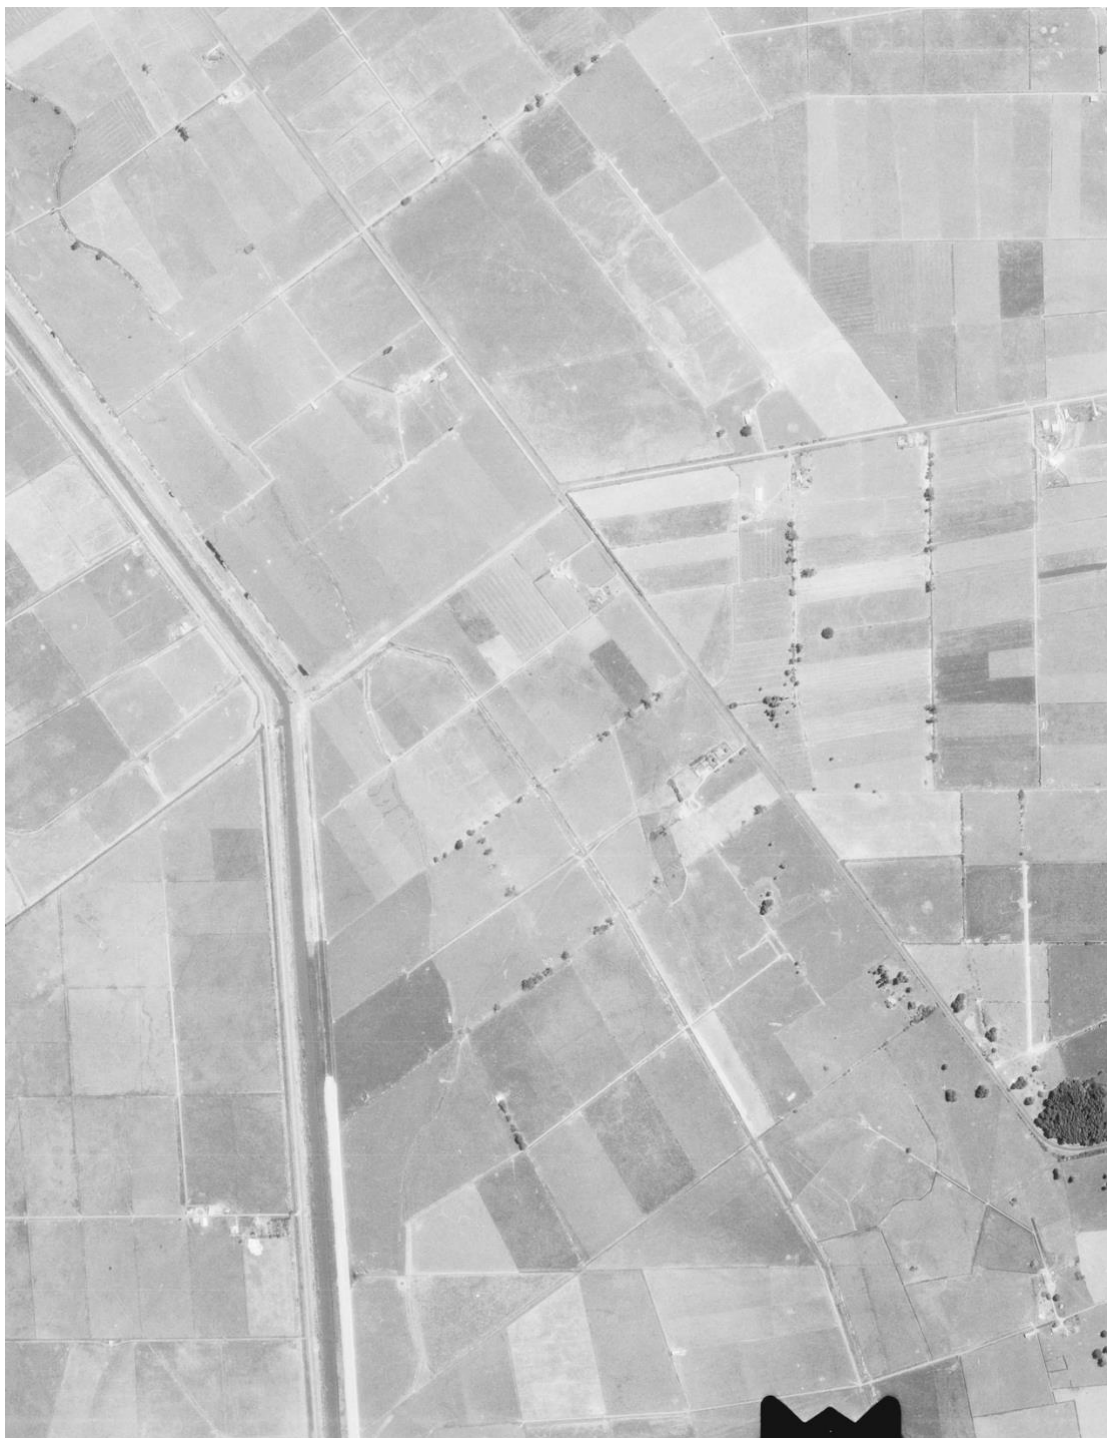
| | SK05 |

- 3.1.2.5 The 1982 reproduction (SK05) shows similar conditions on site to the previous reproductions with lines present in a number of the paddocks. These lines are considered to be drainage channels. Site boundaries and immediate adjacent land shows similar conditions to the previous reproductions.

- 3.1.3.5 The 1982 reproduction (SK05) shows similar conditions on site to the previous reproductions except only the remnants of the dwelling in the southeastern corner remain. Site boundaries and immediate adjacent land shows similar conditions to the 1969 and 1975 reproductions.

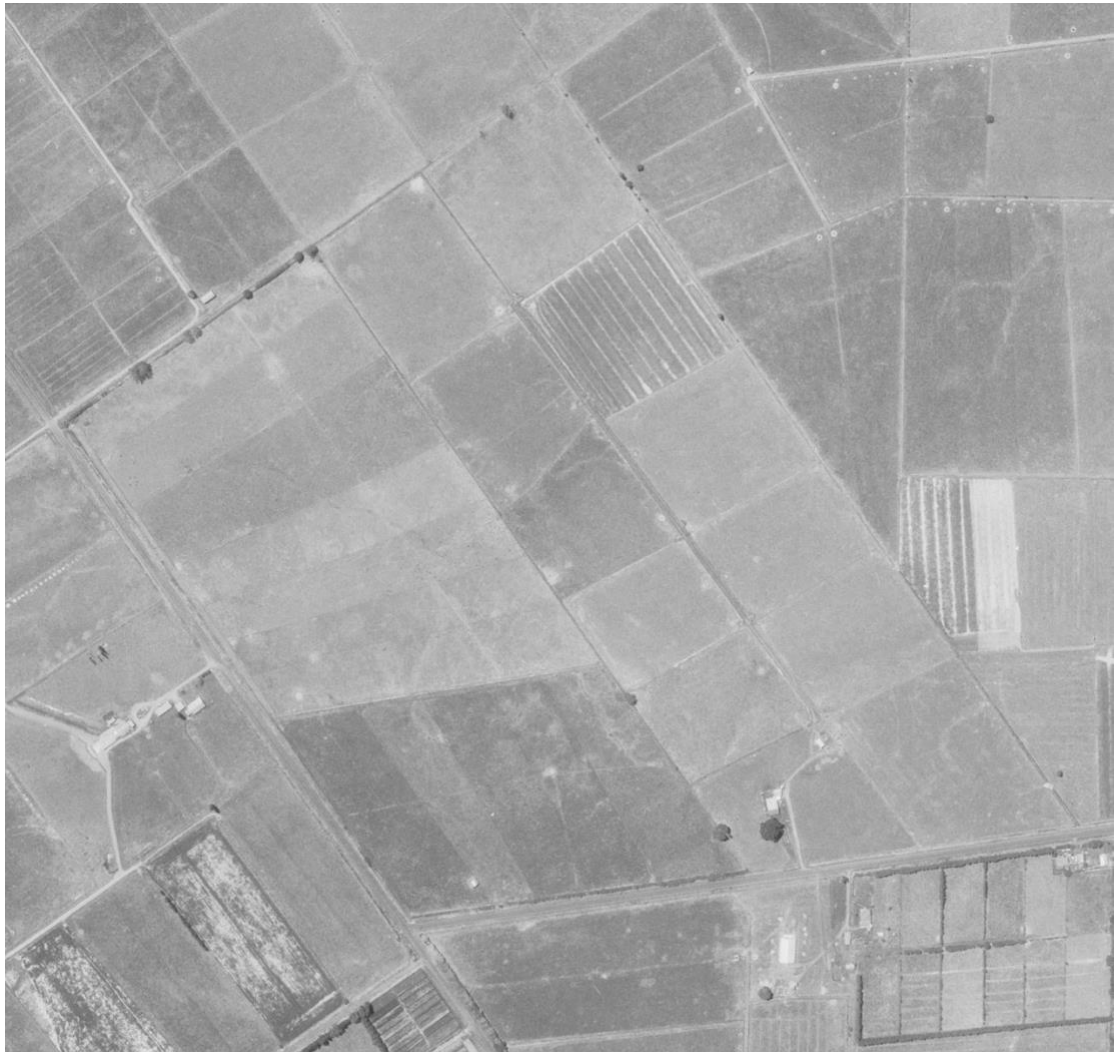
| | SK06 |

- 3.1.2.6 The 1991 reproduction (SK06) shows similar conditions on site to the previous reproductions. Site boundaries and immediate adjacent land shows similar conditions to the previous reproductions.

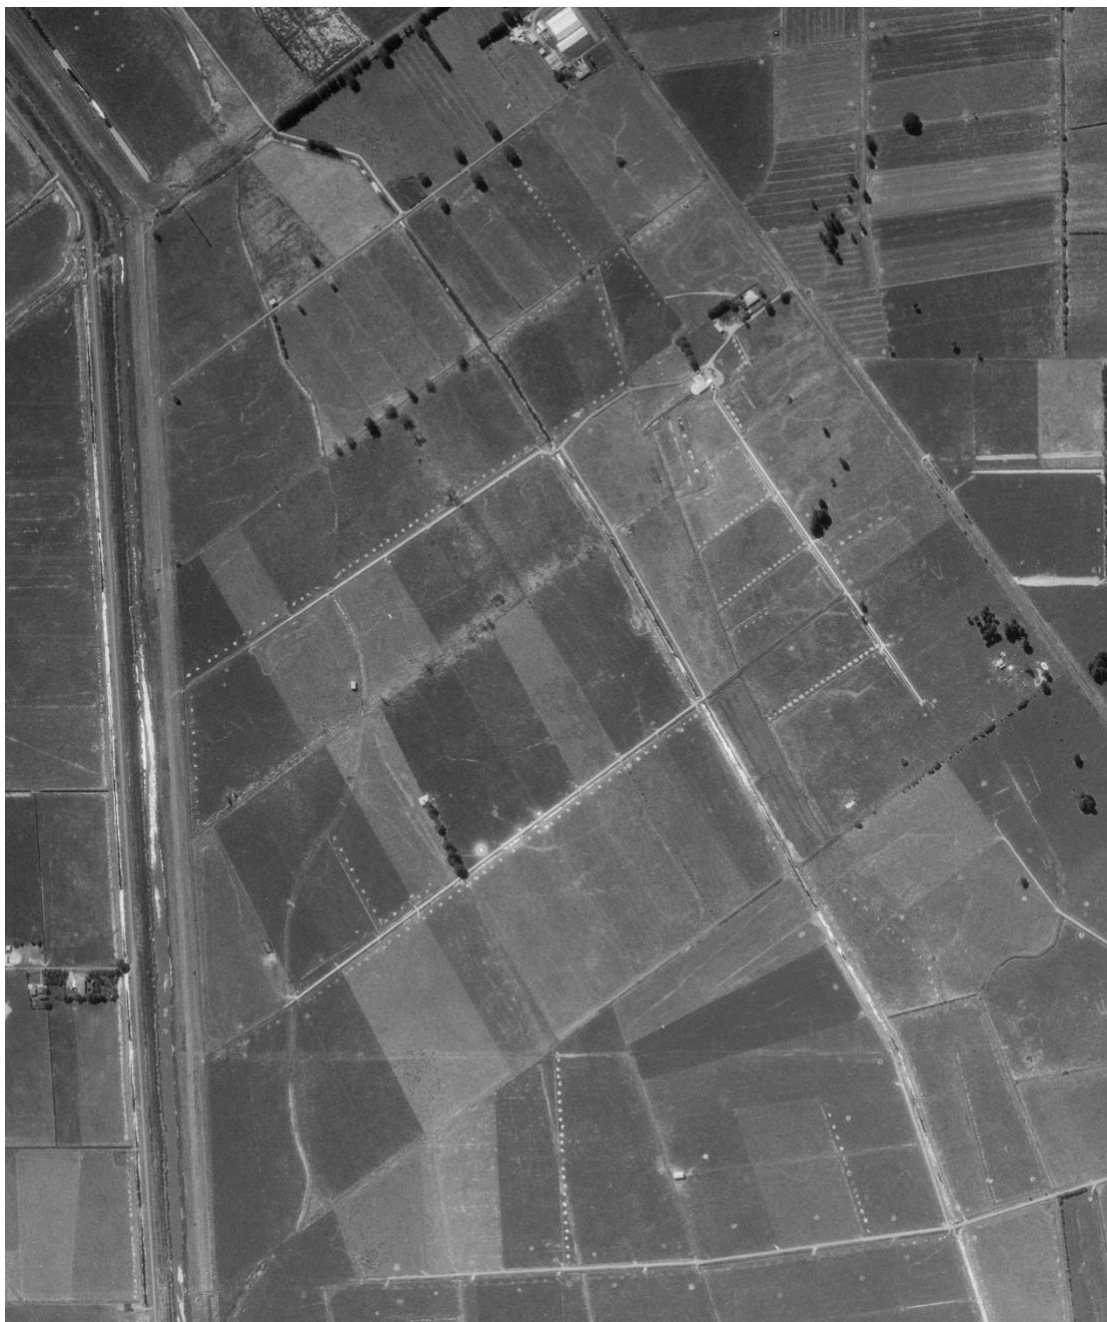
| | SK06 |

- 3.1.3.6 The 1991 reproduction (SK06) shows similar conditions to the 1982 reproduction except white dots are present next to the farm drains which, are considered to piles of drain sediment. Site boundaries and immediate adjacent land shows similar conditions to the previous reproductions.

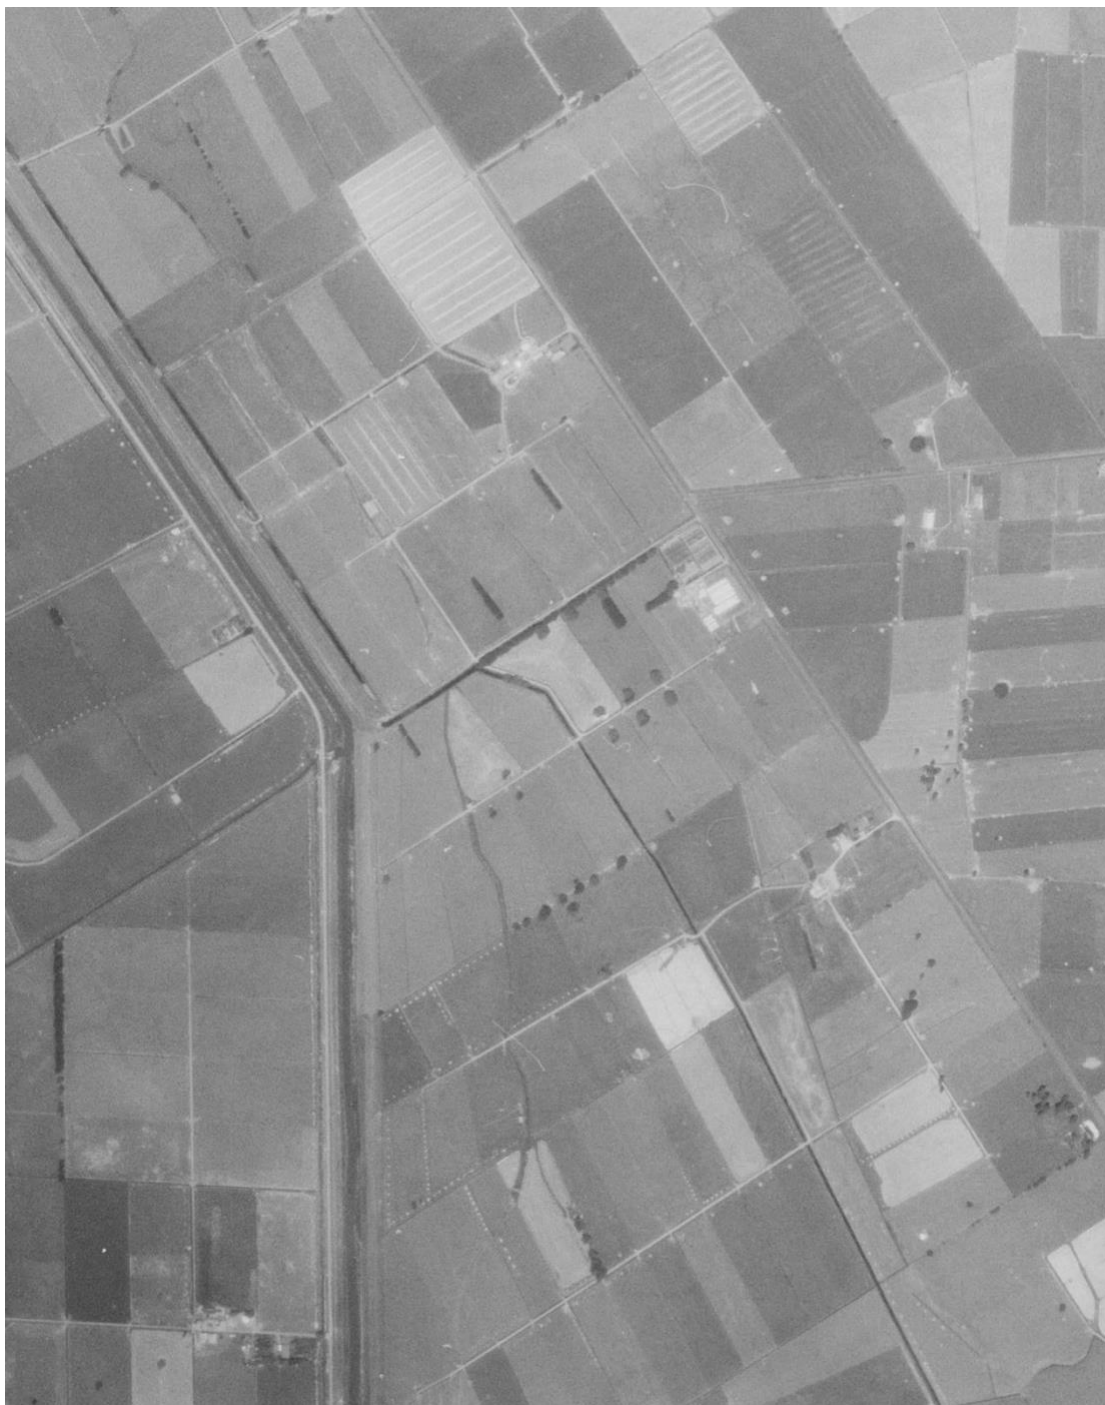
| | SK07 |

- 3.1.2.7 The 1994 reproduction (SK07) shows similar conditions on site to the previous reproductions. Site boundaries and immediate adjacent land shows similar conditions to the previous reproductions.

- 3.1.3.7 The 1994 reproduction (SK07) shows similar conditions on site to the previous reproductions except the white dots are no longer present. Site boundaries and immediate adjacent land shows similar conditions to the previous reproductions.
- 3.1.3.8 The 1999 reproduction (SK08) shows similar conditions on site to the previous reproductions except the dwelling remains has gone. Site boundaries and immediate adjacent land shows similar conditions to the previous reproduction.
- 3.1.3.9 The 2004 reproduction (SK08) shows similar conditions on site to the previous reproductions except no structures are present. A silage pit is present in the southwest. Lines running east to are present over the majority of the site which, are considered to be drainage channels. Site boundaries and immediate adjacent land shows similar conditions to the previous reproductions.

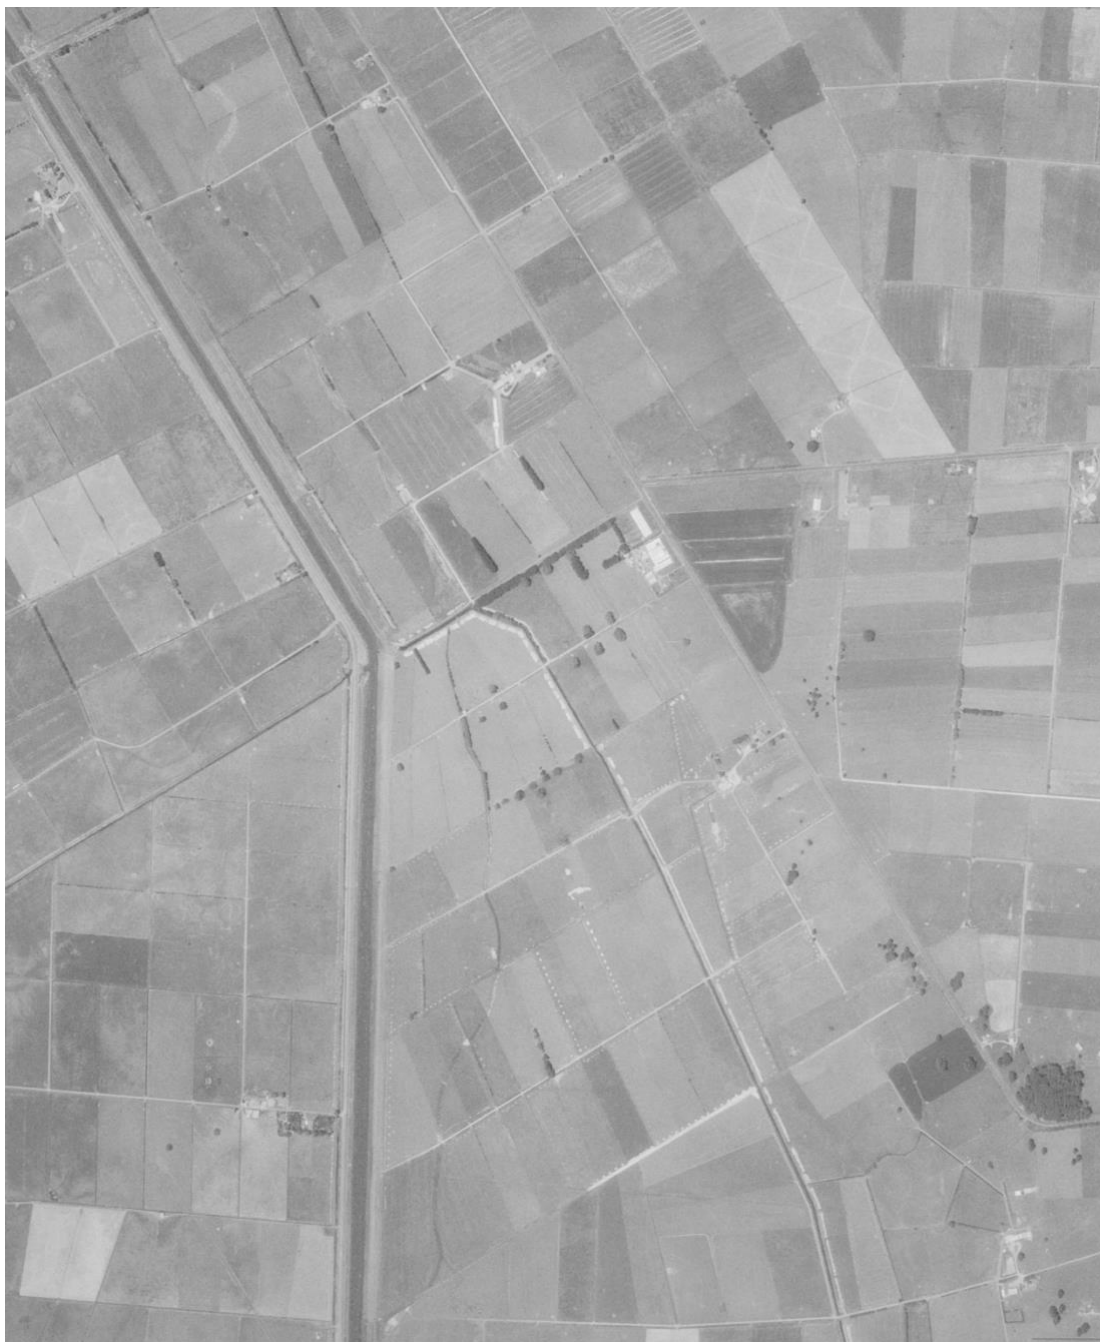
| | SK08 |

- 3.1.2.8 The 1999 reproduction (SK08) shows similar conditions on site to the previous reproduction. Site boundaries and immediate adjacent land shows similar conditions to the previous reproductions.
- 3.1.2.9 The 2004 reproduction (SK09) shows similar conditions on site to the previous reproductions except a structure is present in the southwestern corner. Site boundaries and immediate adjacent land shows similar conditions to the previous reproductions.
