NGATEA ACCESSIBILITY AUDIT REPORT

CCS DISABILITY ACTION

TAYLORED ACCESSIBILITY SOLUTIONS LTD

DECEMBER 2014

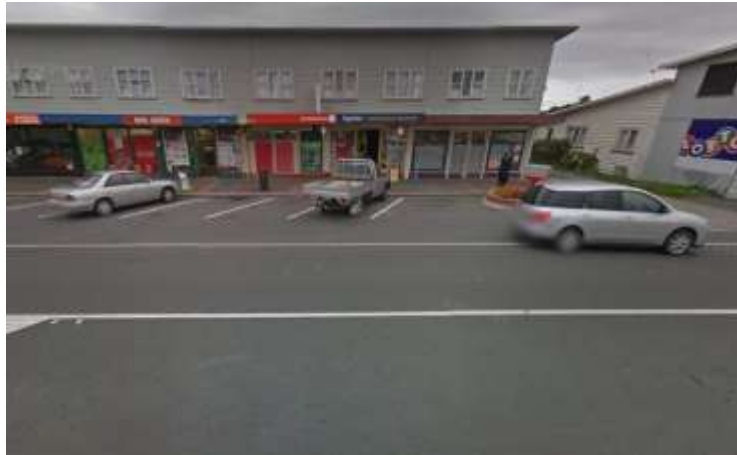
Figure 1: Proposed location for a Mobility Space on SH.2

Installing a Mobility Space outside NZ Post will improve accessibility to the southern side of SH.2. Relocating the Mobility Space on the Northern Side of SH.2, west of River Road, to the north-western side of the pedestrian crossing will improve access to the shops on the southern side.

Recommendation 4 Install a Mobility Space at the western end of the carparks outside NZ Post to comply with NZS 4121:2001.

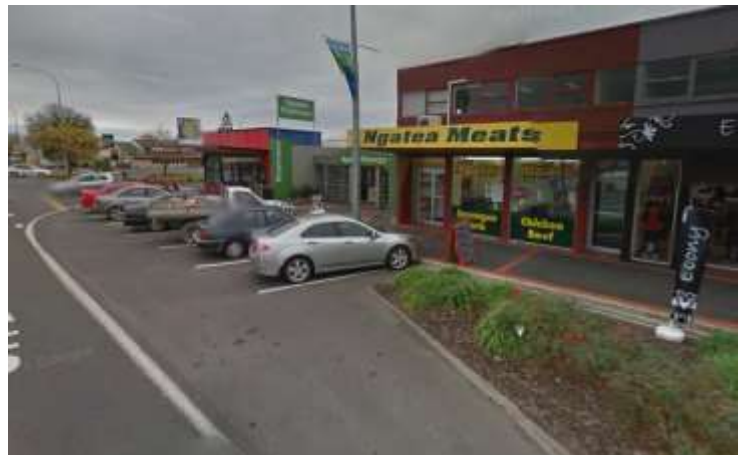
Figure 2: Proposed location for a Mobility Space on SH.2

Recommendation 5 Re-locate the Mobility Space on the northern side of SH.2, west of River Road, to next to the pedestrian crossing on the north-western side.

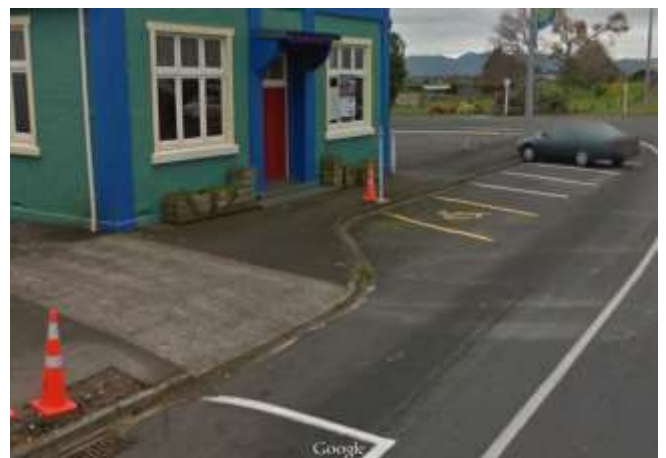
A common practise in New Zealand is for Mobility Spaces is to use driveways as access to the footpath. This is not ideal due to vehicles using the driveway and the small lip that is often installed. This is the current situation for the Mobility Space outside FVC Veterinary Services. The Mobility Space west of River Road uses a driveway to the west of the Mobility Space.

Figure 3: Mobility Space west of River Road

The Mobility Space west of River Road is below the recommended 3.5m in width. Re-locating this as per **Recommendation 5** will eliminate this issue.

Recommendation 7 Install full length kerb ramps at the Mobility Spaces in Ngatea to provide quick, easy access to the footpath.

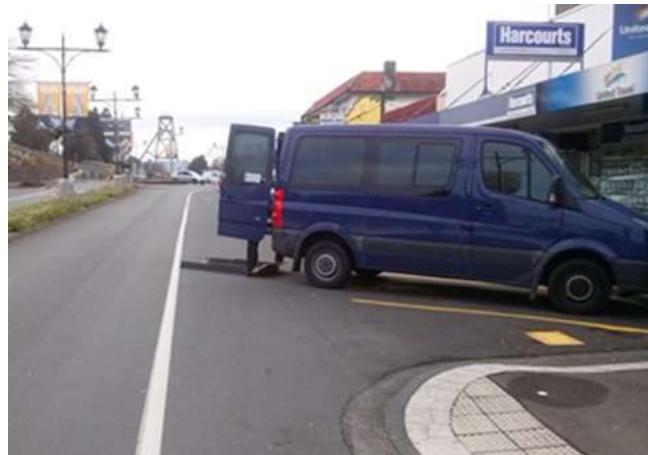
Figure 4: Rear-Loading Wheelchair Van

By planning and designing a range of mobility spaces which allow for these four methods, barriers and hazards can be minimised for the wheelchair user. Allowance for these methods can be achieved by lengthening parallel parks, widening parking spaces, removing obstacles beside the carpark (gardens, street furniture, signs etc.)

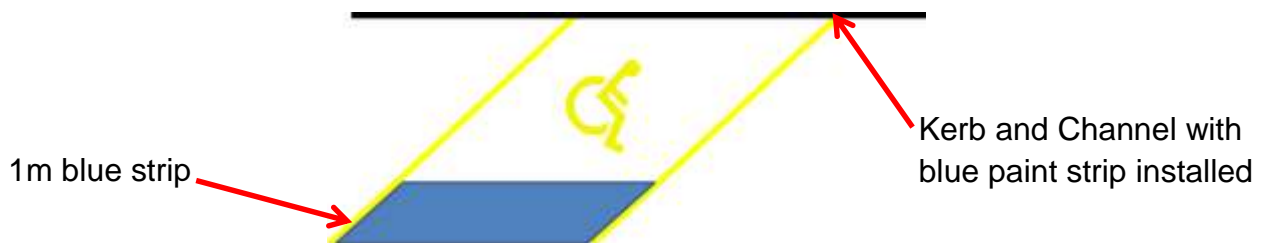
A 1m strip for the length of the road edge of the carpark will provide visual notice to road users, reduce installation costs, and reduce the need for repair when replacing kerb and channel etc.

During previous consultation processes where this has been suggested, concern was raised about visibility of the mobility parking space from the footpath. Installing a blue coloured metal plate or a blue strip on the top of the kerb will aid pedestrians to 'police' the spaces.

Figure 5: Mobility Space with blue surfacing design

Recommendation 10 Install blue marking as per figure 5 and maintain a non-slip surface with the colour of both the surface and the marking to comply with Land Transport Rule: Traffic Control Devices 2004.

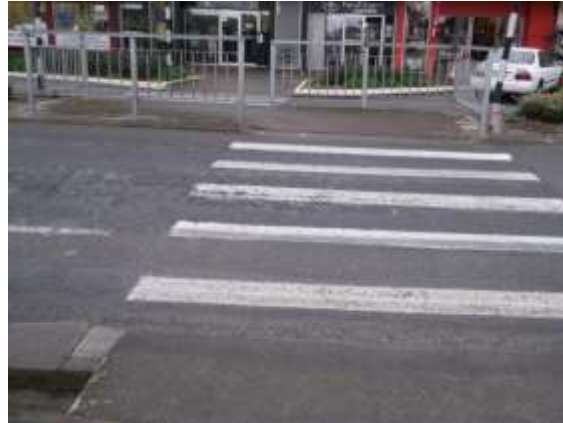
The kerb ramp on the north side of the Pedestrian Crossing on SH.2 (kerb and refuge island) has a grade of 1 in 7 (14.2%).

Figure 6: Pedestrian Crossing on SH.2

Recommendation 14 Replace the kerb ramp on the north side of the Pedestrian Crossing on SH.2 (kerb and refuge island) to a maximum grade of 1 in 14 (7.1%).

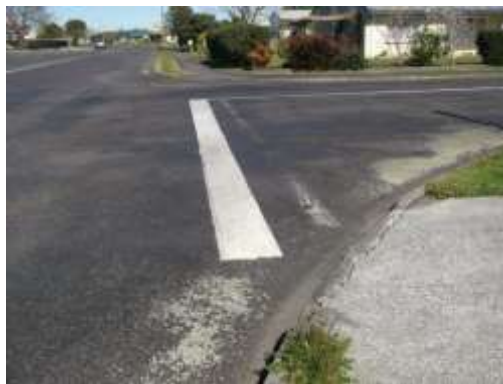
- Darlington Street/Harris Place – refuge island north of Harris St, crossing Darlington St;
- Darlington Street/Harris Place – north-west and south-west crossing Harris St;
- Darlington Street/Hayward Road – south-east crossing Hayward Rd;
- Darlington Street/Walton Street – north-west crossing Walton St;

Figure 7: Darlington Street/Walton Street intersection

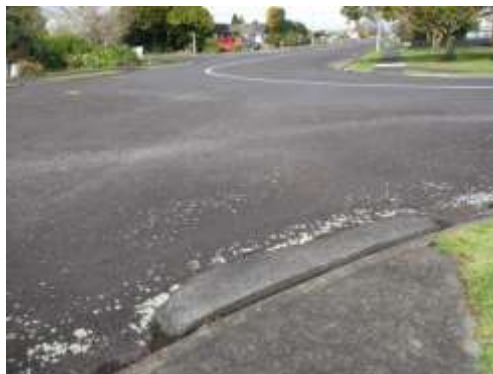
- Hayward Road/Miller Place – south-west crossing Miller Pl;
- Mahana Road/Side Road (approx. 285m west of Paul Dr) – north-west and north-east crossing the side road;
- Paul Drive/Mahana Road – north-west and south-east crossing Mahana Rd;

Figure 8: Paul Drive/Mahana Road intersection

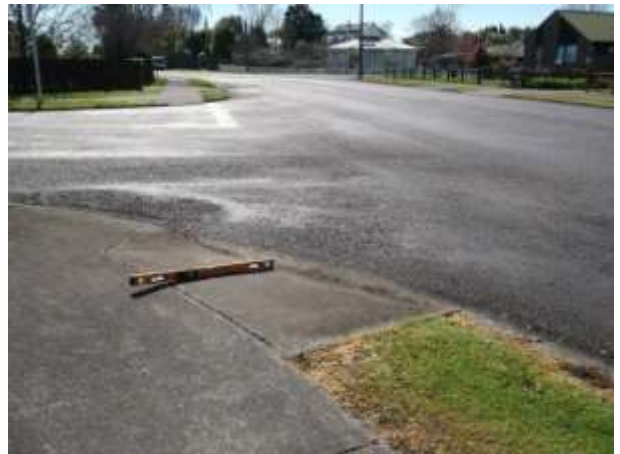
- Darlington Street/Madgwick Place – north-west crossing Madgwick Pl – 1 in 7.9 (12.6%);
- Dent Street/Hale Place – north-east crossing Hale Pl – 1 in 4.6 (21.8%);
- Darlington Street/Walton Place – south-west crossing Walton Pl – 1 in 7.2 (13.8%);
- Dent Street/Weddell Place – north-east crossing Weddell Pl – 1 in 4.8 (21%);
- Dent Street/Weddell Place – south-east crossing Weddell Pl – 1 in 4 (25%);
- Leonard Street/McClean Place – north-east crossing McClean Pl – 1 in 5.5 (18.2%); and
- Leonard Street/Paul Drive – south-east crossing Paul Dr – 1 in 3.4 (29%).

Figure 9: Darlington Street/Walton Street intersection

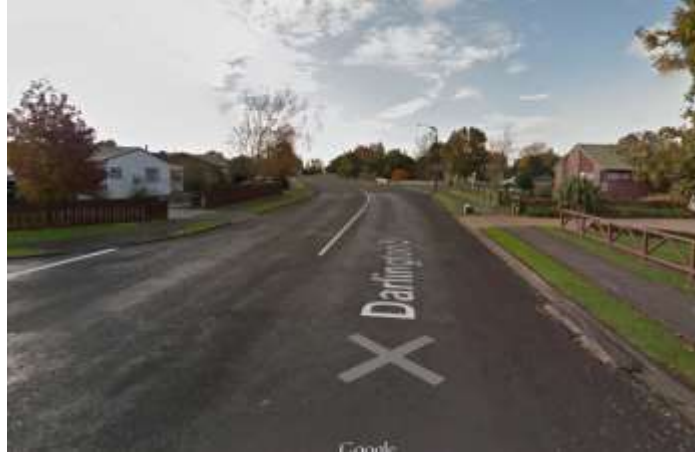
The intersection of Darlington Street/Walton Place has a kerb ramp for crossing Darlington St in the middle of the intersection.

Figure 10: Darling Walton Place intersection

Re-locate the kerb ramp north to opposite the north-west intersection to improve access in this location.

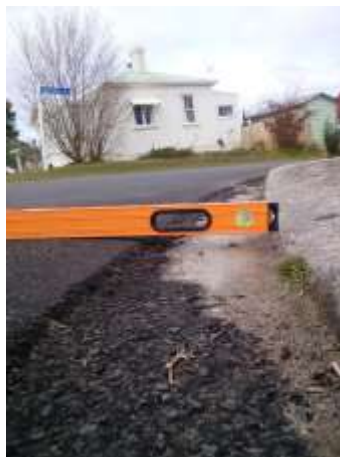
Re-sealing the carriageway can create a small lip where joining the kerb channel. This can require a wheelchair user to stop in the channel before negotiating the barrier. Milling the seal edge before re-sealing can eliminate this problem.

Figure 11: Seal edge join after re-sealing

Recommendation 22 Adopt the practise of milling seal edges at the join of the seal and the kerb channel, especially at areas where a flush kerb cut down is present, in maintenance contracts.

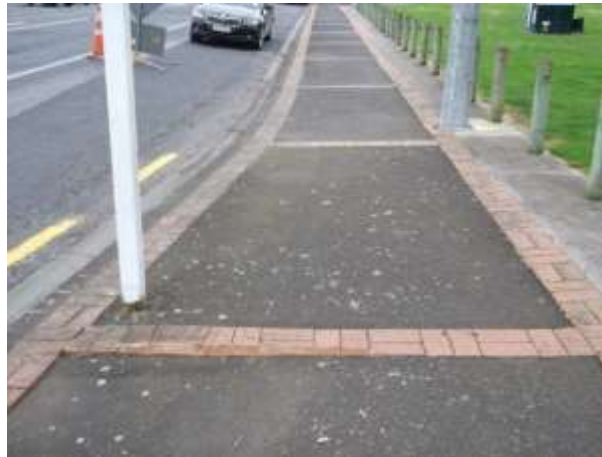
A number of improvements have been made to the footpaths in the main shopping centre of Ngatea. As a result, a combination of Asphaltic Concrete with cobblestone strips has been laid to create a softer, more appealing environment.

Figure 14: Footpath surface on Sh.2

Often Local Authorities use cobblestones as a surface to make the main shopping centre a more appealing, pedestrian like environment. Cobblestones are good when newly laid, but after a while lose surface structure either through poor basecourse compaction or repair of underground services. Wheelchair users and mobility scooter users can struggle on the surface due to the jarring of the joints between the cobblestones.

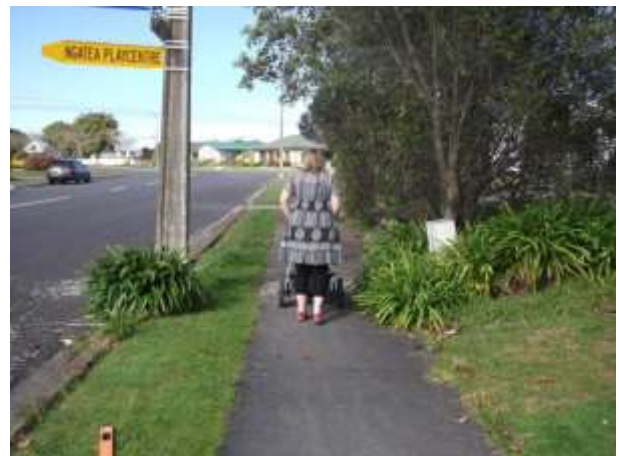
- Amuri Place - #4, and #6;
- Brenner Drive - #11, and #54;
- Darlington Street – opp. Z Service Station, #7, and #20;
- Hayward Road – Outside Hauraki Plains College, #15;
- Leonard Street – Intersection with Paul Drive;
- McQuarrie Place – 47 Mahana Road, and #2;
- 5 Madgwick Place;
- Mahana Road - #8, #24, and #52;
- 4 Miller Place;
- 38 Paul Drive;
- 6 Parfitt Place;
- 5 Pinnock Place;
- SH.2 – North side (bridge to River Road); and
- 3 Walton Place.

Figure 15: Vegetation outside 20 Darlington Street

Recommendation 32 Liaise with adjoining land owners to trim vegetation extending from the boundary over the footpath as required.

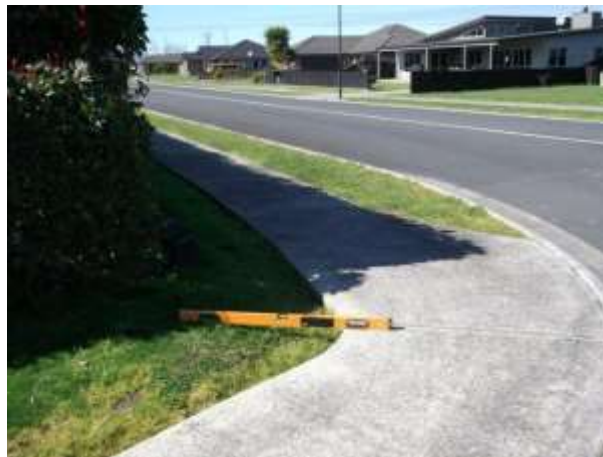
This is a major concern in Ngatea. A large number of streets were identified as having berms lower than the adjoining footpath and these are listed in Appendix C: Table 12 – Footpaths with low berm.

Figure 16: Low berm at 53 Darlington Street

Recommendation 33 Raise the berm level to the adjoining footpath at the following locations listed in Appendix C: Table 12 – Footpaths with low berm.

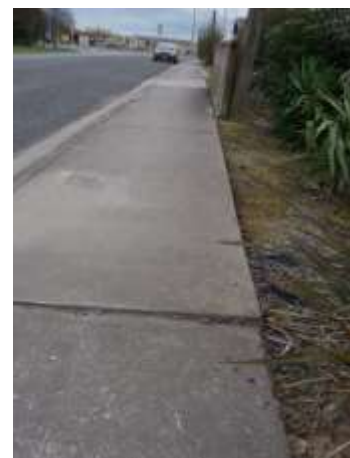
Lifting of the footpath at joints or by tree roots create tripping hazards, particularly for older persons. Similarly sunken footpath, due to failure in the basecourse, also causes an uneven surface and the potential for older persons to lose their footing.

Figure 17: Lifting footpath on Kohunui Street

Recommendation 34 Repair the lifting footpath at the locations listed in Appendix C: Table 13 – Lifting Footpath.

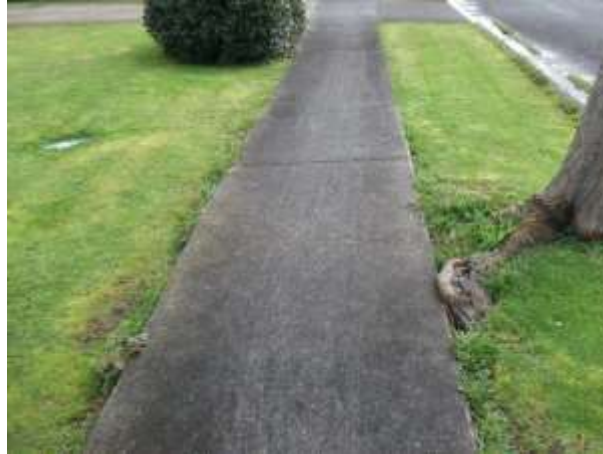
The locations identified with lifting or sunken footpaths are listed in Appendix C: Table 13 – Lifting Footpath

Figure 18: Tree root lifting footpath at 14 Madgwick Place

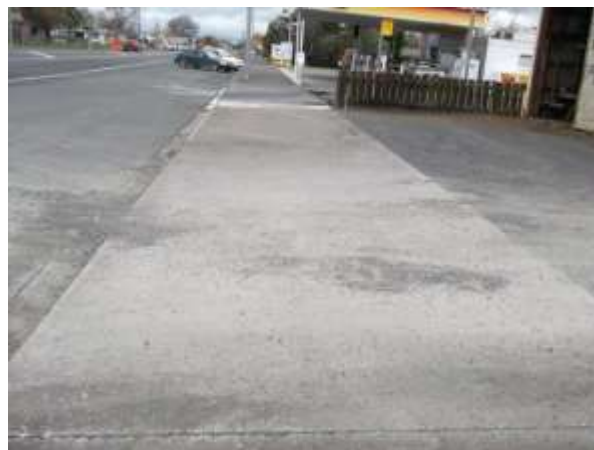
- Kaihere Road – Hauraki Plains College Entrance;
- Kohunui Street – Autoworks Ltd;
- Pipiroa Road – Ngatea Panelbeaters Ltd, RSA;
- River Road – Central Kids Kindergarten; and
- SH.2 – Hauraki Engineering Ltd, opp. Hauraki Plains College.

Figure 19: Entrance to Hauraki Engineering Ltd

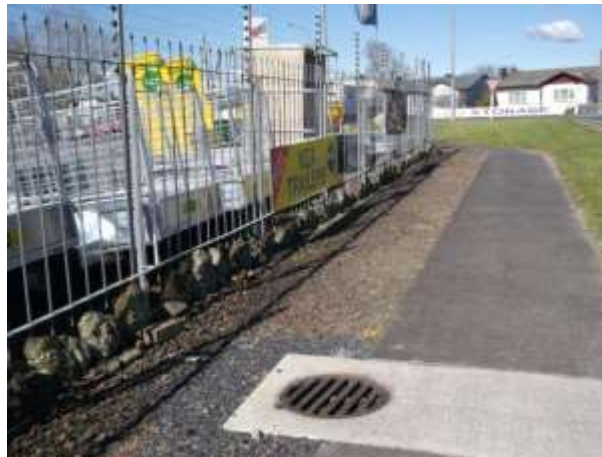
A catchpit outside Ngatea Panelbeaters Ltd has a grate cover. Although it is slightly off the direct line of the footpath, this is a minor concern.

Figure 20: Catchpit at Ngatea Panelbeaters Ltd

Recommendation 38 Replace the catchpit cover with a full cover at the edge of the footpath outside Ngatea Panelbeaters Ltd.

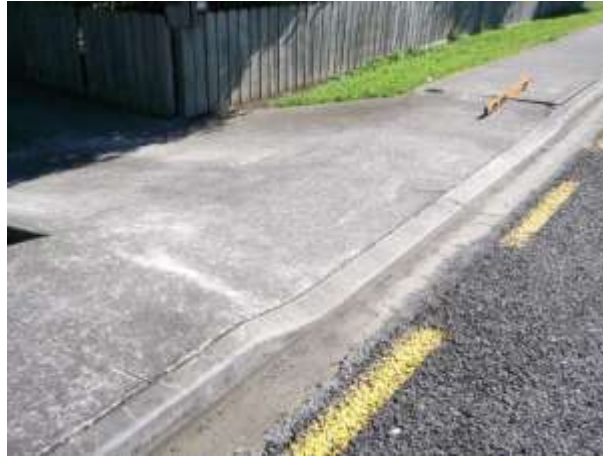
- Bratlie Place – connection to Ngatea Water Gardens – 1 in 2.5 (40%);
- 8 Harris Place – 1 in 10.1 (9.9%, east);
- 34 Kaihere Road – 1 in 10 (10%) and 1 in 7.1 (14%);

Figure 21: Driveway to 34 Kaihere Road

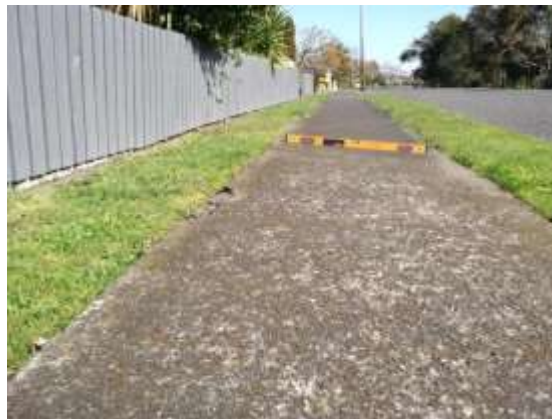
- 37 Hayward Road – 1 in 8.8 (11.3%); and
- SH.2 – Richardson Real Estate – 1 in 10.9 (9.2%).

Figure 23: Crossfall of footpath at 37 Hayward Road

Recommendation 43 Re-grade the crossfall on SH.2, outside Richardson Real Estate, and 37 Hayward Road, to achieve a grade of between 1% and 2%.

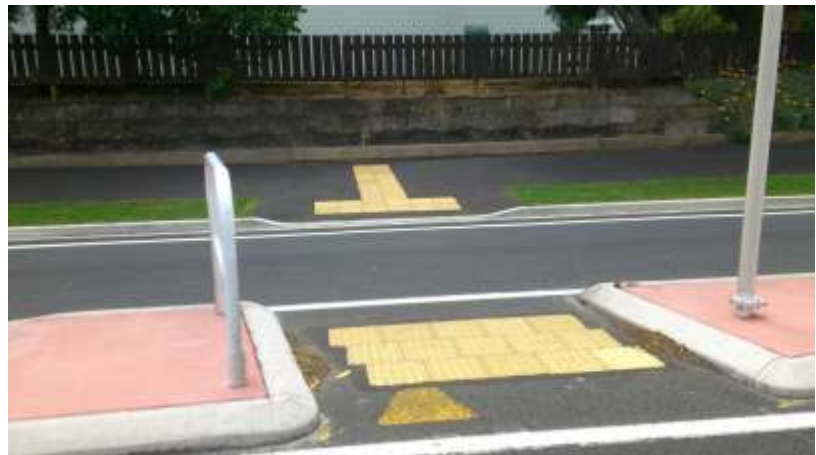
Figure 24: Ideal pedestrian refuge island crossing facility

Pedestrian refuge islands can be used where there is a demand for pedestrians to cross the road, but where the numbers of pedestrians are not high enough to warrant a signalised pedestrian crossing⁴⁵.

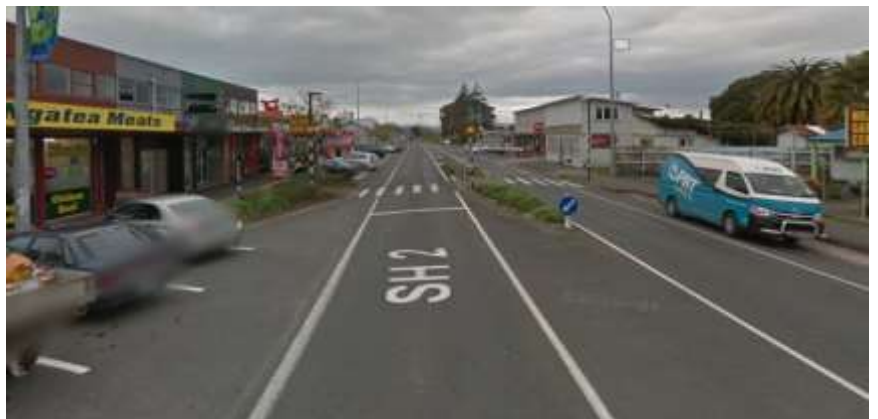
Figure 26: Pedestrian Crossing on SH.2

Crossing opportunities provide linkage for pedestrians to each side of the road. In some cases, they complete links between footpaths, particularly if the street has a footpath on one side only. By providing kerb ramps, pedestrian refuge islands, and/or pedestrian crossings, safer connectivity can be provided for mobility impaired pedestrians.

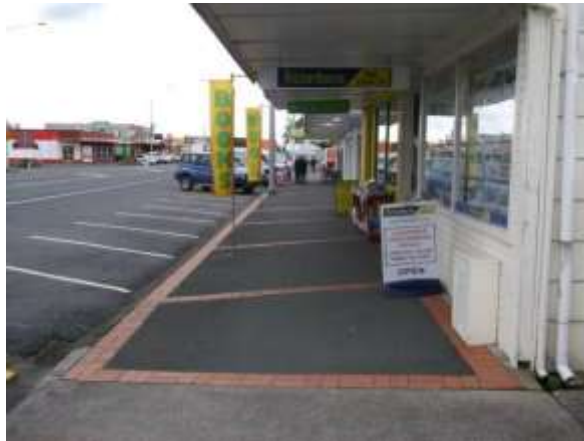
Businesses along SH.2 regularly install street signage, stock and tables and chairs outside of their premises. This has implications for people with significant visual impairment as they frequently use environmental cues such as buildings to navigate around a community and they won't necessarily see stock that are low to the ground, they become a trip hazard.

Figure 27: Shop wares and signage on SH.2

By having obstacles on the shop boundary, visually impaired people are forced to use the kerb line as a navigation aid.
