PAEROA ACCESSIBILITY AUDIT REPORT

CCS DISABILITY ACTION

TAYLORED ACCESSIBILITY SOLUTIONS LTD

DECEMBER 2014

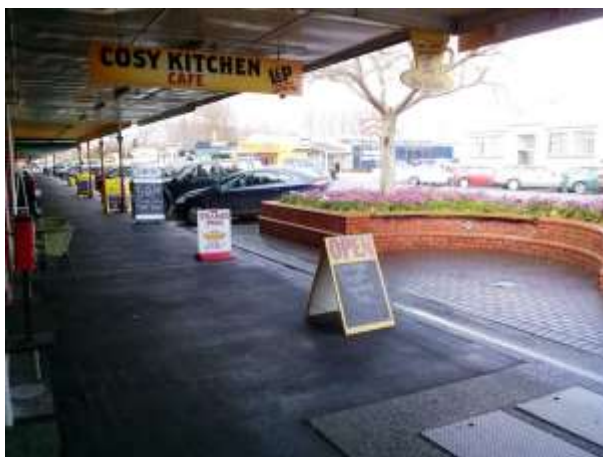
Figure 1: Belmont Road (SH.2)

Shop owners take pride in the town by minimising footpath clutter and maintaining access routes. Council has contributed by installing a textured footpath surface on Belmont Road (SH.2).

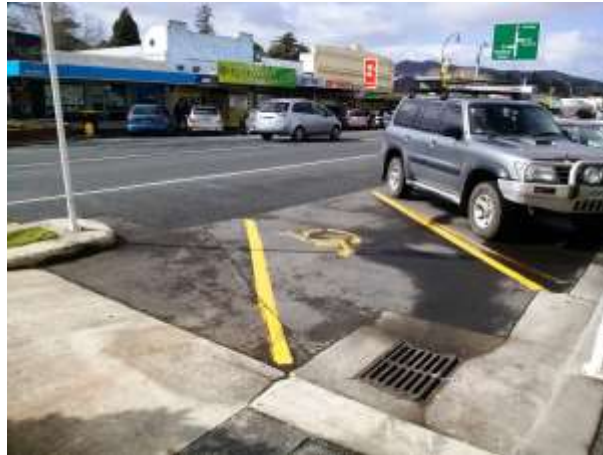
Figure 2: Mobility Space at NZ Post Shop, SH.2

The Mobility spaces along SH.2 are evenly spaced from each other except for the section from William Street to Wharf Street. Although the spaces outside the Public Library and Westpac is approx. 250m apart and has a space on Hughenden Street, there may be a need to install a Mobility Space between Hughenden Street and Hall Street. Monitor the situation to determine demand for a space in this area.

Recommendation 5 Monitor requests for a Mobility Space to be installed on SH.2, between Hughenden Street and Hall Street.

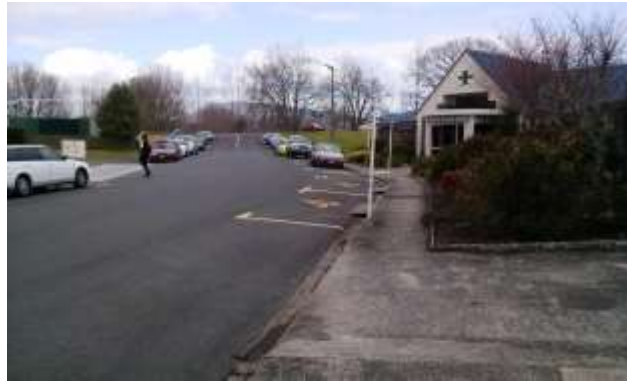
Figure 3: Princes Street Mobility Spaces

The Mobility Spaces situated at Princes Street is ideally placed, directly outside the Medical Centre.

As HDC cannot control the turnover of businesses in a specific site, as part of the consent process, HDC can explore the options of developers providing Mobility Spaces if the business is considered to have the potential for access customers. Types of businesses that may attract access customers (but not limited to):

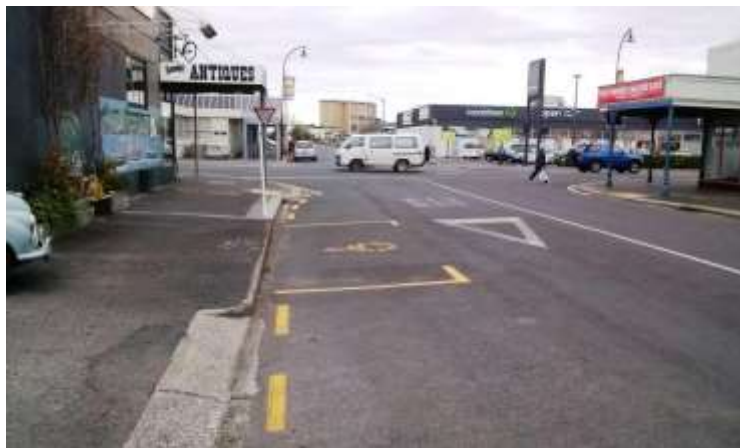
Figure 4: Mobility Space on Corbett Street

By installing a full length access, both passengers and drivers can safely move to the footpath without having to go into a live traffic lane.

Recommendation 7 Install full length kerb ramps at the remaining Mobility Spaces in Paeroa to provide quick, easy access to the footpath.

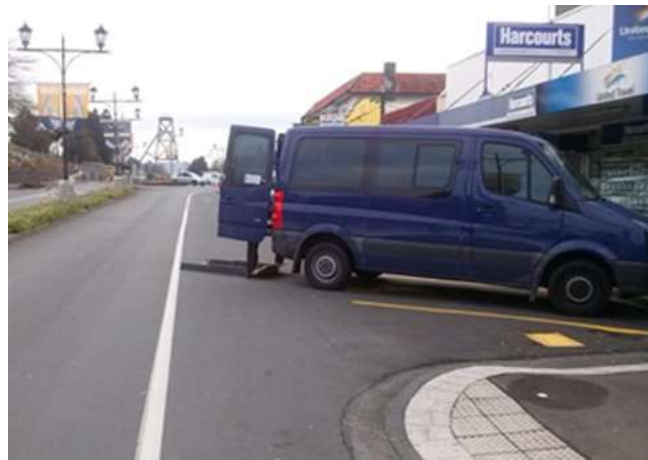
Figure 5: Rear-Loading Wheelchair Van

There are four commonly used methods of transporting people who use wheelchairs:

- Wheelchair user transfers from wheelchair to driver position (independently drives);
- Wheelchair user transfers from wheelchair to front passenger position;
- Wheelchair user remains in wheelchair and uses passenger side entrance to enter vehicle (ramp or hoist); and
- Wheelchair user remains in wheelchair and uses rear of vehicle to enter vehicle (most commonly by hoist).

By planning and designing a range of mobility spaces which allow for these four methods, barriers and hazards can be minimised for the wheelchair user. Allowance for these methods can be achieved by lengthening parallel parks, widening parking spaces, removing obstacles beside the carpark (gardens, street furniture, signs etc.) and, for angle parking, allowing space between the rear of the vehicle and the live traffic lane.

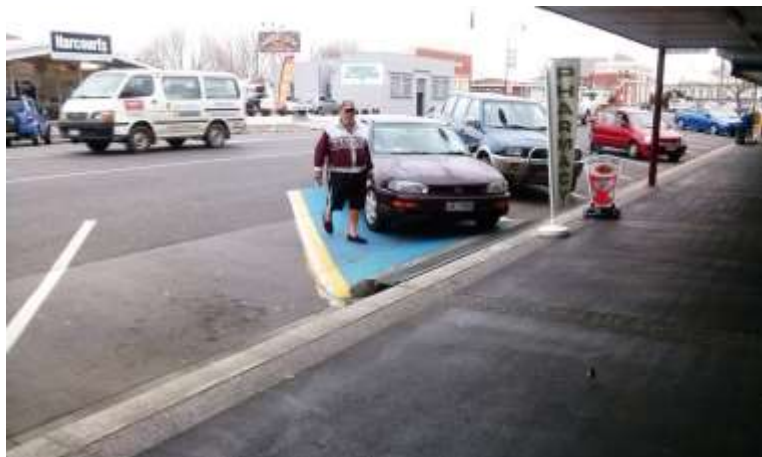
Figure 6: Mobility Space outside Paeroa Pharmacy

Widening the spaces to 3.5m by narrowing the carparks surrounding the Mobility Spaces will greatly improve access for wheelchair users to quickly and safely access the footpath.

Recommendation 10 Widen the Mobility Spaces to 3.5m by narrowing the surrounding carparks on Hughenden Street and SH.2 (outside NZ Post, Ohinemuri Club, Paeroa Pharmacy, and Westpac).

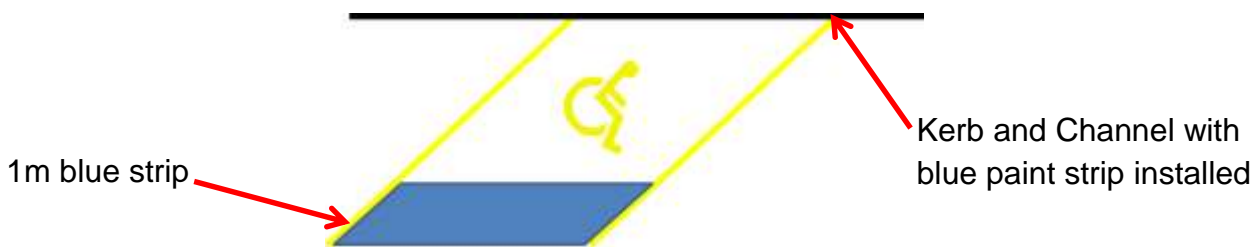
Figure 7: Mobility Space with blue surfacing design

During previous consultation processes where this has been suggested, concern was raised about visibility of the mobility parking space from the footpath. Installing a blue coloured metal plate or a blue strip on the top of the kerb will aid pedestrians to 'police' the spaces.

Recommendation 11 Install blue marking as per figure 7 and maintain a non-slip surface with the colour of both the surface and the marking to comply with Land Transport Rule: Traffic Control Devices 2004.

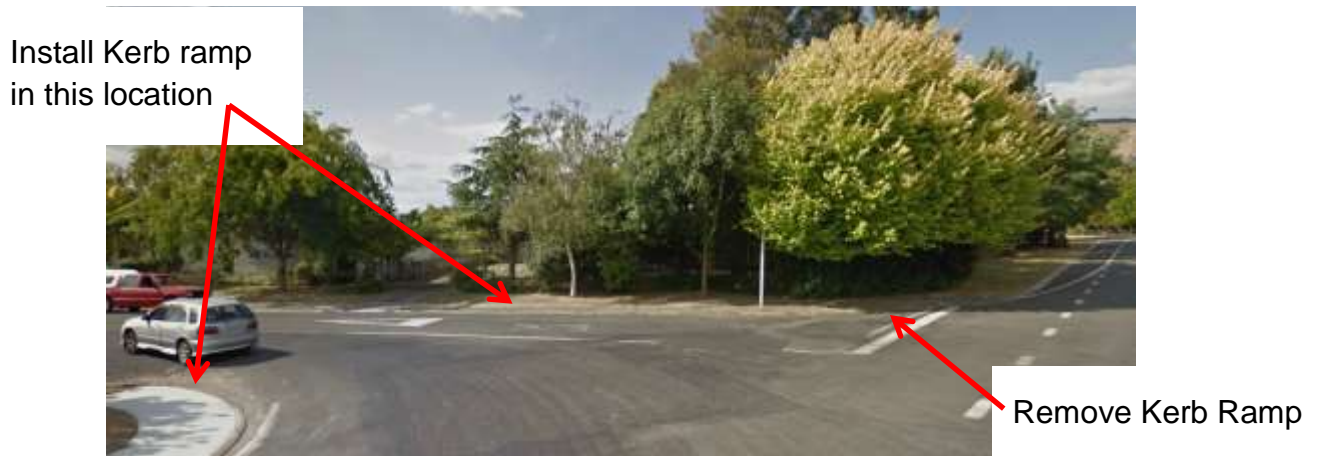
Figure 8: Norwood Road/Wamarei Place Intersection.

Waimarei Place has a footpath only on the east side and this footpath has a connection only to the footpath on the south side of Norwood Road. This connection uses the driveway of 20 Norwood Road for access to the footpath. By re-locating the kerb ramp to connect to the footpath on the north side of Norwood Road, the safety risk of using a driveway is removed.

Recommendation 24 Install kerb ramps to a maximum grade of 1 in 14 (7.1%) at the intersection of Norwood Road and Waimarei Place, crossing Waimarei Place. Remove the kerb ramp at the end of the footpath on Waimarei Place for crossing Norwood Road.

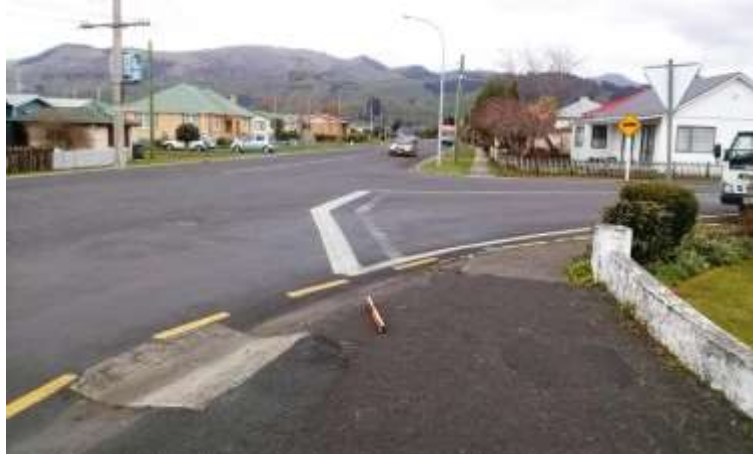
Figure 9: Corbett Street/Willoughby Street Intersection

- Corbett Street/Willoughby Street (southwest crossing Willoughby St) – 1 in 4.4 (22.5%);

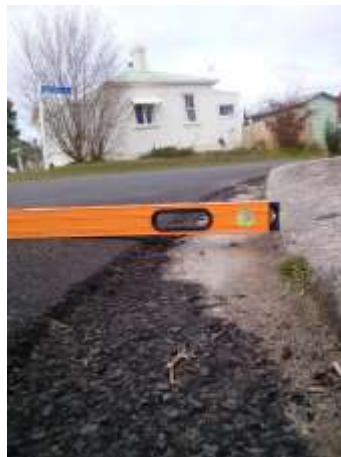
Figure 10: Seal edge join after re-sealing

Re-sealing the carriageway can create a small lip where joining the kerb channel. This can require a wheelchair user to stop in the channel before negotiating the barrier. Milling the seal edge before re-sealing can eliminate this problem.

Recommendation 34 Adopt the practise of milling seal edges at the join of the seal and the kerb channel, especially at areas where a flush kerb cut down is present, in maintenance contracts.

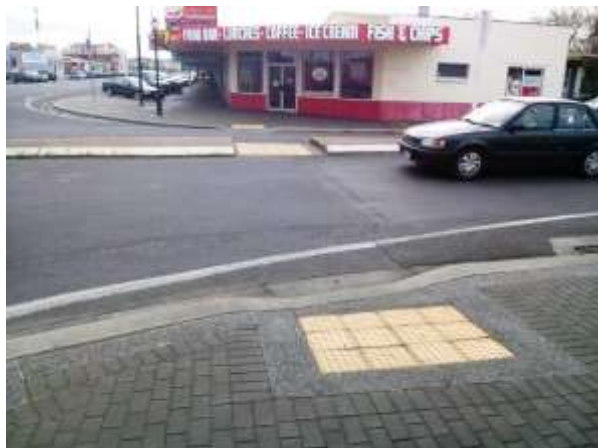
Figure 11: Tactiles at SH.2/SH.26 Intersection

Research by Bentzen et al (Accessible design for the blind, May 2000) indicated that the colour 'safety yellow' is so salient, even to persons having very low vision, that it is highly visible even when used in association with adjoining surfaces having a light reflectance value differing by as little as 40%. Their research found that safety yellow Tactiles having a 40% contrast from new concrete was subjectively judged to be more detectable than darker Tactiles having an 86% contrast with new concrete.

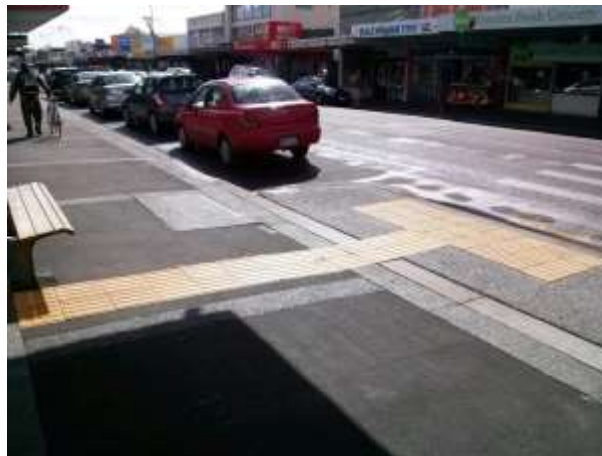
Figure 13: Mid-Block pedestrian crossing on SH.2

Figure 12 shows an excellent example of Directional Indicators installed in Paeroa.

In Paeroa, Directional Indicators need to be installed at every crossing opportunity which is not on the continuous access route. This includes all mid-block crossing points discussed in Section 12: Crossing Opportunities and intersection layouts as detailed in Section 9: Kerb Ramps.

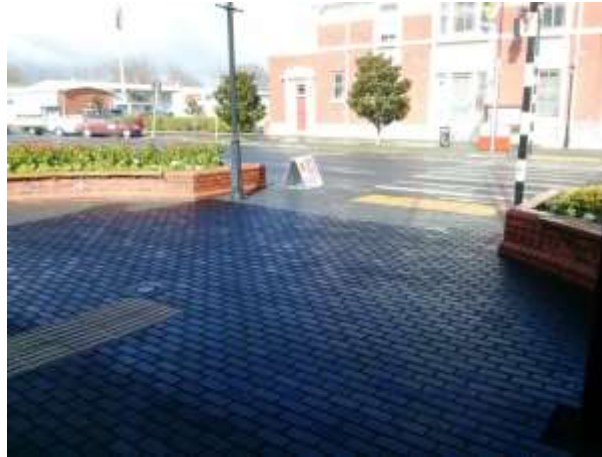
Figure 14: Pedestrian Crossing at NZ Post on SH.2

The pedestrian crossing at NZ Post on SH.2 has Directional Indicators installed on the east side of SH.2. Good practise is to have the Directional Indicators extend the full width of the footpath and lead to the Warning Indicators at the pedestrian crossing.

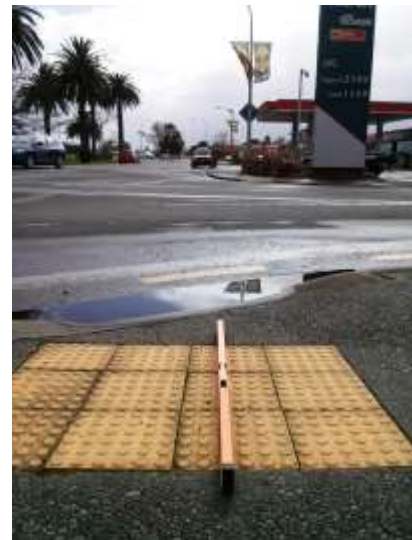
The Warning Indicators at the intersection of SH.2/Station Road were slightly out of alignment. When this intersection is upgraded (see Section 12: Crossing Opportunities), ensure the Warning Indicators are correctly aligned.

Recommendation 40 Ensure all Tactiles installed in future works align the user to the crossing alignment.

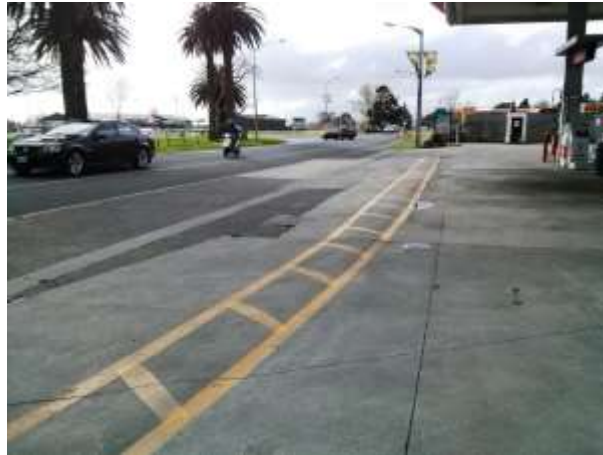
Figure 15: Yellow footpath guideline at Caltex – north of Station Road on SH.2

Sometimes it is necessary to provide contrasting visual guidance without the need for installing Warning or Directional Indicators. A yellow guideline at the boundary or back of footpath of a vehicle crossing can aid visually impaired users to stay on the footpath. The guideline can also remind vehicle users of the footpath and the need to give way to pedestrians. **An excellent example of the use of yellow guidelines is at Caltex on SH.2 in Paeroa.**

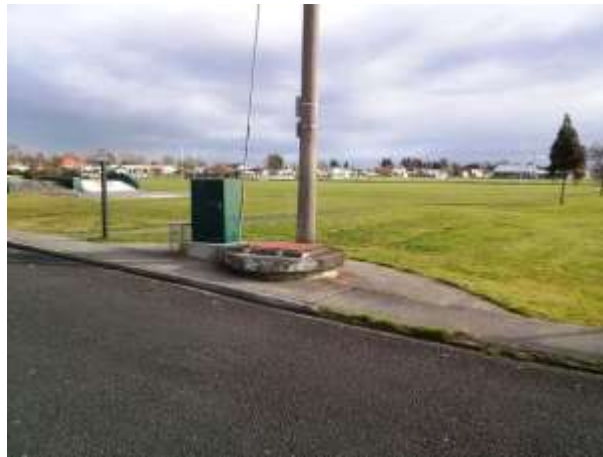
Figure 18: Service cover on Norwood Road

A service cover on Norwood Road is raised above the surface of the footpath approx. 200m from Station Road. Highlighting the footing in yellow will aid visually impaired users when navigating the footpath in this location.

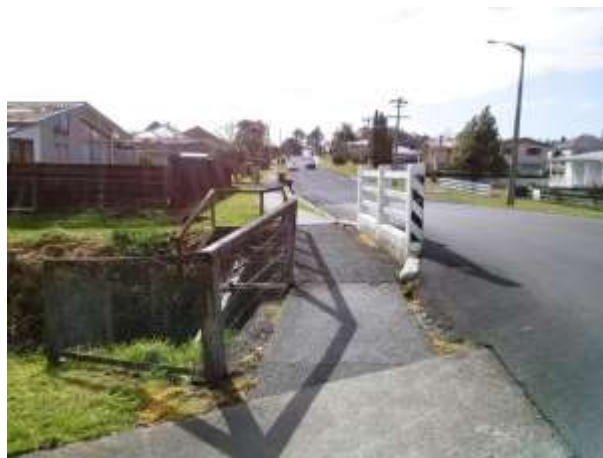
Figure 19: Bridge Barrier on Towers Street

Similarly, painting the bridge barrier on Towers Street will improve identification of the bridge for visually impaired users.

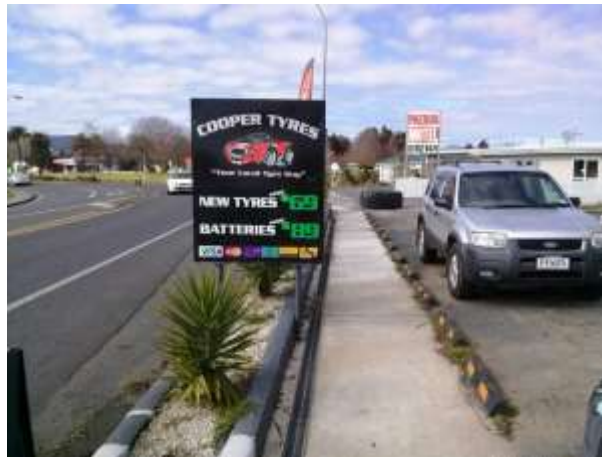
Figure 20: Sign on SH.2 next to the footpath

The Coopers Tyres sign on SH.2 is low and potentially hazardous for pedestrians. Re-locating the sign will eliminate the hazard.

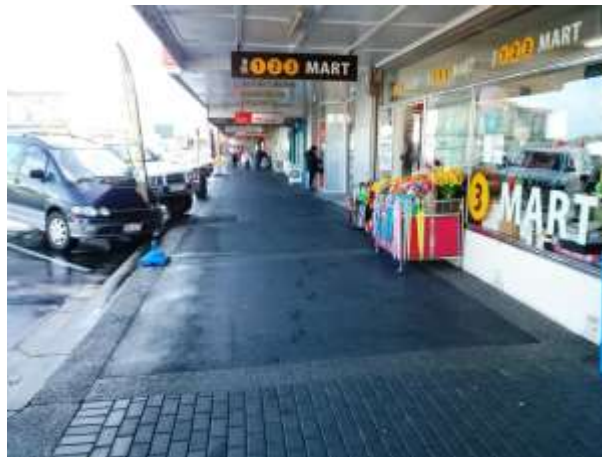
Figure 21: Footpath surface on Sh.2

A number of improvements have been made to the footpaths in the main shopping centre of Paeroa. As a result, a combination of Asphaltic Concrete with Concrete strips has been laid to create a softer, more appealing environment.

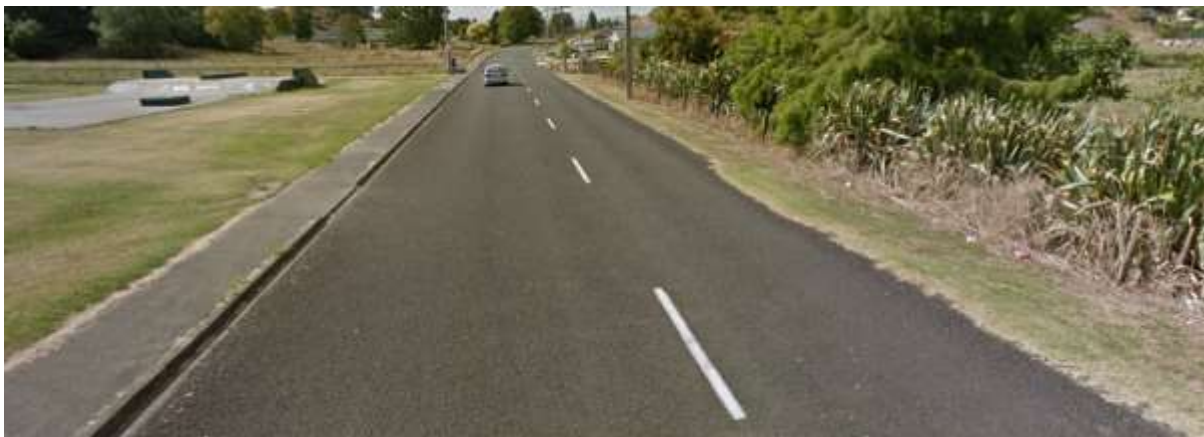
Figure 22: Footpath on west side of Norwood Road only

When considering footpaths on minor roads, consideration should be given to achieving access to the existing footpath from the other side of the road and side roads.

The first priority is to complete the connections to ensure a continuous access route. This can be achieved by either installing new footpaths or providing crossing opportunities. Given the locality and traffic volumes along these roads, installing footpaths on both sides of local roads would be deemed a low priority, long term plan. The short term plan should be to ensure sufficient access across the road can be achieved. Crossing opportunities is discussed in Section 12: Crossing Opportunities.

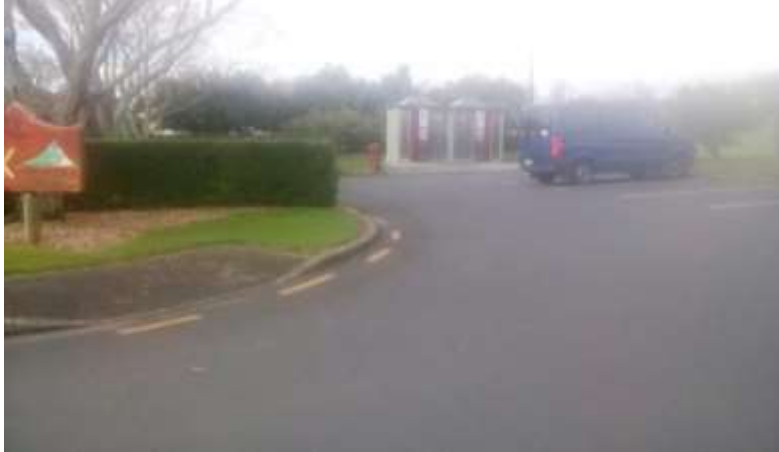
Figure 24: Ohinemuri Park

The second location is at Ohinemuri Park. Extending the footpath from the Bus Stop to the Public Toilets will improve access in this location.

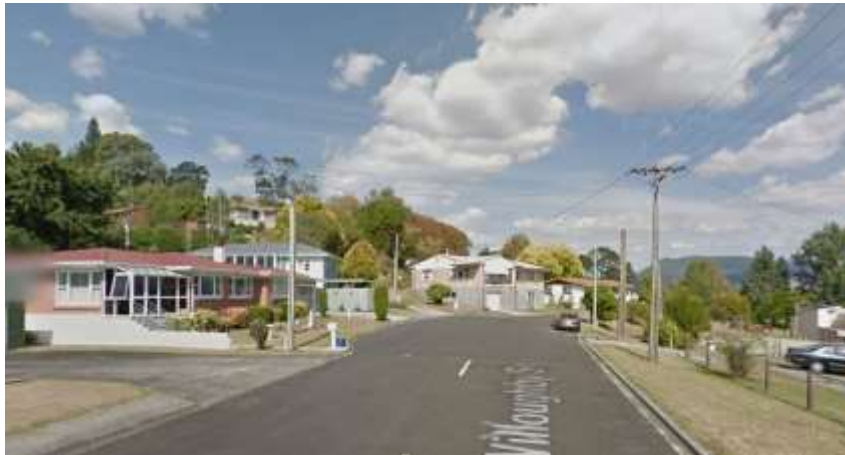
Figure 25: Willoughby Street - to St Joseph's Catholic School

The third location is on Willoughby Street to St Joseph's Catholic School. The footpath ends at #54. Extending the footpath to the school will complete the access route to the school.

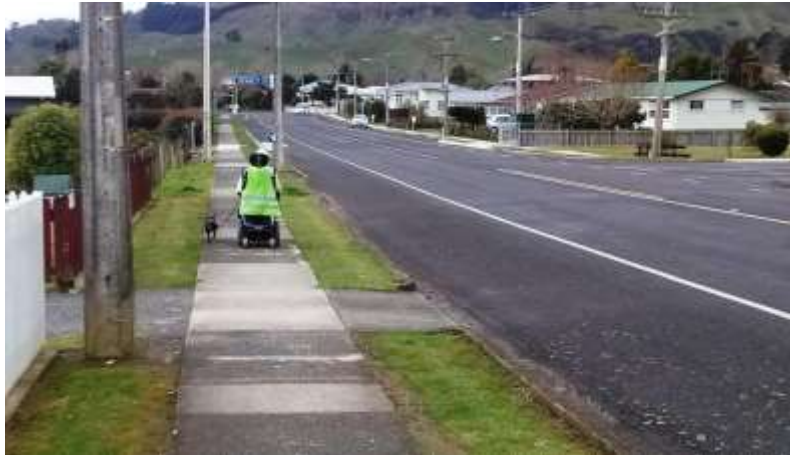
Figure 26: Power Wheelchair user walking her dog on SH.26

Most of the footpaths in the geographic area of interest are below the absolute minimum of 1.5m. A narrow footpath creates difficulty for mobility scooters and pushchairs to pass. With a steep crossfall, a narrow footpath can also limit recovery time if an access user loses control of their scooter or wheelchair.

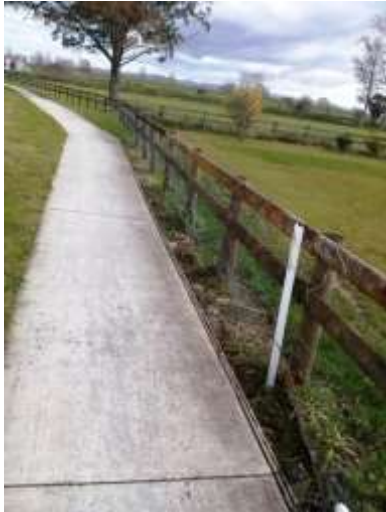
West of the Paeroa College is a section with the level below the footpath level with a fence offset from the back of the footpath. Moving the fence line to be directly behind the footpath will eliminate the potential risk of a mobility scooter or young cyclist falling off the footpath and causing serious injury.

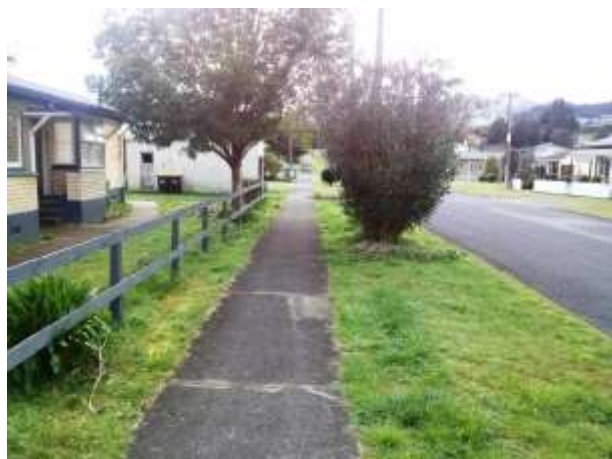
Figure 28: Broken footpath on Thorp Street at 168 Normanby Road

- Corbett Street - South intersection of Bradley St/Corbett St, #24;
- Hughenden Street – North side west of SH.2, southeast of Marshall St;
- Kennedy Street – Opp. #1;
- Marshall Street – Re-locate boulder at car park from footpath;
- 38 Norwood Road;
- Opatito Road/Dearle Street – Outside Waikato Regional Council;
- Princes Street – Outside Liquor Warehouse;
- SH.2 – Outside Paeroa Tyres, Limm Motors, Vintage and Retro Shop;
- Shaw Avenue - #12, #34, #36;
- Station Road - #37, #41;
- Thorp Street – Driveway at 168 Normanby Rd (SH.2), east of school entrance;
- Towers Street – Outside Towers Court, #22;
- Victoria Street – Sh.2 to Willoughby Street (south side);
- Wharf Street – Joint of driveway to Idea Services, opp. RSA entrance;
- Willoughby Street - #39, southeast corner SH.26; and
- Wood Street – Victoria St corner on southeast corner.

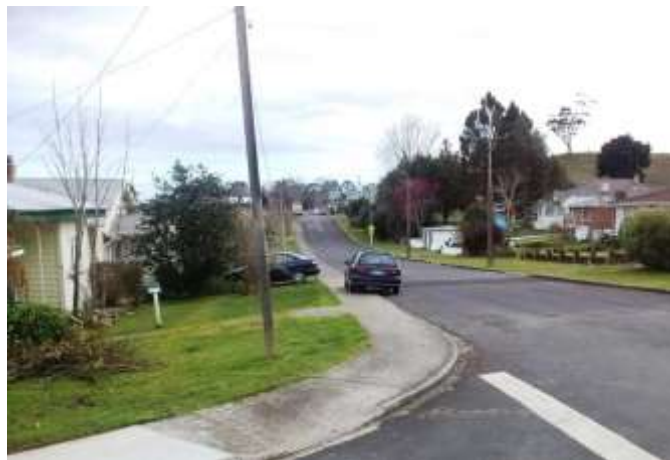
Figure 29: Parking on the footpath at 33 Wood Street

- Francis Street – Between William St and Hughenden St;
- Marshall Street – Outside Auto Electrical between SH.2 and William St;
- 34 and 36 Willoughby St; and
- 33 Wood Street.

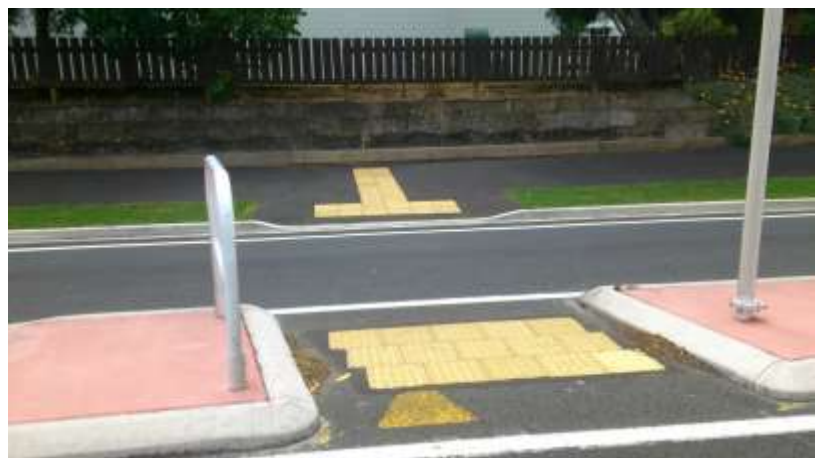
Figure 30: Ideal pedestrian refuge island crossing facility

Pedestrian refuge islands should ideally be at least 1.8 metres wide (narrow refuge islands put pedestrians at risk of being hit by truck side mirrors) and can be part of an un-signalised pedestrian crossing⁴⁷. This width also allows for a mobility scooter to fully park on the refuge island (most mobility scooters range from 1.3m to 1.5m in length).

Pedestrian refuge islands can be used where there is a demand for pedestrians to cross the road, but where the numbers of pedestrians are not high enough to warrant a signalised pedestrian crossing⁴⁸.

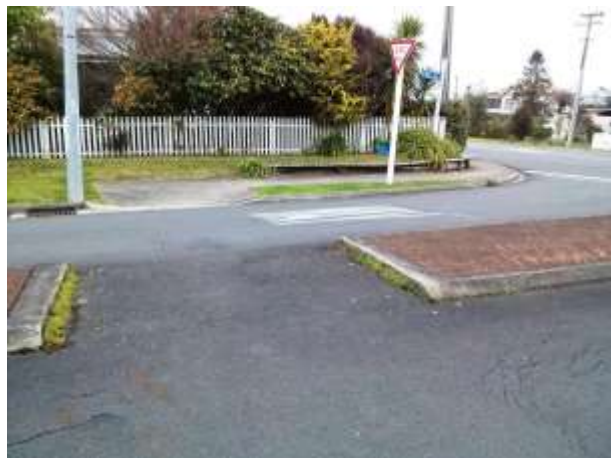
Figure 32: Refuge Island in Paeroa

A very good example of providing a good crossing facility is SH.26, west of Wood Street. With the footpath on the south side ending at Wood Street, by providing a safe crossing facility to the north side will encourage users to use the other side. There are exceptions though, as shown in Figure 32 below! Sometimes, pedestrians will walk where they want to. But, by providing a safe crossing facility, HDC (and NZTA) reduces the risk for injury for many.

Crossing opportunities provide linkage for pedestrians to each side of the road. In some cases, they complete links between footpaths, particularly if the street has a footpath on one side only. By providing kerb ramps, pedestrian refuge islands, and/or pedestrian crossings, safer connectivity can be provided for mobility impaired pedestrians.

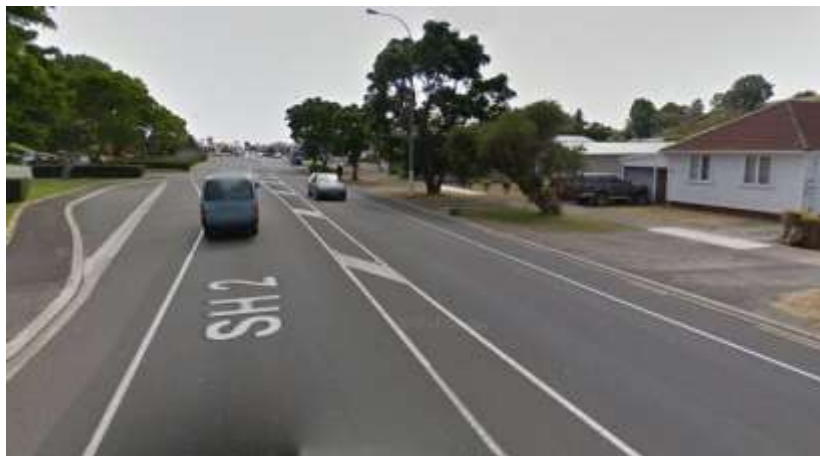
Figure 35: SH.2 – Ohinemuri Park

- SH.2 – Ohinemuri Park – Install a Refuge Island to provide connection to Ohinemuri Park from town;

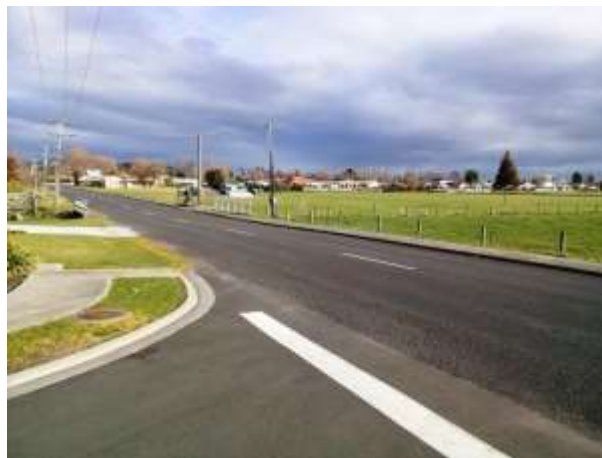
Figure 36: New subdivision on Norwood Road.

Kerb ramps are now required on both sides of Norwood Road at the subdivision to complete access.

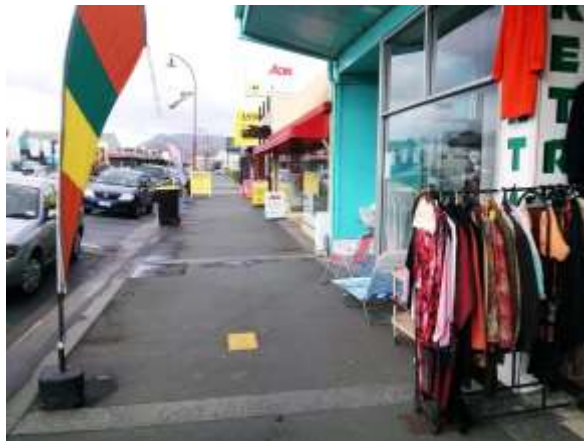
Figure 37: Shop wares and signage on SH.2

Businesses along SH.2 regularly install street signage, stock and tables and chairs outside of their premises. This has implications for people with significant visual impairment as they frequently use environmental cues such as buildings to navigate around a community and they won't necessarily see stock that are low to the ground, they become a trip hazard.

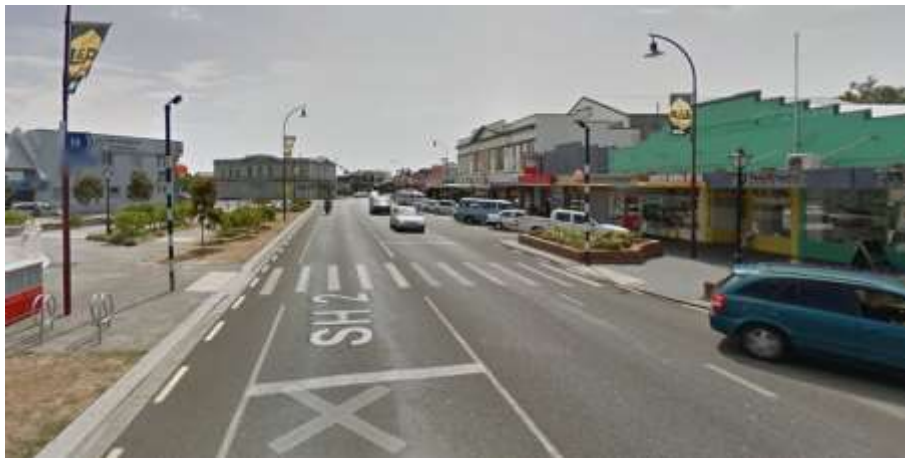
Figure 38: Pedestrian Crossing outside NZ Post on SH.2

HDC has placed a garden at the pedestrian crossing at the NZ Post Office. The garden is placed on the side of the approaching traffic. Given the height of a Mobility Scooter or Wheelchair User, sight visibility can be impaired for both vehicle users and mobility users.

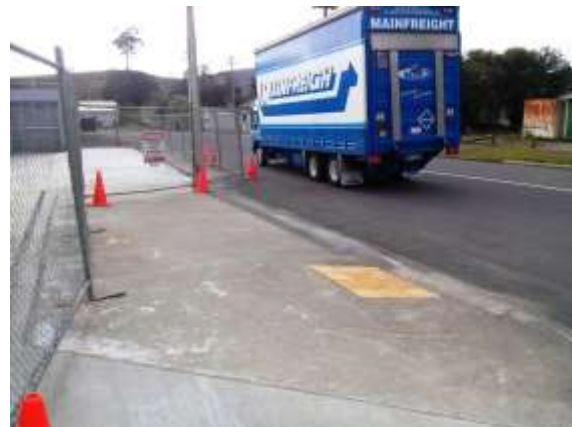
Figure 39: Temporary Traffic Management on Victoria Street

The former Mobil Service Station at the intersection of SH.2 and Victoria Street is currently under a re-development. The footpath is currently closed on Victoria Street. This is not a major concern in this situation, given that access is available to the south side of Victoria Street. Signage is required advising the footpath is closed and that access is available on the south side of Victoria Street. Improvements will need to be carried out to improve the footpath on the south side, including trimming vegetation.
