WAIHI ACCESSIBILITY AUDIT REPORT

CCS DISABILITY ACTION

TAYLORED ACCESSIBILITY SOLUTIONS LTD

DECEMBER 2014

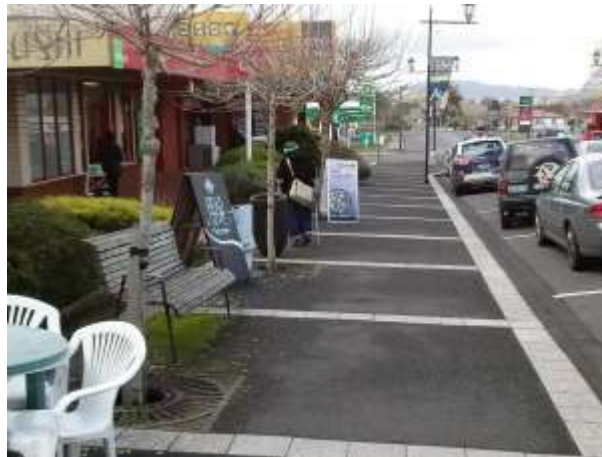
Figure 1: Rosemont Road (SH.2)

Shop owners take pride in the town by minimising footpath clutter and maintaining access routes. Council has contributed by installing a textured footpath surface on Seddon Street and Rosemont Road (SH.2).

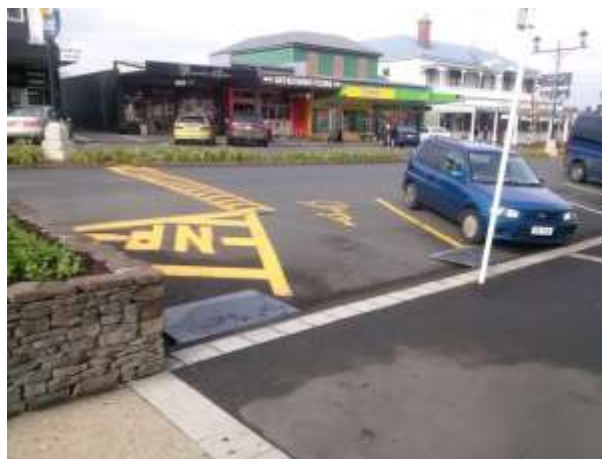
Figure 2: Mobility Space at the War Memorial Hall, Seddon Street

Overall, the condition of the Mobility Spaces provided in Waihi is good with crossfall on all Mobility Spaces except for one measuring below 1 in 14 (7.1%).

Recommendation 14 Relocate the Mobility Space outside the War Memorial Hall to 47 Seddon Street to improve the crossfall of the space and remove the speed hump as a barrier.

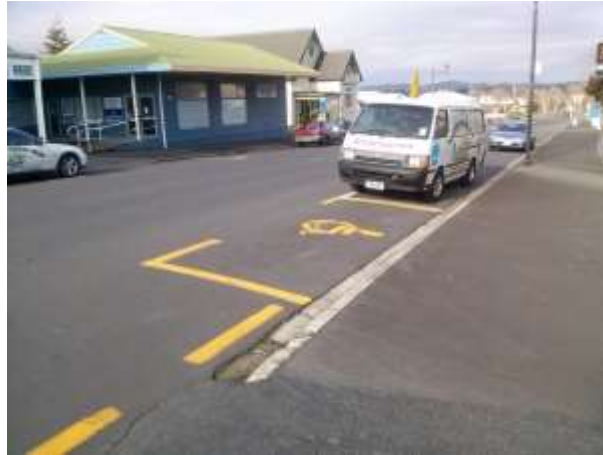
Figure 3: Mobility Space on Haszard Street

Although the overall total of Mobility Spaces comply when compared to the overall total of parking spaces, when the parking spaces are broken down into specific areas, the following areas do not comply:

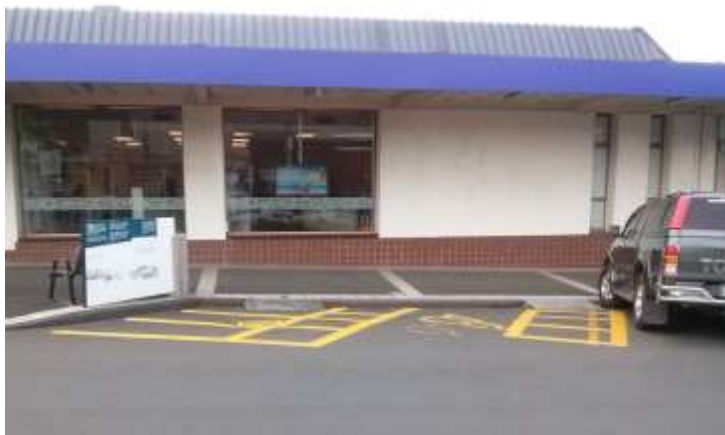
Figure 5: Mobility Space at 68 Seddon Street (BNZ)

This is good practise as it allows for access to the footpath for both mobility user drivers and passengers. Installing full length ramps at the remaining Mobility Spaces on Seddon Street, Haszard Street and Seddon Avenue (SH.2) will complete access to the footpath.

Recommendation 8 Install full length kerb ramps at the remaining Mobility Spaces in Waihi to provide quick, easy access to the footpath.

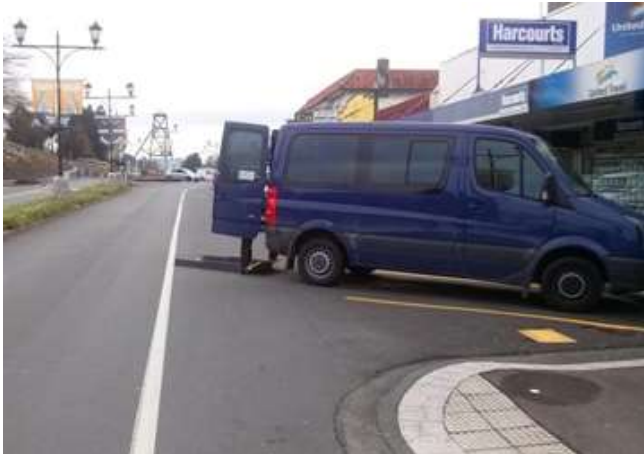
- Wheelchair user remains in wheelchair and uses rear of vehicle to enter vehicle (most commonly by hoist).

Figure 6: Rear Loading Wheelchair Van

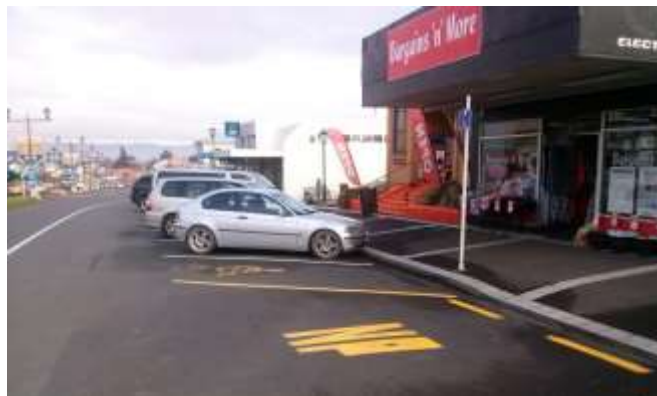
Figure 7: Mobility Space outside Bargains' n' More

The Mobility Space at 67 Seddon Street is below the recommended 3.5m in width (2.7m). A driveway is to the east of the Mobility Space and is used to access the footpath. Widening the space to 3.5m by removing the carpark to the west of the Mobility Space will greatly improve access for wheelchair users to quickly and safely access the footpath.

Recommendation 11 Remove a carpark and widen the Mobility Space at 67 Seddon Street to achieve better access for mobility users.

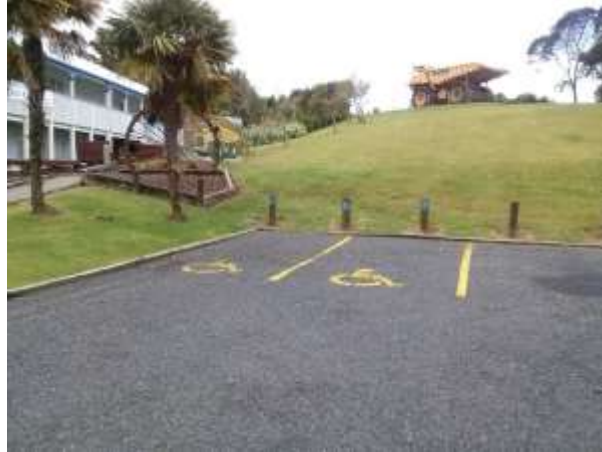
Figure 8: Mobility Spaces at Golden Legacy Centre, Moresby Avenue

The two Mobility Spaces at the Golden Legacy Centre measured at a total of 5m wide for the two spaces.

Recommendation 12 Widen the two Mobility Spaces at the Golden Legacy Centre to a minimum total width of 6.5m.

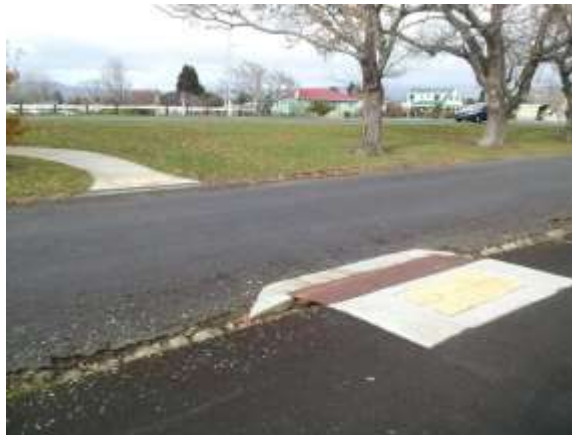
Of greatest concern is the lack of crossing opportunities of SH.2. For the Seddon Avenue section of SH.2, the crossing opportunities provided for mobility impaired users are:

- Mid-block crossing with refuge island at Victoria Park; and
- Seddon Avenue / Moresby Avenue / Seddon Street / Rosemont Road roundabout.

Figure 11: Mid-block crossing opportunity on SH.2 to Victoria Park

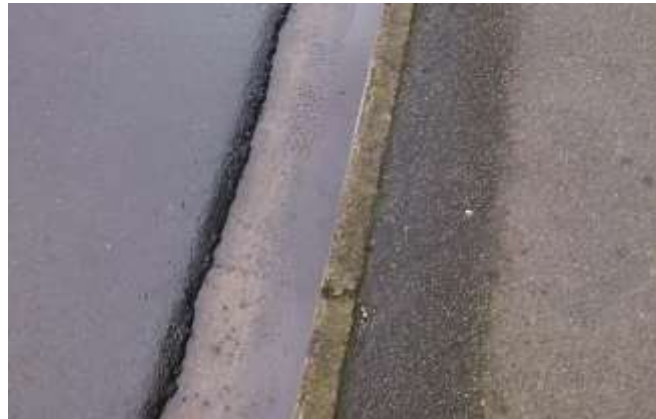
Figure 13: Seal edge join after re-sealing

Re-sealing the carriageway can create a small lip where joining the kerb channel. This can require a wheelchair user to stop in the channel before negotiating the barrier. Milling the seal edge before re-sealing can eliminate this problem.

Recommendation 32 Adopt the practise of milling seal edges at the join of the seal and the kerb channel, especially at areas where a flush kerb cut down is present, in maintenance contracts.

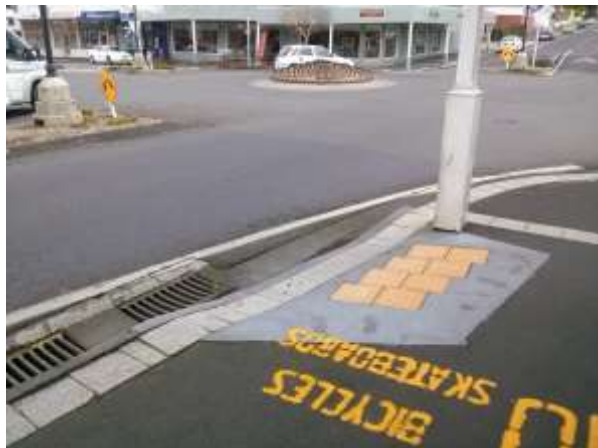
Figure 14: Tactiles at SH.2/Seddon Street Roundabout

Research by Bentzen et al (Accessible design for the blind, May 2000) indicated that the colour 'safety yellow' is so salient, even to persons having very low vision, that it is highly visible even when used in association with adjoining surfaces having a light reflectance value differing by as little as 40%. Their research found that safety yellow Tactiles having a 40% contrast from new concrete was subjectively judged to be more detectable than darker Tactiles having an 86% contrast with new concrete.

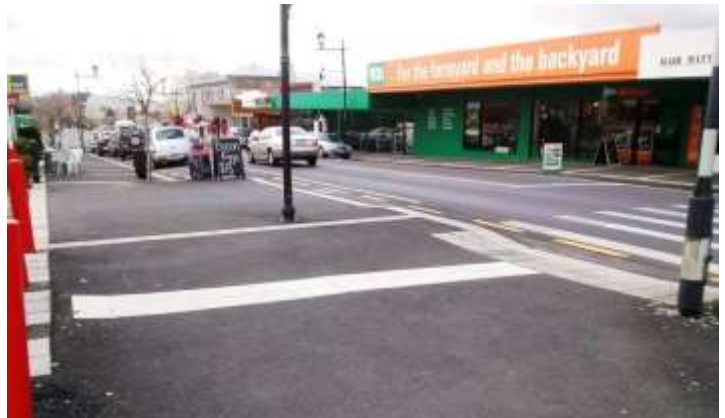
The following locations need to have the Warning Indicators replaced to a safety yellow standard:

- SH.2 mid-block pedestrian crossing (Seddon Street to SH.25);

Figure 15: SH.2 Pedestrian Crossing

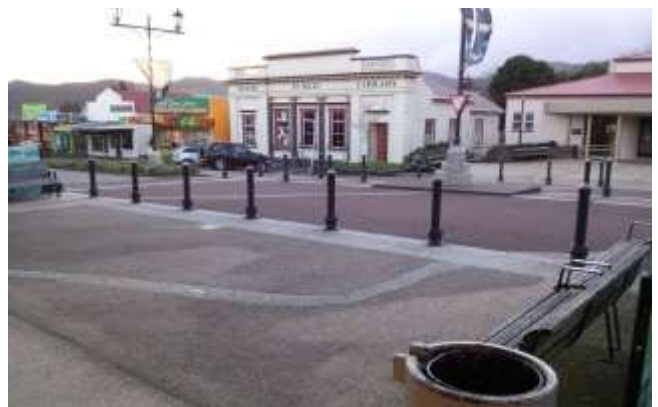
- Mid-block crossing point on Seddon Street – outside the War Memorial Hall; and

Figure 16: Seddon Street crossing opportunity - War Memorial Hall

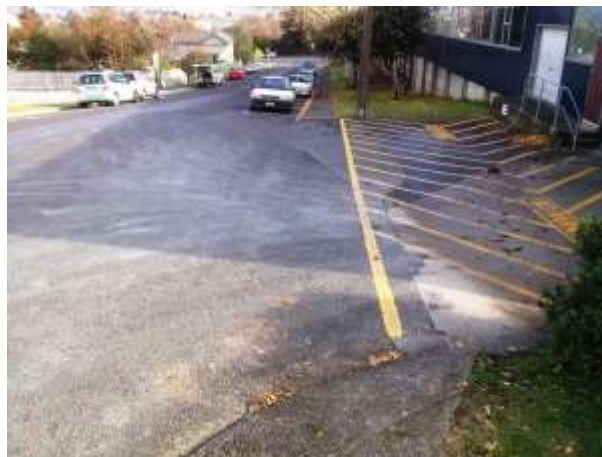
Figure 19: Yellow footpath guideline at Newmont Gold Waihi

Sometimes it is necessary to provide contrasting visual guidance without the need for installing Warning or Directional Indicators. A yellow guideline at the boundary or back of footpath of a vehicle crossing can aid visually impaired users to stay on the footpath. The guideline can also remind vehicle users of the footpath and the need to give way to pedestrians. An excellent example of the use of yellow guidelines is at Newmont Waihi Gold on Martha Street.

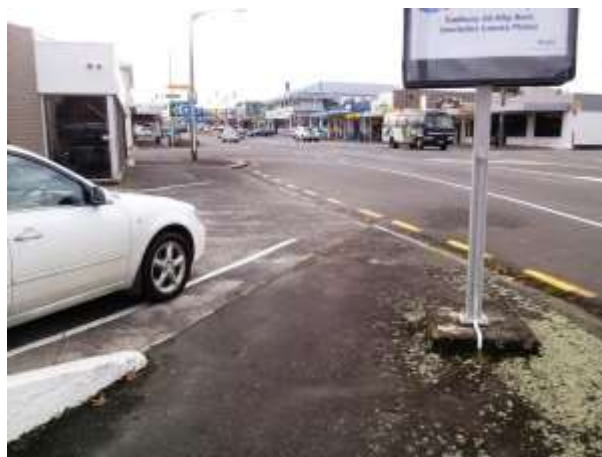
Figure 21: Sign at the Mobil Service Station on SH.2

A footing of a sign at the Mobil Service Station on SH.2 protrudes the surface of the footpath at the School Lane end of the Service Station. Highlighting the footing in yellow will aid visually impaired users when navigating the sign in this location.

Recommendation 40 Highlight the sign footing at the Mobil Service Station and the power pole outside Countdown on SH.2 in yellow to aid visually impaired users navigate these locations.

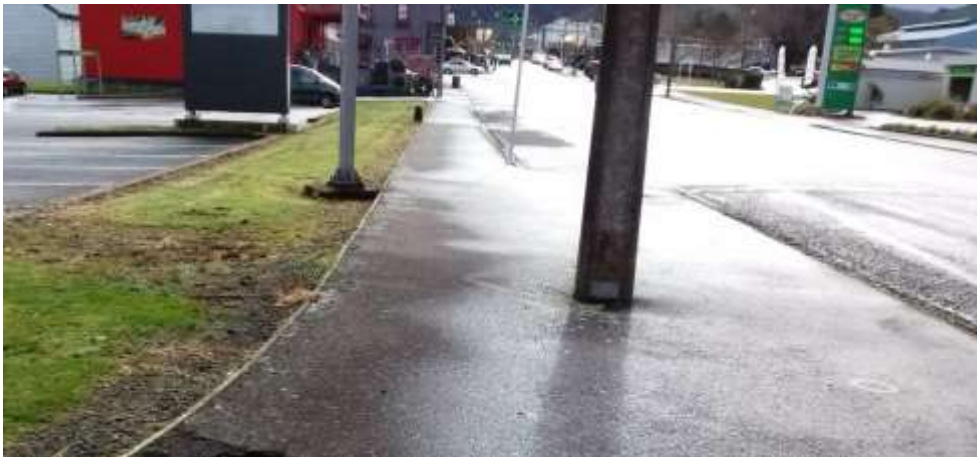
Figure 22: Power Pole outside Countdown on SH.2

Similarly, a power pole outside Countdown on SH.2 is in the middle of the footpath. This can create a hazard for visually impaired users and young children. A long term solution would be to request Powerco to re-locate the power pole to the rear of the footpath. A short term solution is to highlight the pole by painting the first two metres in yellow.

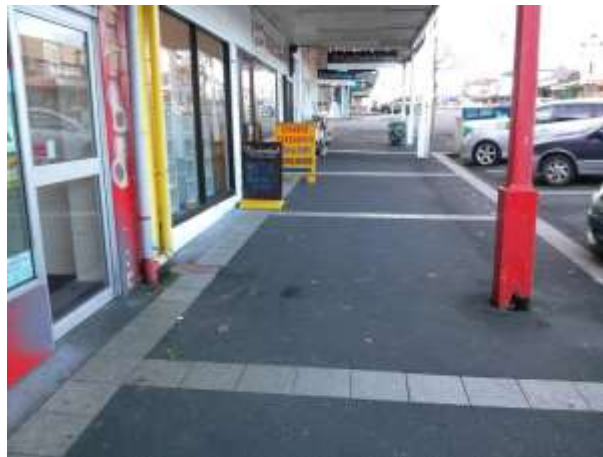
Figure 23: Excellent footpath surface on Seddon Street

Note: Care needs to be taken when the surface of the tiles is wet. Monitor the situation by recording complaints of slipping on the tiles to determine the continued use of these tiles.

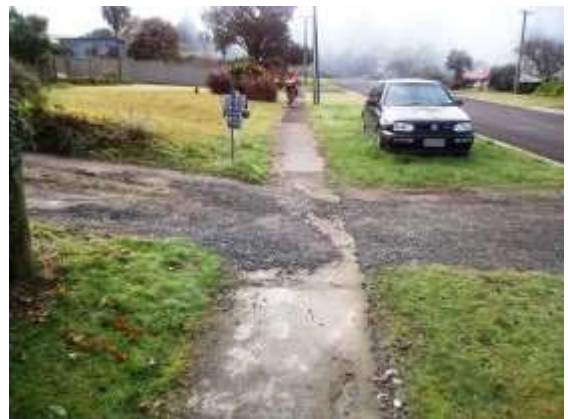
Figure 25: Loose metal from a driveway on George Street.

- 8 Featon Road;
- George Street – outside #5, #15, and #19;
- 32 Gilmour Street;
- 36a Martin Road;
- 35 Moresby Avenue;
- 59 Union Street;
- 16 Victoria Street; and
- 39c Walker Street.

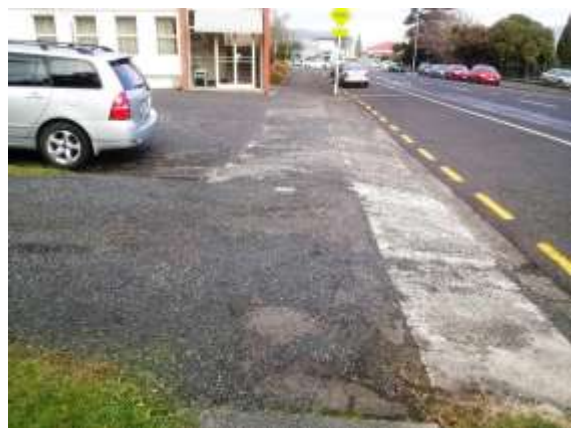
There are locations where HDC can repair the surface and eliminate loose metal and broken surfaces:

Figure 26: Footpath outside Newmont Waihi Gold on Moresby Avenue.

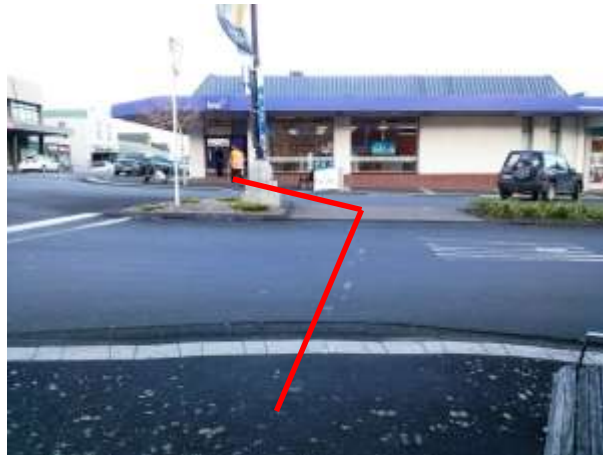
The following crossing alignments need relocating:

- Seddon Street/Haszard Street – crossing point outside BNZ;

Figure 29: Crossing Seddon Street at Haszard Street Intersection.

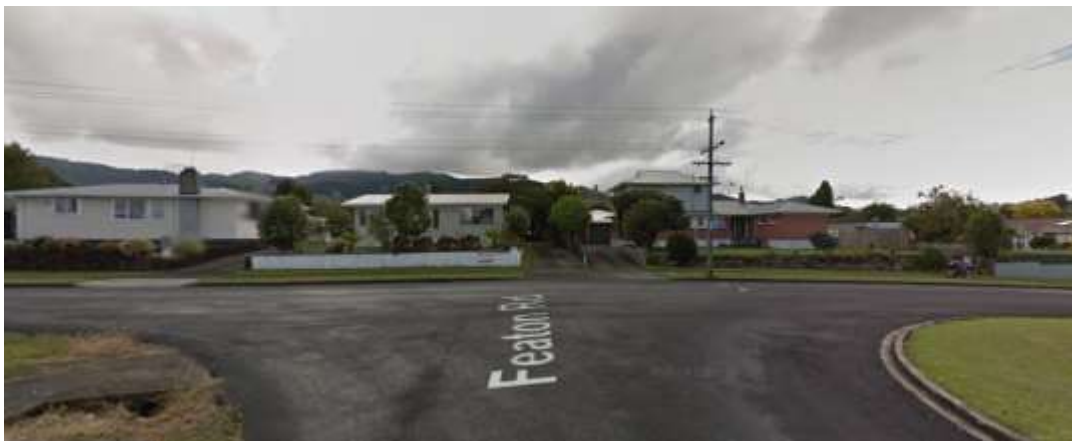
Figure 30: No footpath connection from Featon Road to Walker Street

- Featon Rd/Walker St – Install a kerb ramp on the north side of Walker St to connect to the footpath on Featon Road;

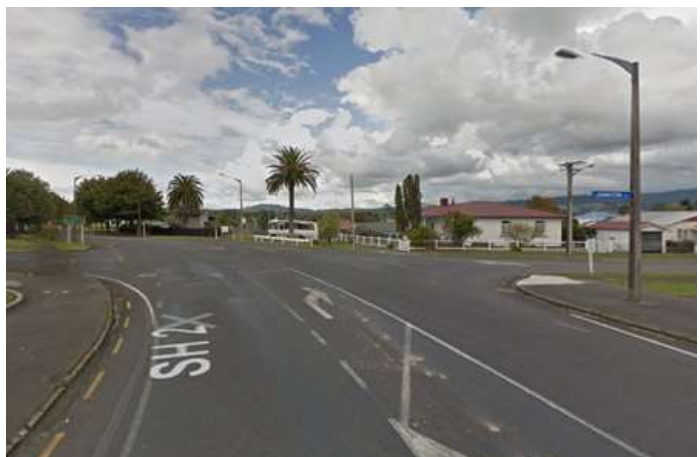
Figure 31: SH.2/Johnstone Street Intersection.

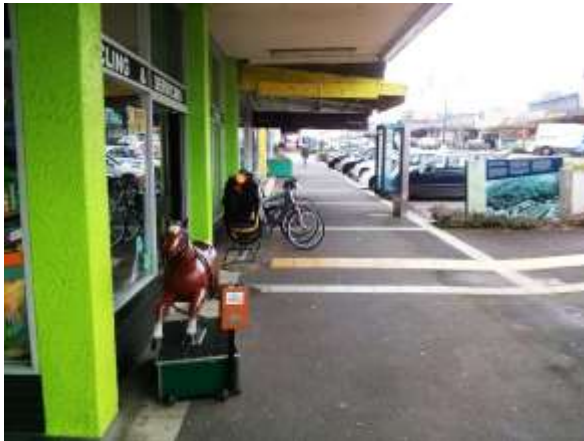
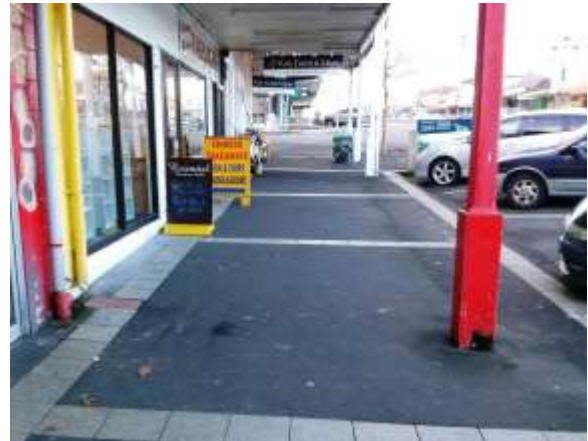
Figure 32: Shop wares and signage on Seddon Street

Businesses along Seddon Street regularly install street signage, stock and tables outside of their premises. This has implications for people with significant visual impairment as they frequently use environmental cues such as buildings to navigate around a community and they won't necessarily see stock that are low to the ground, they become a trip hazard.

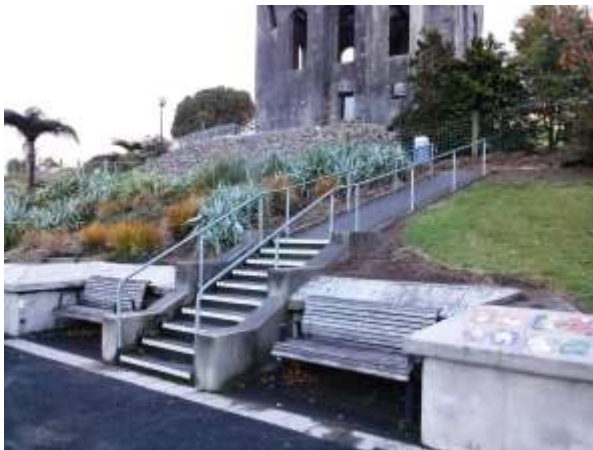
- Positioning of the seat – The seating should be set back from a footway such that it does not cause an obstruction; there should be space for a wheelchair user to pull up alongside a companion; end parking on a firm surface for a wheelchair or scooter. The Department for Transport (UK) (2007) suggests that seating should be located where there is good lighting and natural surveillance because it can sometimes attract anti-social behaviour, and that consideration should be given to pedestrian desire lines.

Figure 33: Public seating on Port Road

Recommendation 70 Adopt the Inclusive Design for Getting Outdoors as part of its design for public seating.

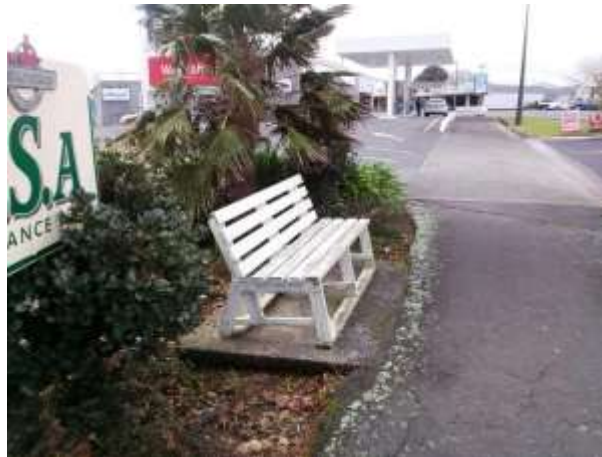
HDC have provided a great amount of seating in Waihi with the majority having armrests. The following seating was identified to have armrests installed at least at one end:

- 6 Russell Street;
- Seddon Street – one seat at Martha Court; and
- SH.2 – Outside Waihi Hospital, intersection with Kensington Road, and at the RSA.

Figure 34: Seating outside the RSA on SH.2

Recommendation 71 Install at least one armrest on the seating provided at:

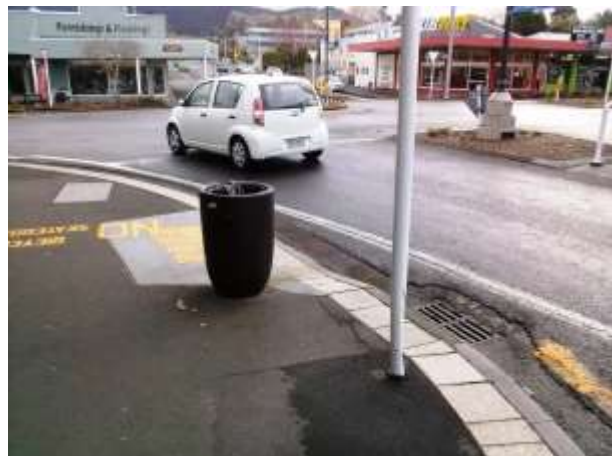
Figure 35: Rubbish bin limiting sight visibility at SH.2/Seddon Street

HDC has placed street furniture at good locations at crossing opportunities. Even though the black and white crossing identification pole is generally located on the side in which traffic is

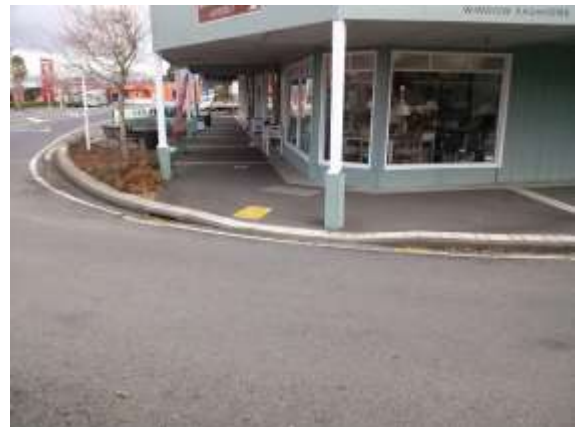
Figure 36: Verandah support in crossing opportunity at SH.2/Moresby Avenue

- SH.2/Moresby Avenue – north/west side;
- SH.2 Pedestrian Crossing near SH.25 – west side.
