OCEANAGOLD
WAIHI OPERATION

Dewatering and Settlement Report 2022

Document Reference: WAI-200-REP-007

DEWATERING & SETTLEMENT MONITORING REPORT 2022

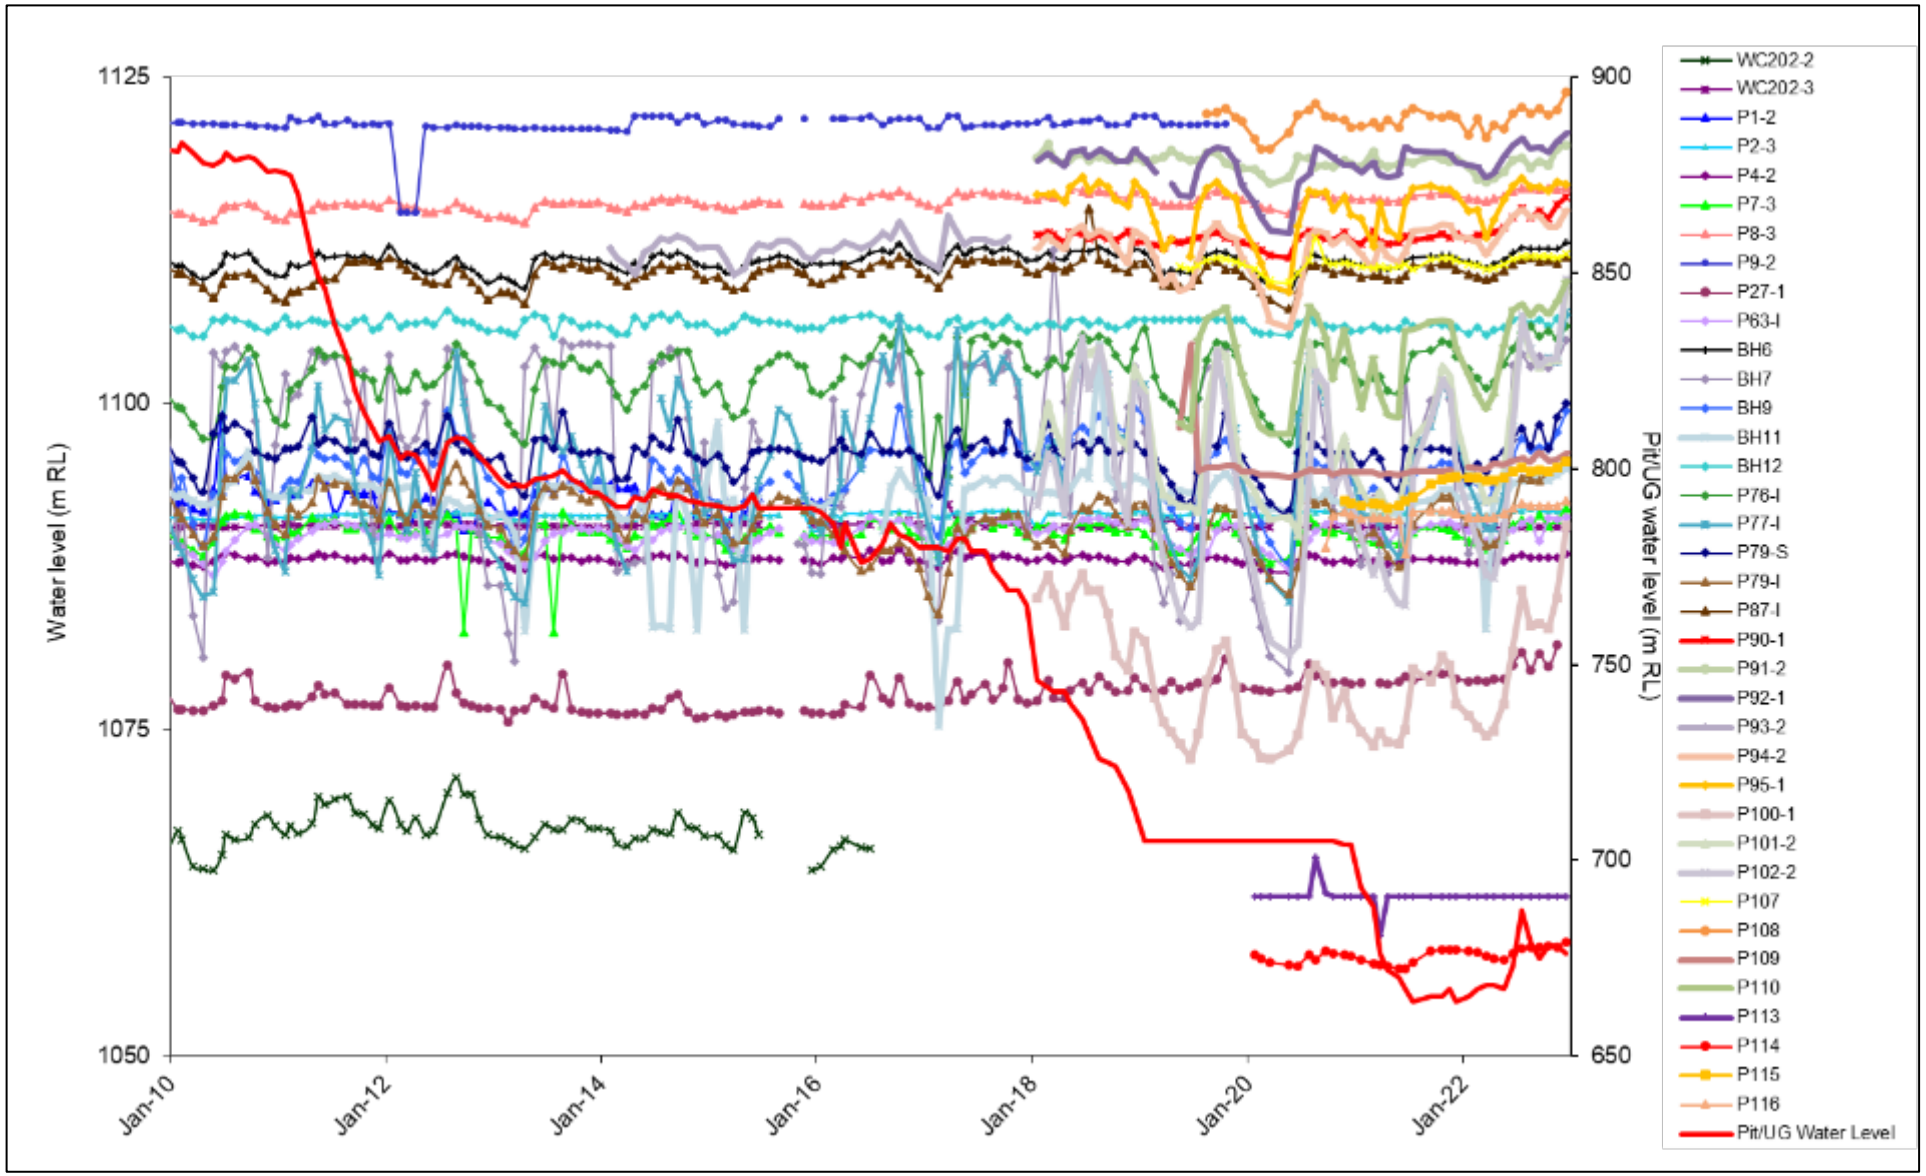
Figure 15. Groundwater level trends – deeper younger volcanics near underlying andesite contact.

The stable water levels in the wells monitoring the deeper younger volcanic materials and the upper andesite layers (Figure 15) indicate that the observed settlement behaviour is not related to on-going consolidation of these materials at these locations as no on-going dewatering is evident at these locations.

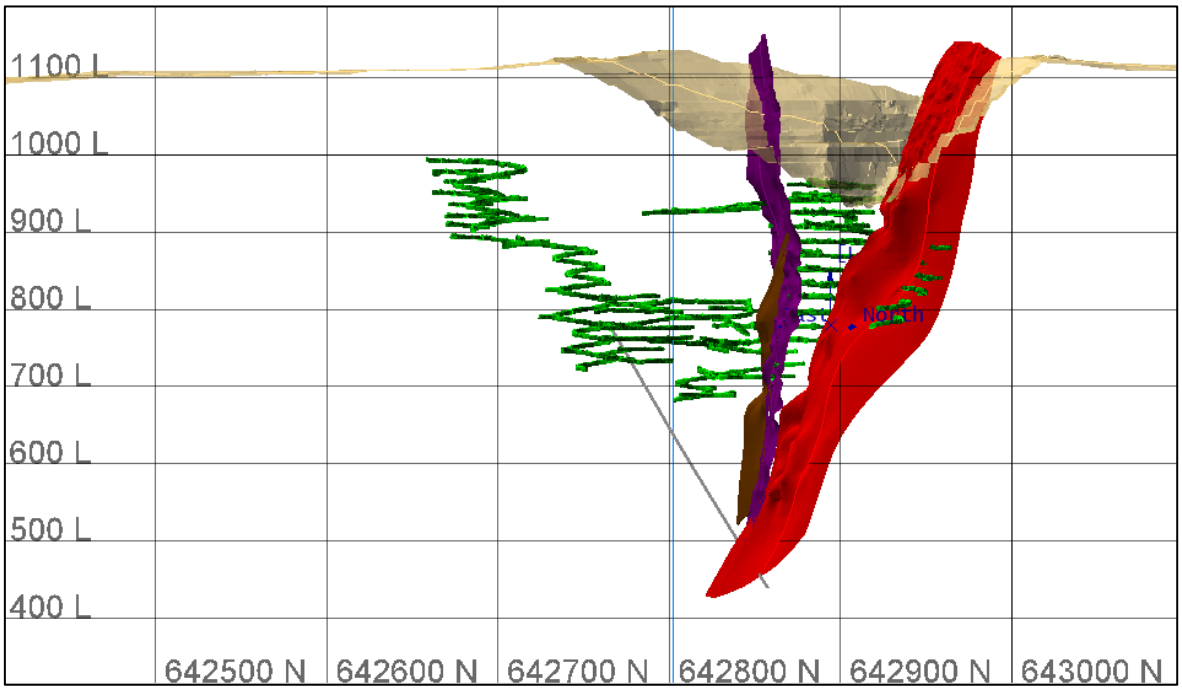
Figure 22: Underground piezometer cross section

In July 2022 a piezometer was installed in an existing exploration drill hole (Figure 22). The drill hole collar is in the Edward decline at 773 mRL. The hole length is around 350m, however vertically it is 300.5 m. The piezo tip is at 472.5 mRL and terminates approximately under the Empire west orebody and in set in deep Martha andesite. Piezometer readings show the December 2022 water level at 668 mRL (Figure 23). This is similar to the water level measured in PC1 borehole at 676 mRL.

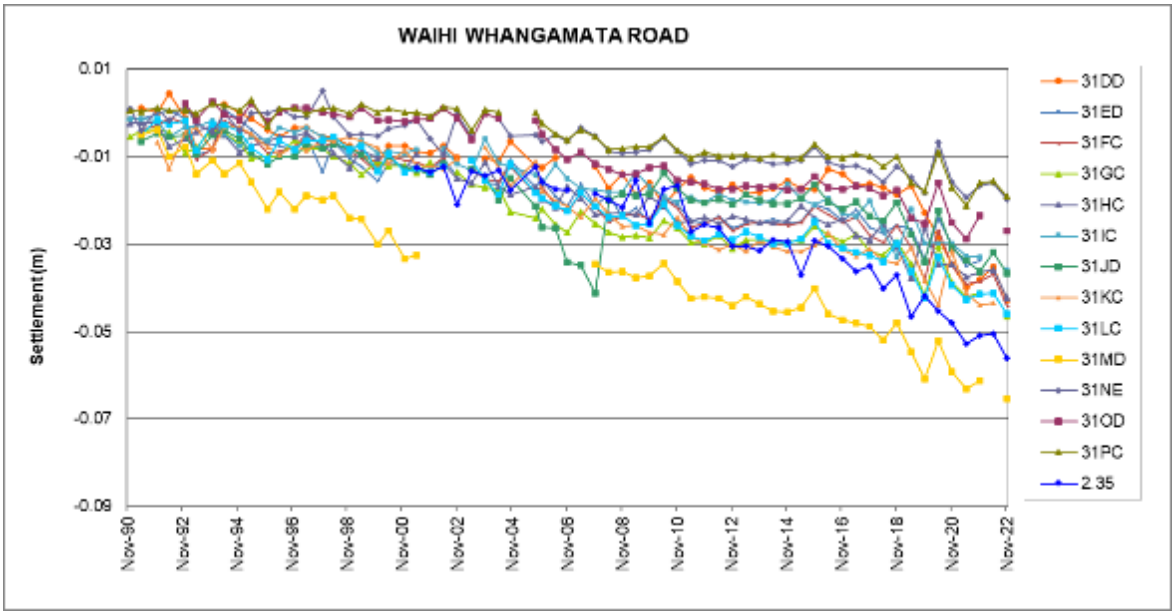
Figure 41: Zone 1 Waihi to Whangamata Road

This grouping shows that the marks in Zone 1 with a slow ongoing settlement trend are located along Waihi to Whangamata Road to the east of Waihi and to the south of Waihi. A steady increase in settlement rate from about 1999 is also be observed in most marks in Zones 2 to 6, suggesting that there is a small and widespread effect occurring at depth. Two of the three settlement marks in Zone 1 to the west show little settlement until 2015 and then a small steady on-going settlement showing the widespread effects at depth have reached these markers (Figure 44).

- The widespread 10 to 50 mm settlement observed from about 1999 at many Zone 1 marks and also the increasing settlement in Zones 2 to 6 marks is a response to the ongoing dewatering of the deeper structures in the andesite rock body (fracture depressurisation) as a result of mine dewatering. This is a broad effect and has negligible influence on differential tilt between marks.

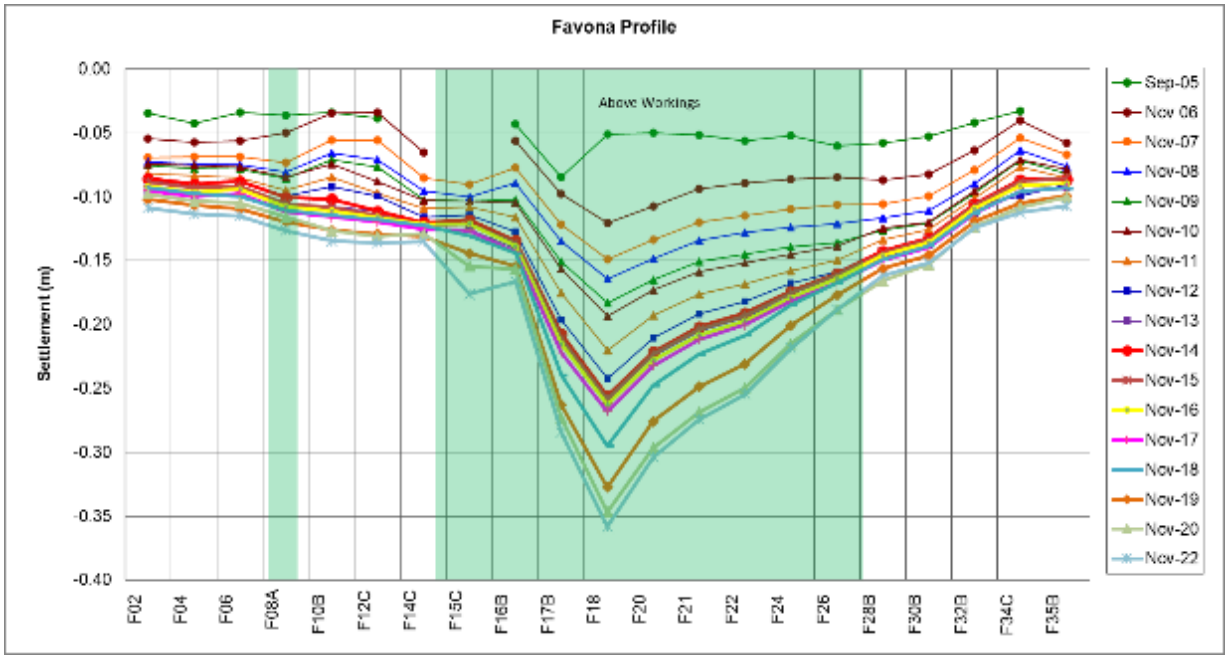
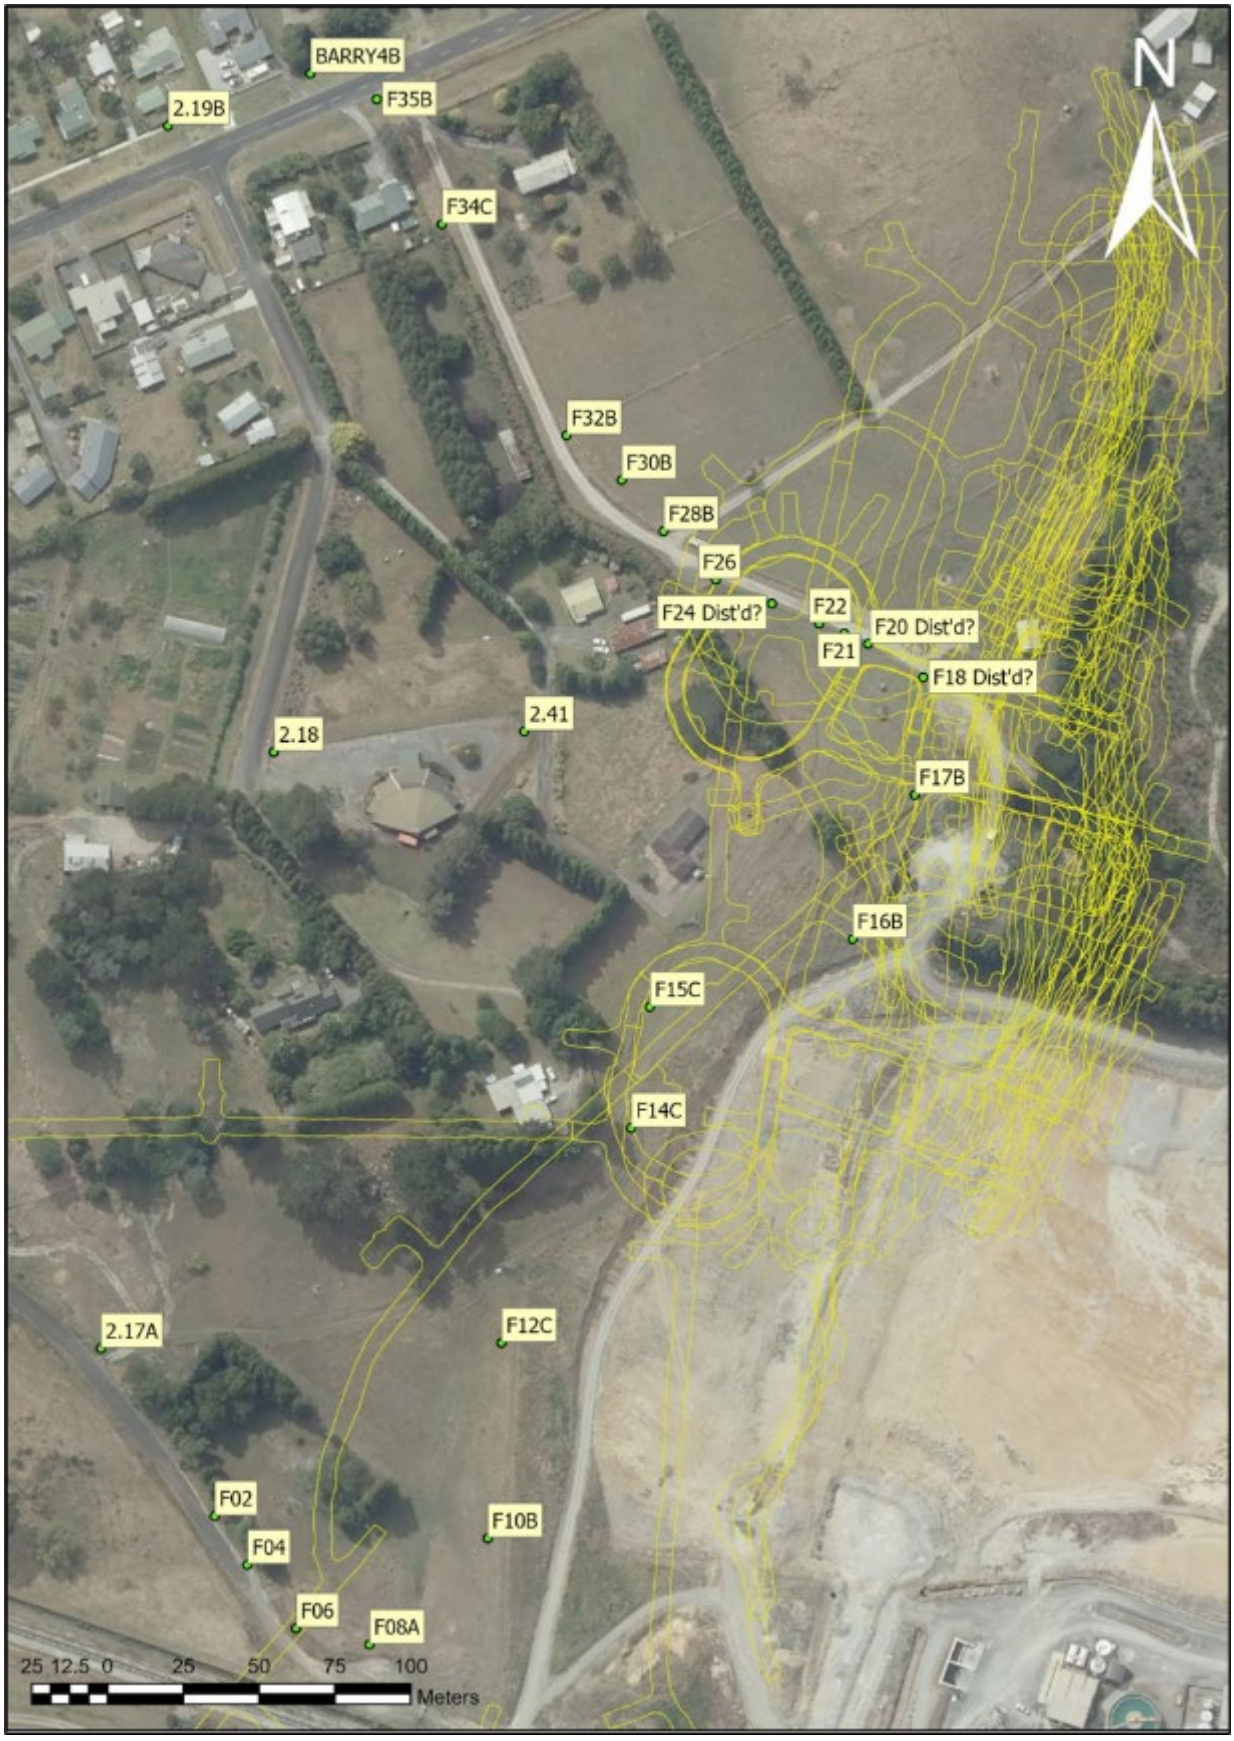
Figure 45: Favona Settlement Profile

The locations surveyed in 2022 with tilt values between adjacent marks steeper than the 1:1000 criterion are highlighted in Table 10 above. The locations of the marks in relation to the Favona mine workings are shown in Figure 45 and Figure 46 below.

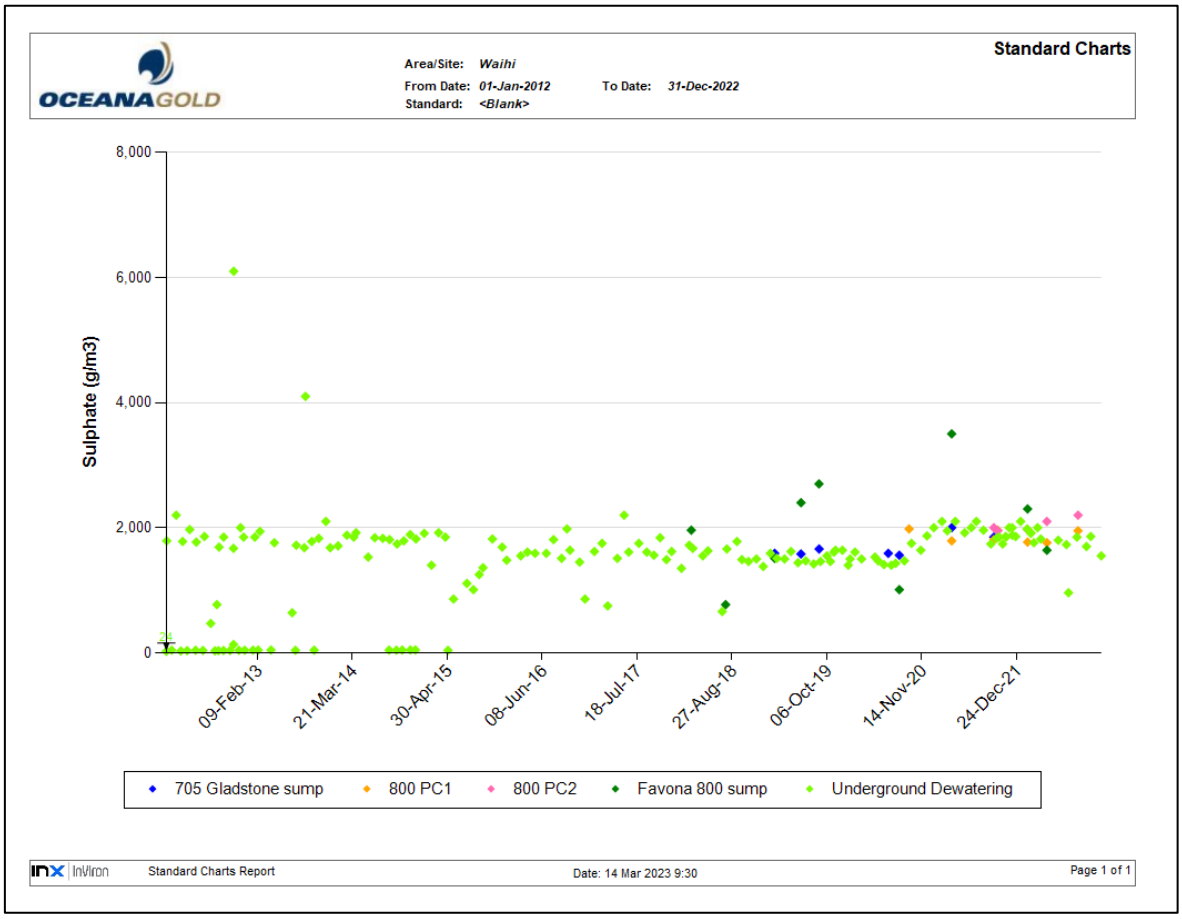
Figure 48: Underground sample sites – Summaries of Key Chemistry

During the reporting period, results from the composite underground dewatering had stable pH and EC values averaging 6.5 units and 276 mS/m respectively. Sulphate values averaged 1796 g/m^3. Iron averaged 7.9 g/m^3 and manganese 17.2 g/m^3. Other metal concentrations were low (Figure 48; Appendix E).

From the sites listed above, the single Favona sample had the highest EC and sulphate (328 mS/m and 2300 g/m^3) (Figure 48). All other samples returned similar results. The eight samples recorded averages of:

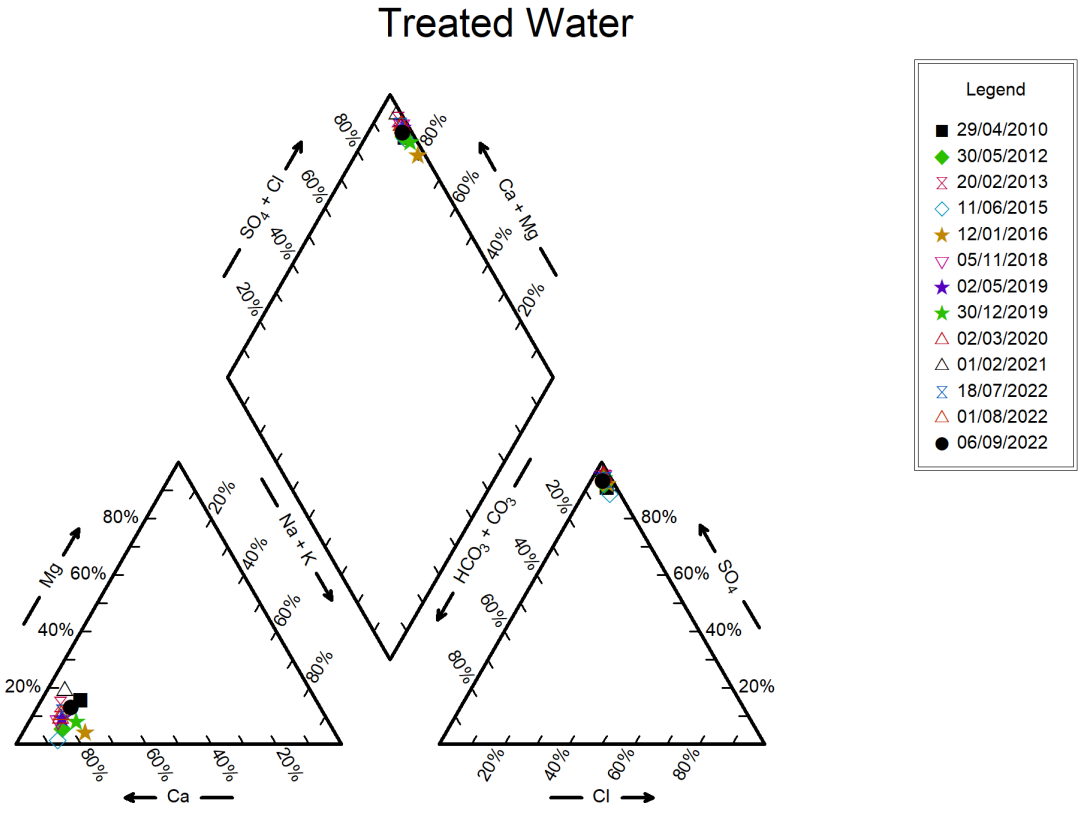
Figure 53: Treated Water Piper Trilinear Diagram

Figure 53 displays a Piper diagram for treated water. Treated water is used a service water underground, as discussed in Section 4. Treated water quality is extremely consistent as it needs to comply with strict water quality parameters prior to river discharge. In 2022 service water made up 7% of the dewatering volume total and is unlikely to have any effect on groundwater quality. Water quality results are provided in Appendix E.

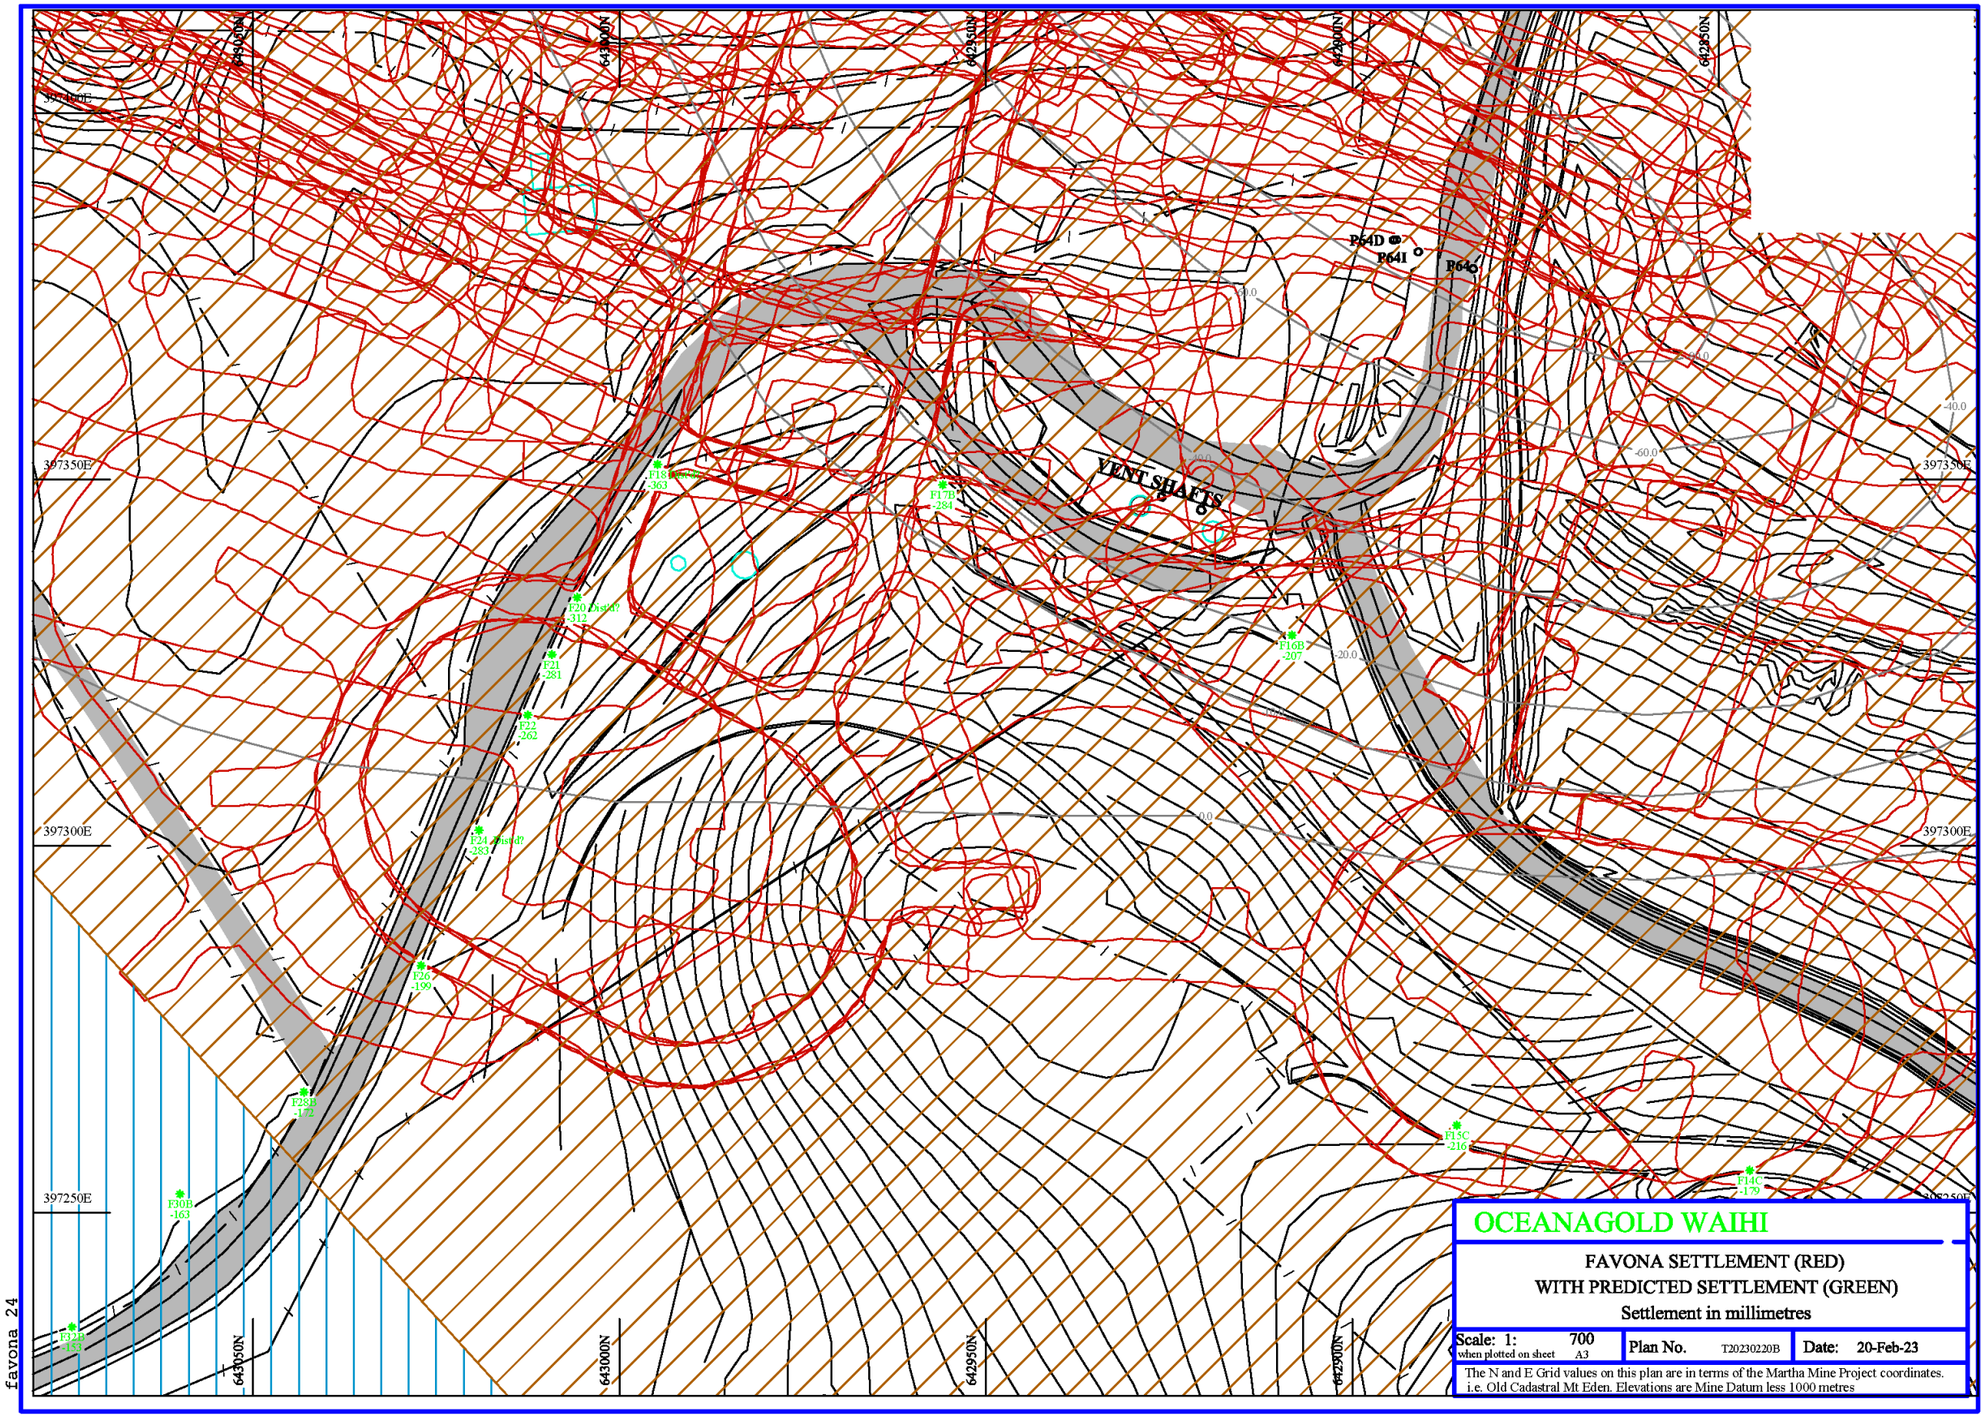
Four Favona marks exceed settlement predictions set for Project Martha, the same as in 2020.

397400E
397350E
397300E
397250E
643050N
643000N
642950N
642900N
642850N
VENT SHAFTS
P64D
P64I
P64O
F18 -363
F17B -284
F20 -312
F21 -281
F22 -262
F24 -283
F26 -199
F28B -192
F30B -163
F32B -153
F16B -207
F15C -216
F14C -179
-20.0
-40.0
-60.0
favona 24
OCEANAGOLD WAIHI
FAVONA SETTLEMENT (RED)
WITH PREDICTED SETTLEMENT (GREEN)
Settlement in millimetres
Scale: 1: 700 when plotted on sheet A3
Plan No. T20230220B
Date: 20-Feb-23
The N and E Grid values on this plan are in terms of the Martha Mine Project coordinates.
i.e. Old Cadastral Mt Eden. Elevations are Mine Datum less 1000 metres
SURPAC - GEOVIA -prepared by B.M. Morrison

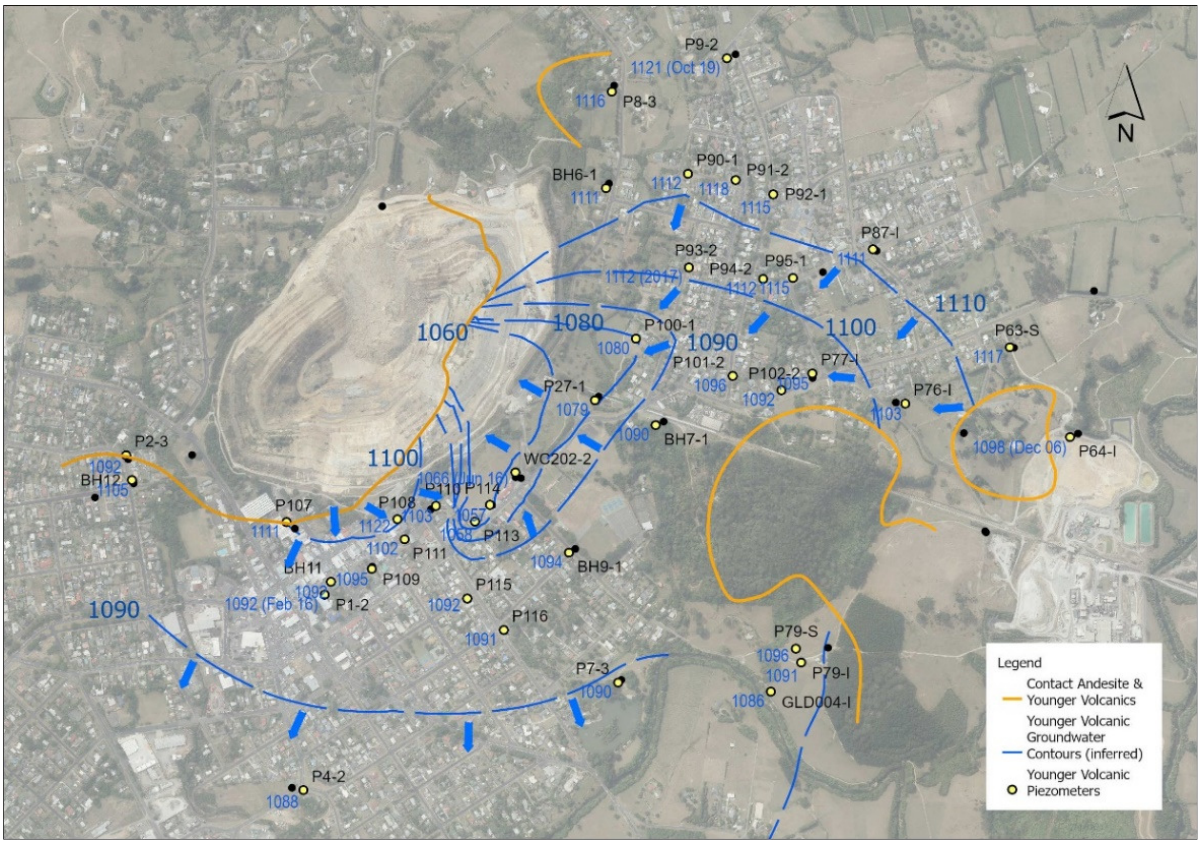
Figure 4 Young Volcanics Interpreted Piezometric Surface

Two separate groundwater systems exist as a function of the geologic units present; one in the andesite rockmass and one in the younger volcanics. In the vicinity of the Rex Orebody, both groundwater systems are interpreted to be draining back into the Martha Pit as shown in Figures 4 and 5. Experience has shown that the groundwater in the Young Volcanics is in a perched system that remains generally unaffected by the drainage in the underlying andesite rocks. This is due to the presence of low permeability layers that separate the systems.

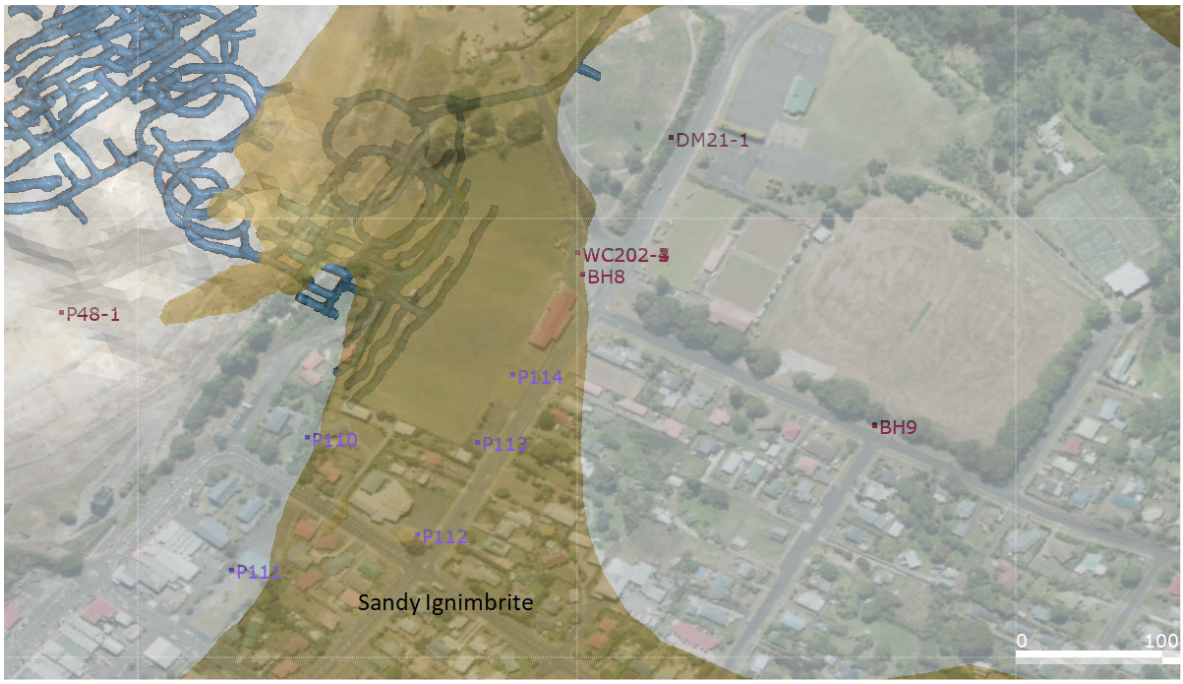
Figure 7 **Distribution of the Sandy Ignimbrite within the Paleo valley**

A site visit to the mine underground operations to view the Rex Orebody exposure from beneath was undertaken on 20/2/2023. The purpose of the site visit was to observe groundwater inflows at various locations. In summary, there is no groundwater ingress through the stope in the north-east part of the orebody in the vicinity of WC202. Between P112, P113 and P114, there is groundwater seepage through the Rex Vein and the inflow rate has remained constant during mining. These inflows are interpreted to be seepage from water contained within the basal sandy ignimbrite unit through the Rex vein “exposure”. This is illustrated in Figures 7 and 8 below.
