# Dewatering and Settlement Monitoring Report

Document Reference: WAI-200-REP-007-004

## DEWATERING & SETTLEMENT MONITORING REPORT 2020

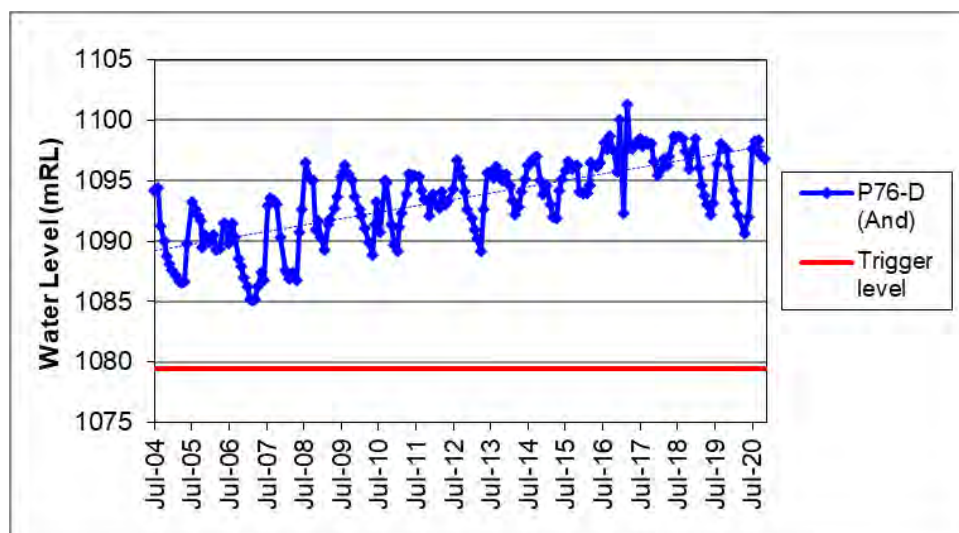
Figure 19: Trigger Level P76-D

Wells P76-D, P77-D, P78-D and P87-D all show a rising trend in water levels; as such, Tier 1 action is not forecast.

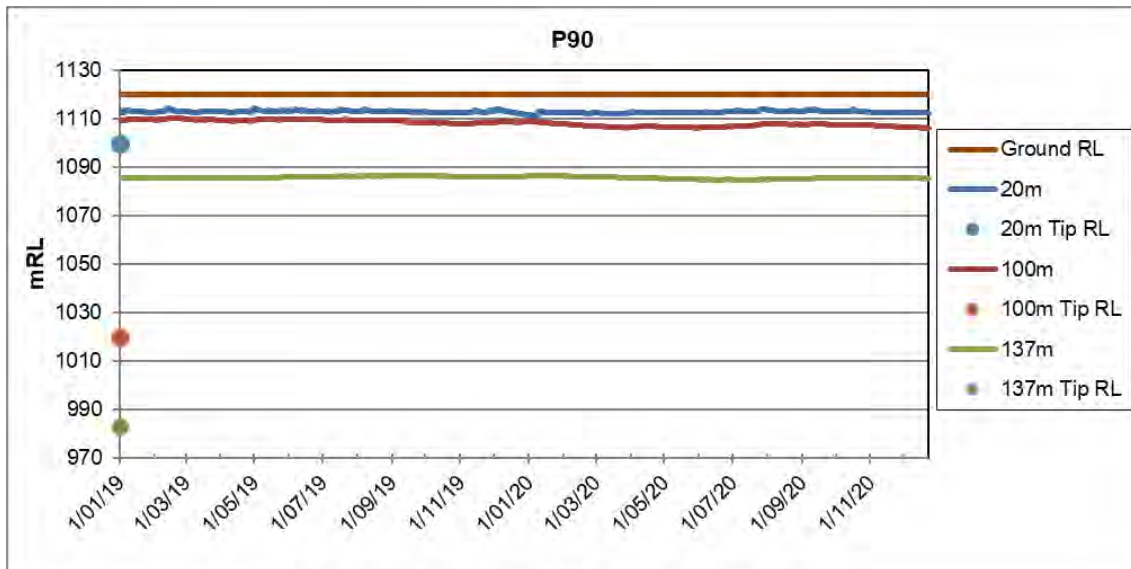
Figure 24: P90 Vibrating Wire Piezometer

Water levels were disrupted during 2012 to 2013 in P90, P91 and P92 by leakage down an incompletely sealed drill hole annulus. Pressures returned to normal after comprehensive effort to seal the leakage pathway.
