# Dewatering and Settlement Report 2024

Document Reference: WAI-200-REP-007

# DEWATERING & SETTLEMENT MONITORING REPORT 2024

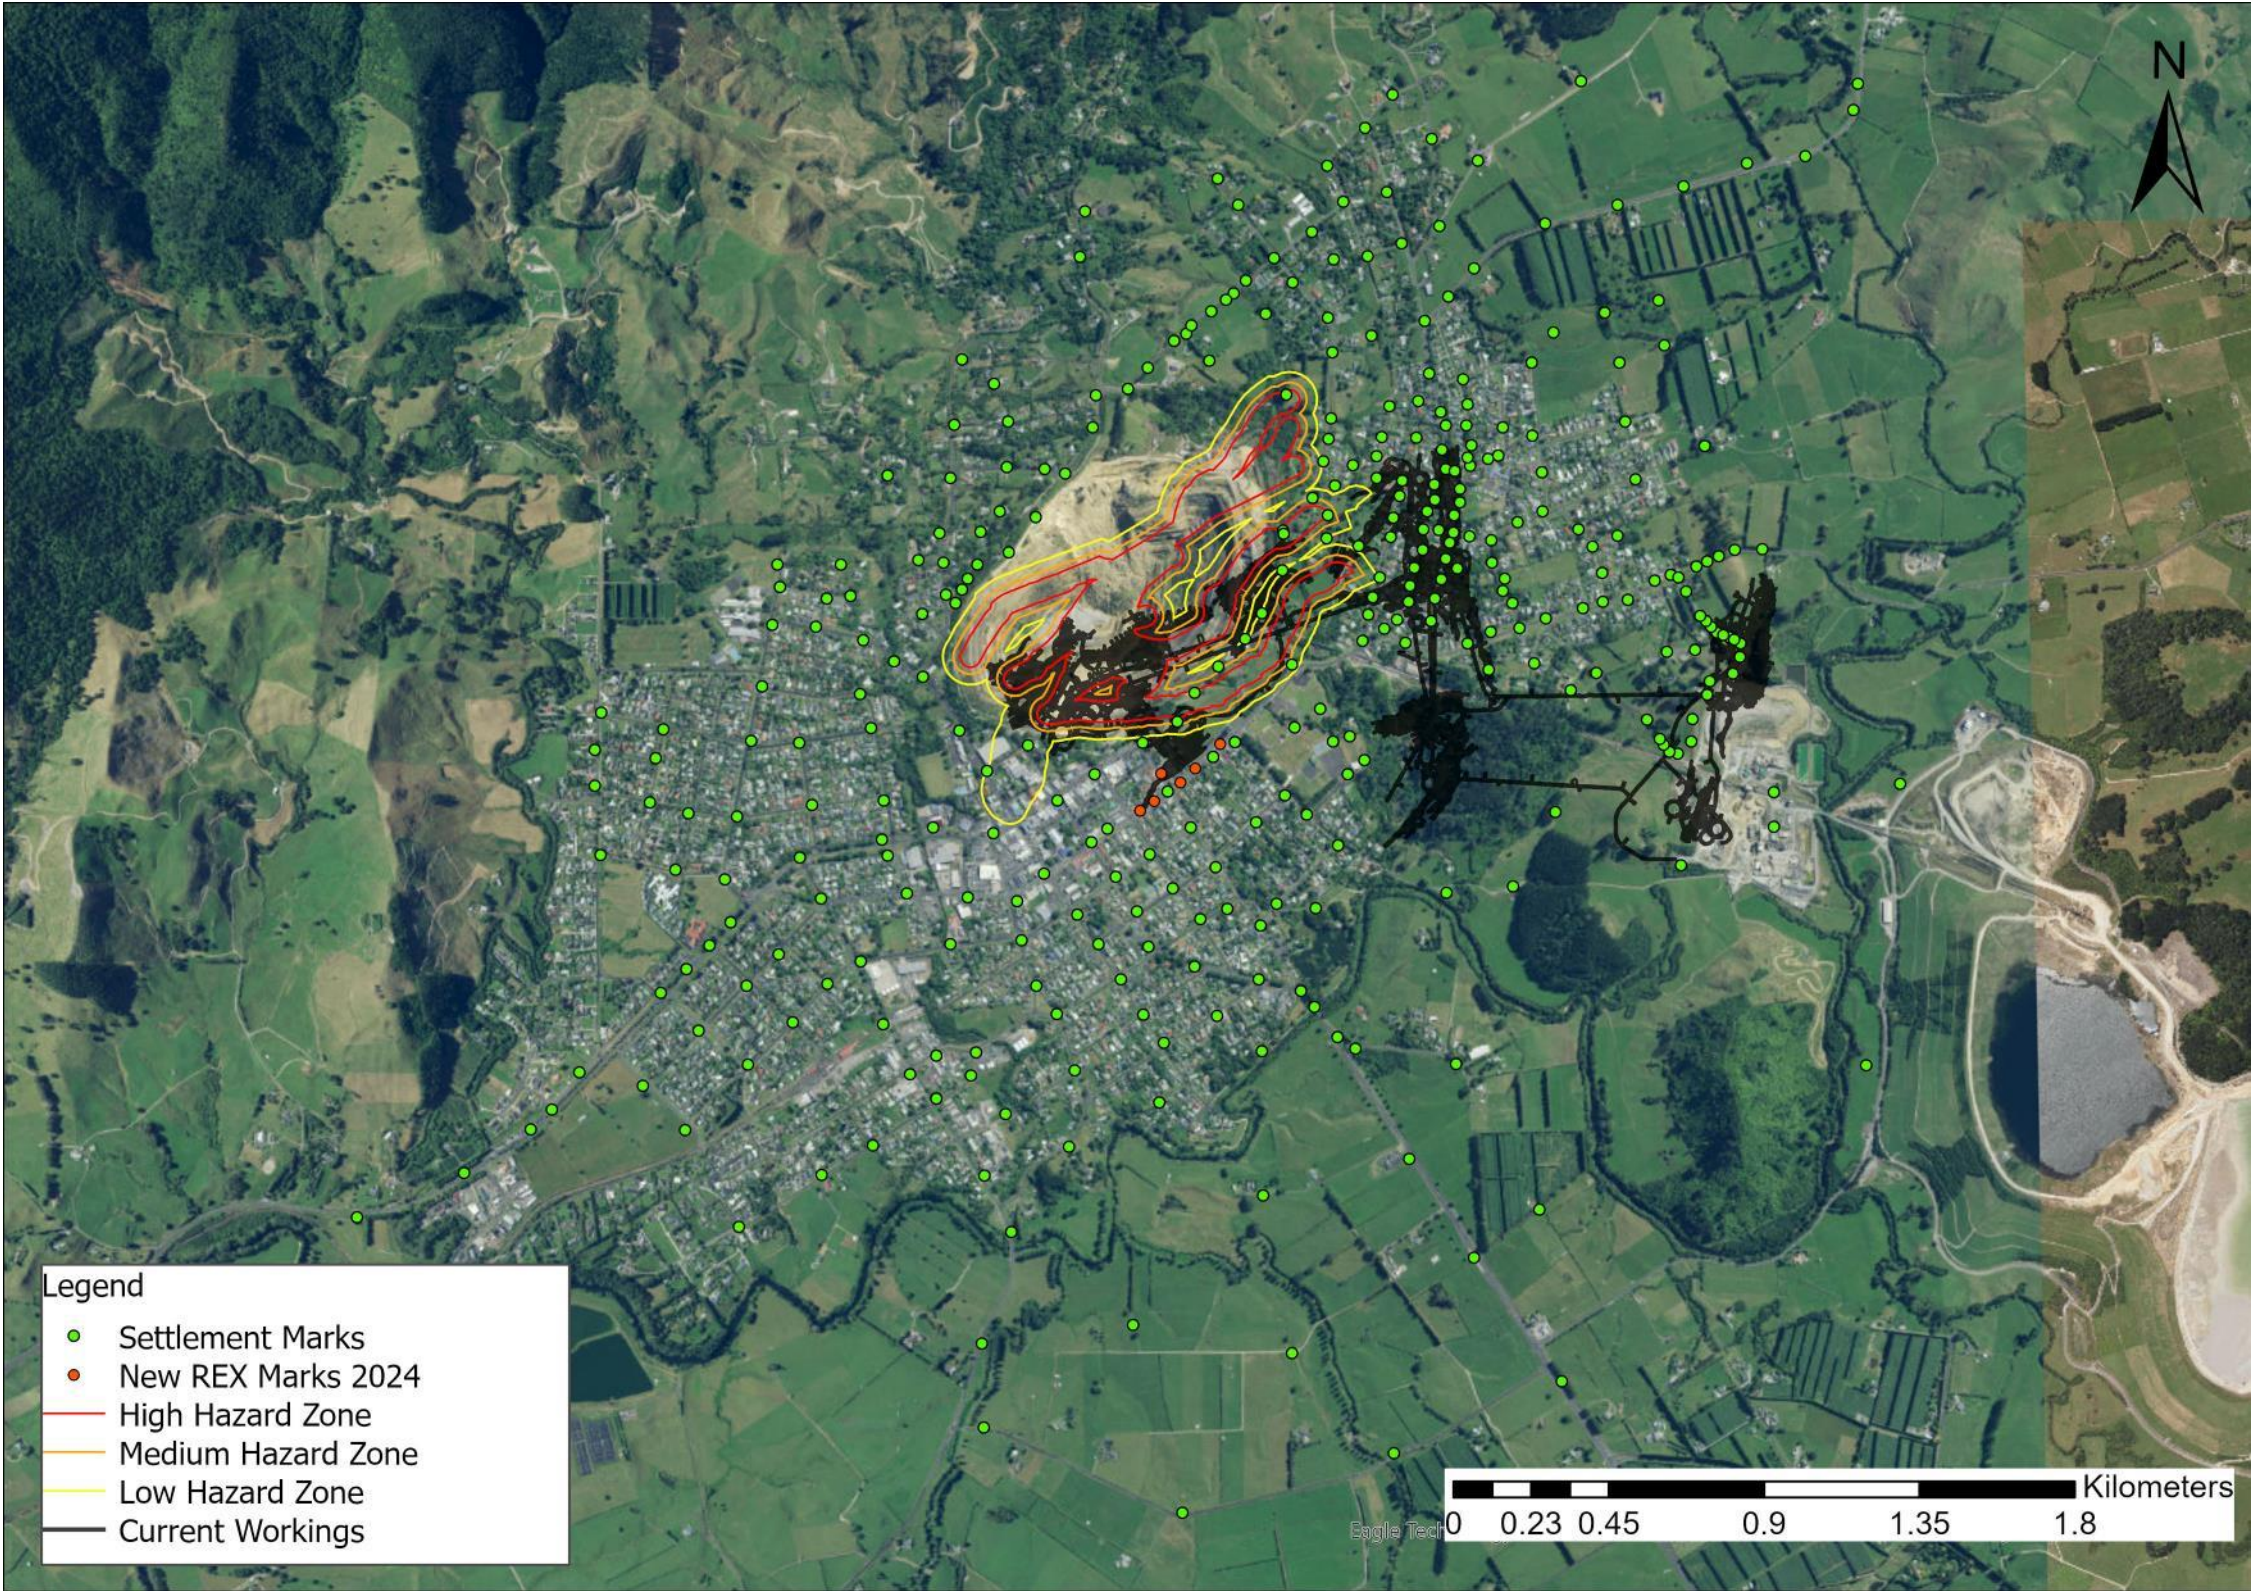
Figure 40. Settlement marker location plan, hazard zones, and recent underground activity.

Figure 40 shows the location of settlement marks monitored by OGNZL up to the end of 2024. Also, included on Figure 40 are the defined subsidence hazard zones related to historical underground mine stopes and shafts (IGNS, 2002). Figure 41 provides the settlement monitoring marks across the Favona Mine and shows the locations of the Favona Mine workings in relation to the marks. Figure 42 provides the marks identified as triggered during the November 2024 survey.

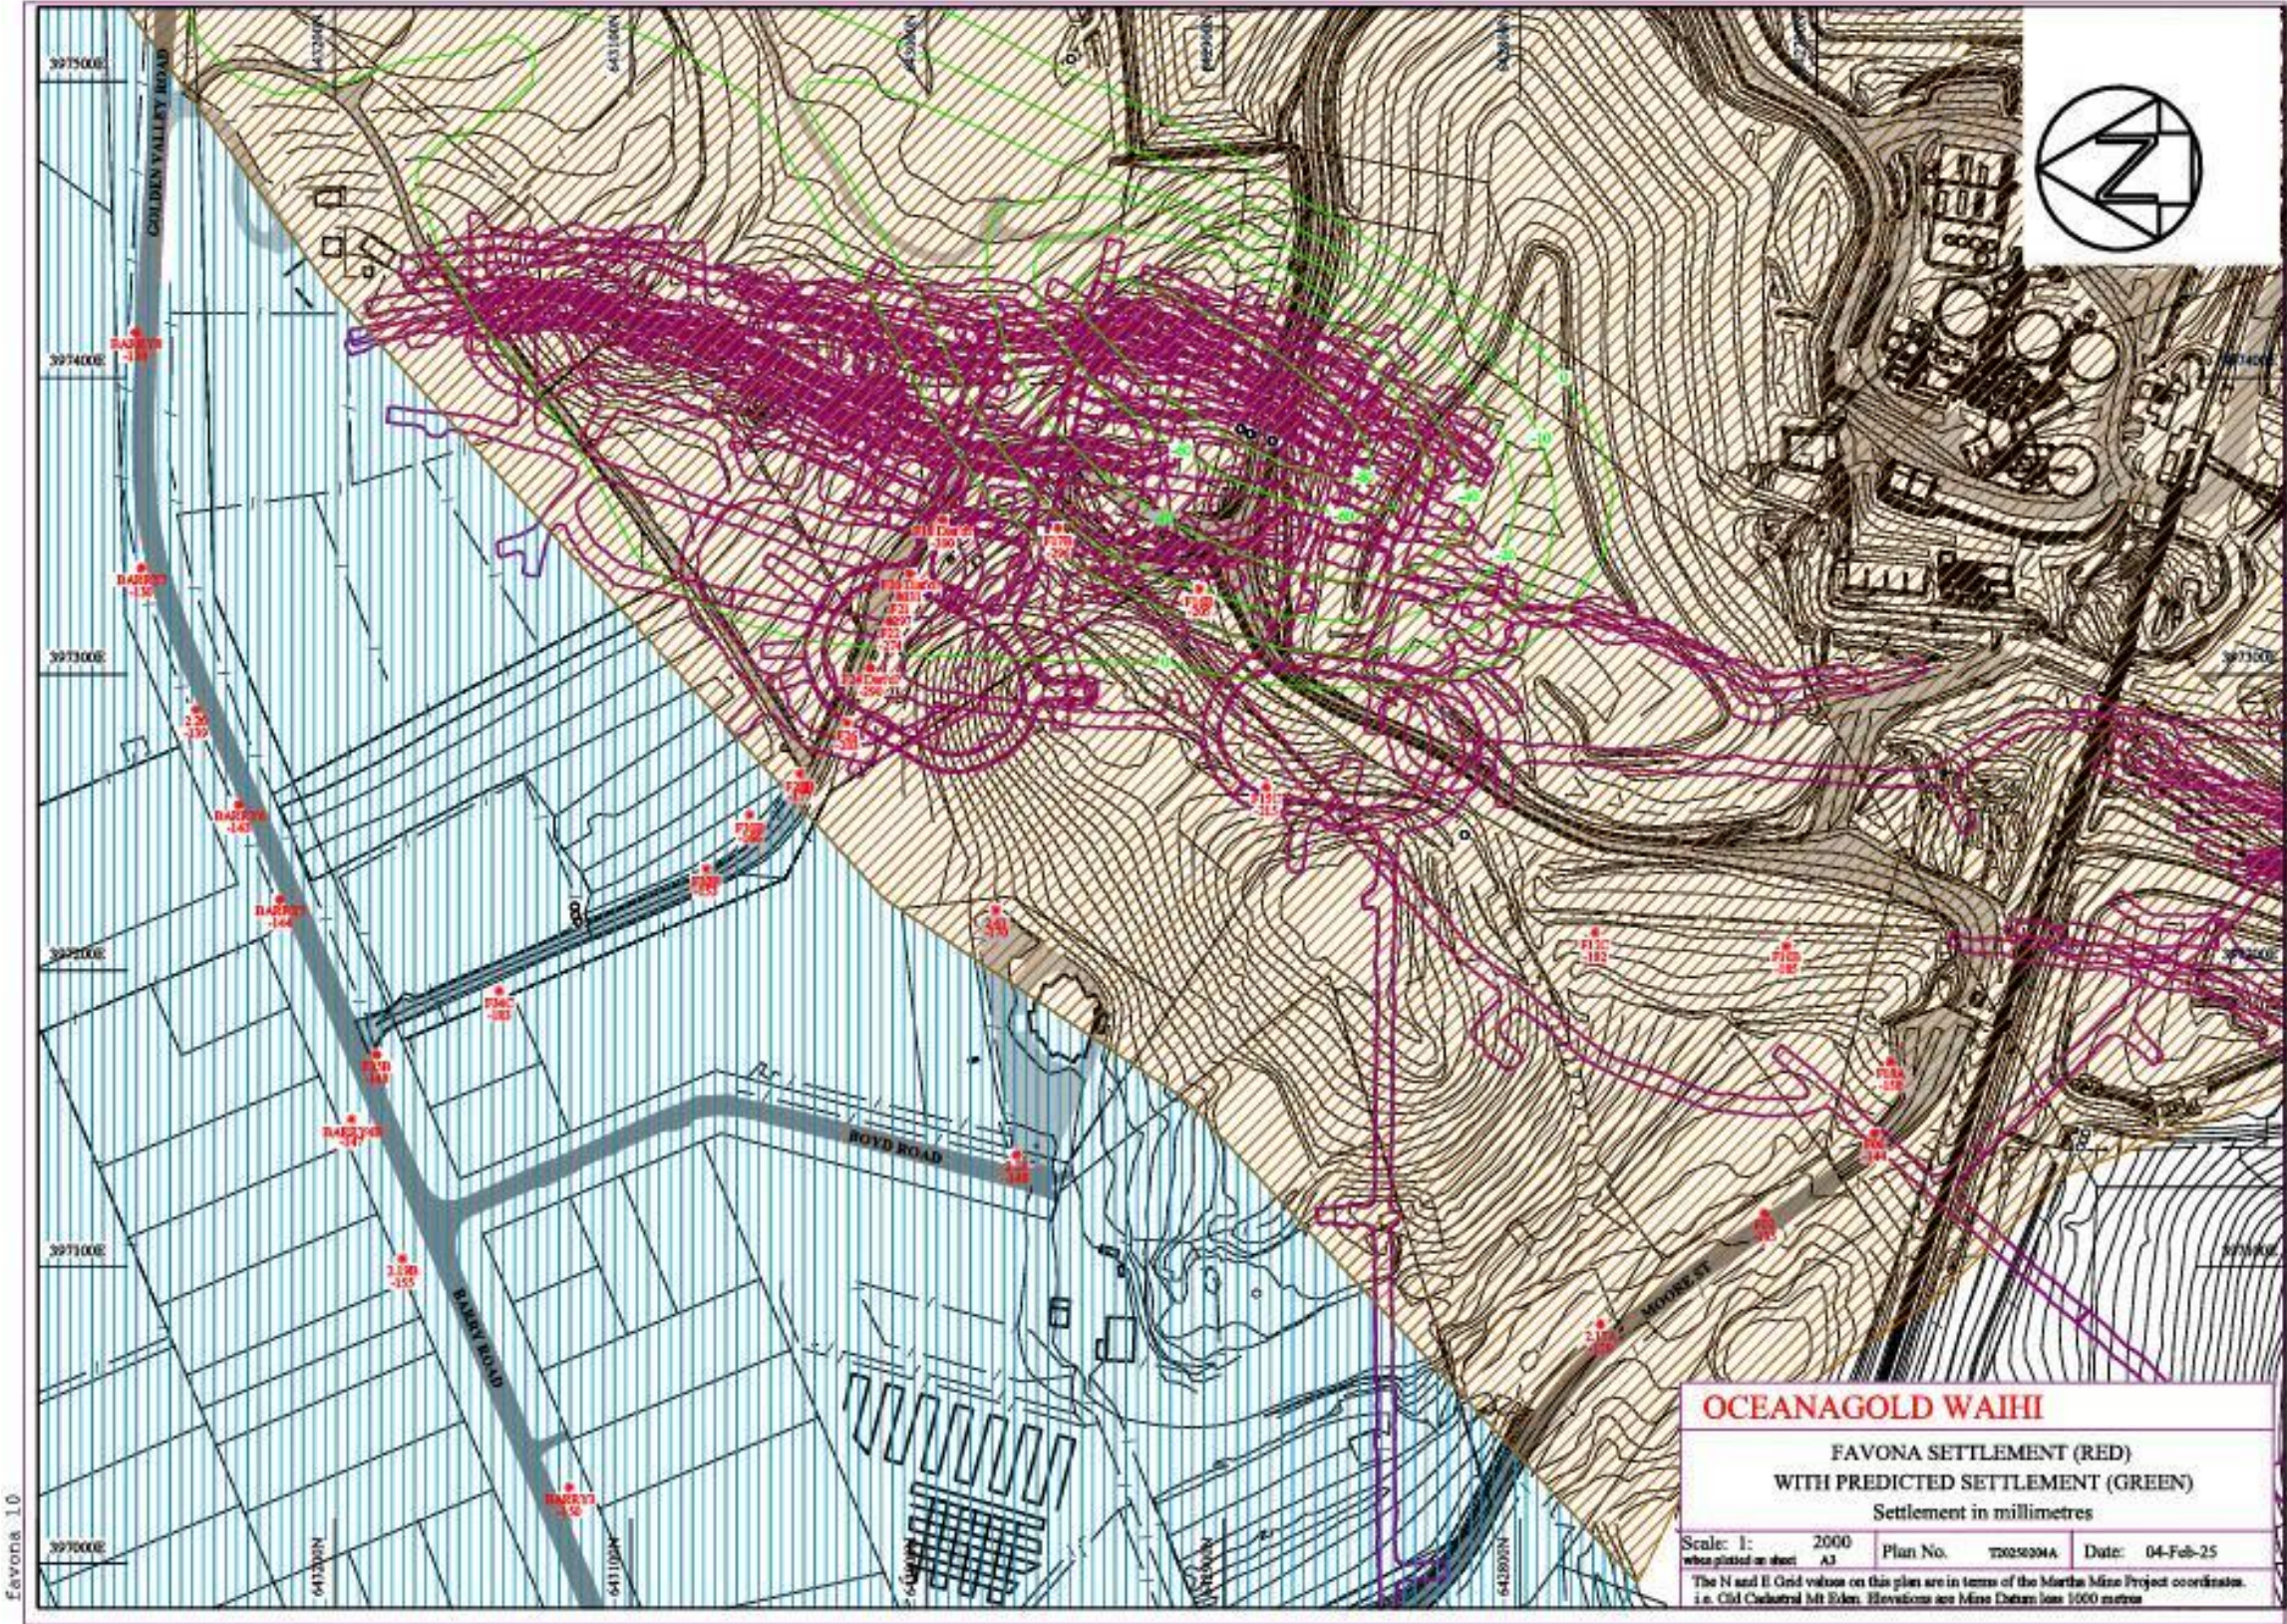
Figure 41. Favona settlement – November 2024.

Settlement predictions for Project Martha have been updated for the zone encompassing Favona marks to reflect the effects outlined above. Five Favona marks exceeded the maximum predicted settlement in the November 2024 survey: F17B, F18, F20, F21 and F22. All are located on company owned land above active underground workings. Marks F18 and F20 are noted by the surveyor as being disturbed (Figure 41, Appendix B).

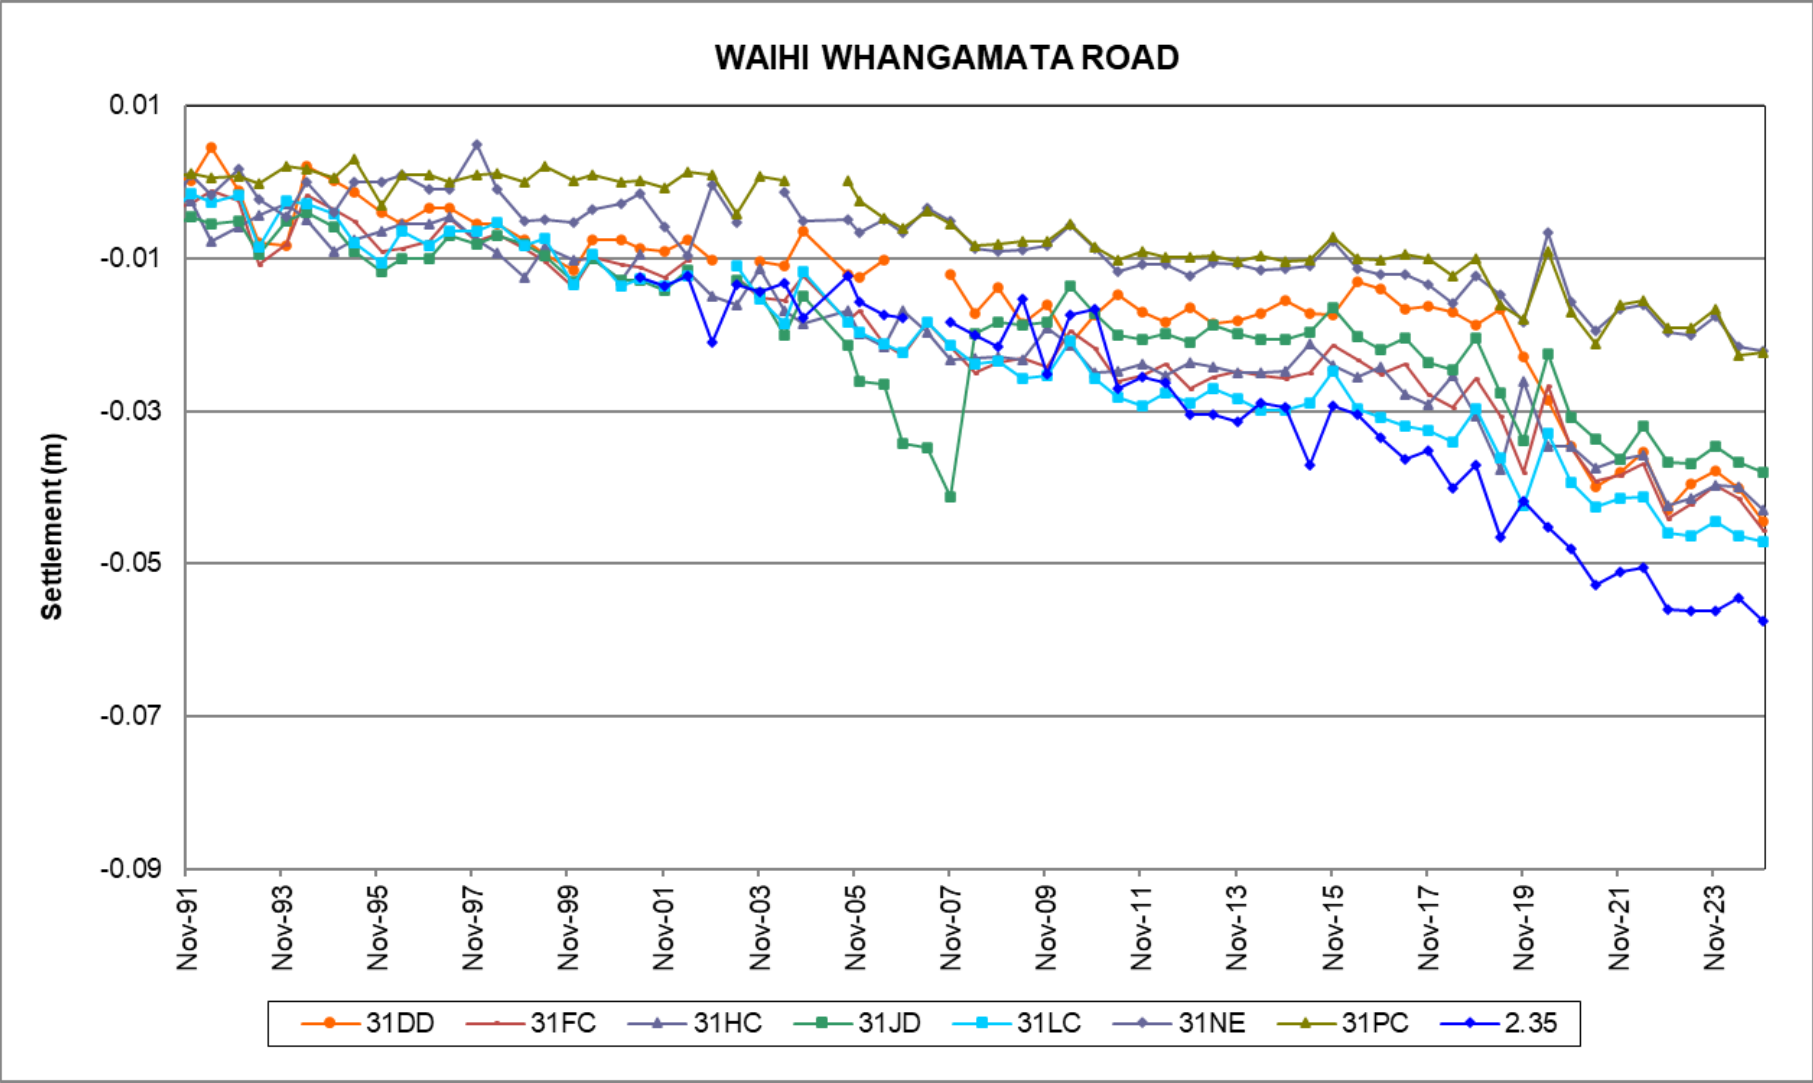
Figure 43. Zone 1 Waihi to Whangamata Road.

- Zone 1 along Waihi-Whangamata Road has had a small steady ongoing settlement since 1999 which has reached between 22 and 58mm during this reporting period (Figure 45)
- Zone 1 south of Waihi has had a small steady ongoing settlement since 1999 which has reached between 17 and 82mm during this reporting period Figure 44)
- Zone 1 west of Waihi has had a very small amount of settlement (less than 12 mm) up to 2015 following which the settlement rate increased to a small steady ongoing settlement which has reached approximately 20mm during this reporting period (Figure 45)
- Zone 1 north of Waihi which has had no measurable settlement (Figure 46)

This grouping shows that the marks in Zone 1 with a slow ongoing settlement trend are located along the Waihi to Whangamata Road to the east of Waihi, and to the south of Waihi. A steady increase in settlement rate from about 1999 is also be observed in most marks in Zones 2 to 6, suggesting that there is a small and widespread effect occurring at depth. The one marked monitored in Zone 1 to the west of Waihi show little settlement until 2015 and then a small steady on-going settlement showing the widespread effects at depth have reached these markers.

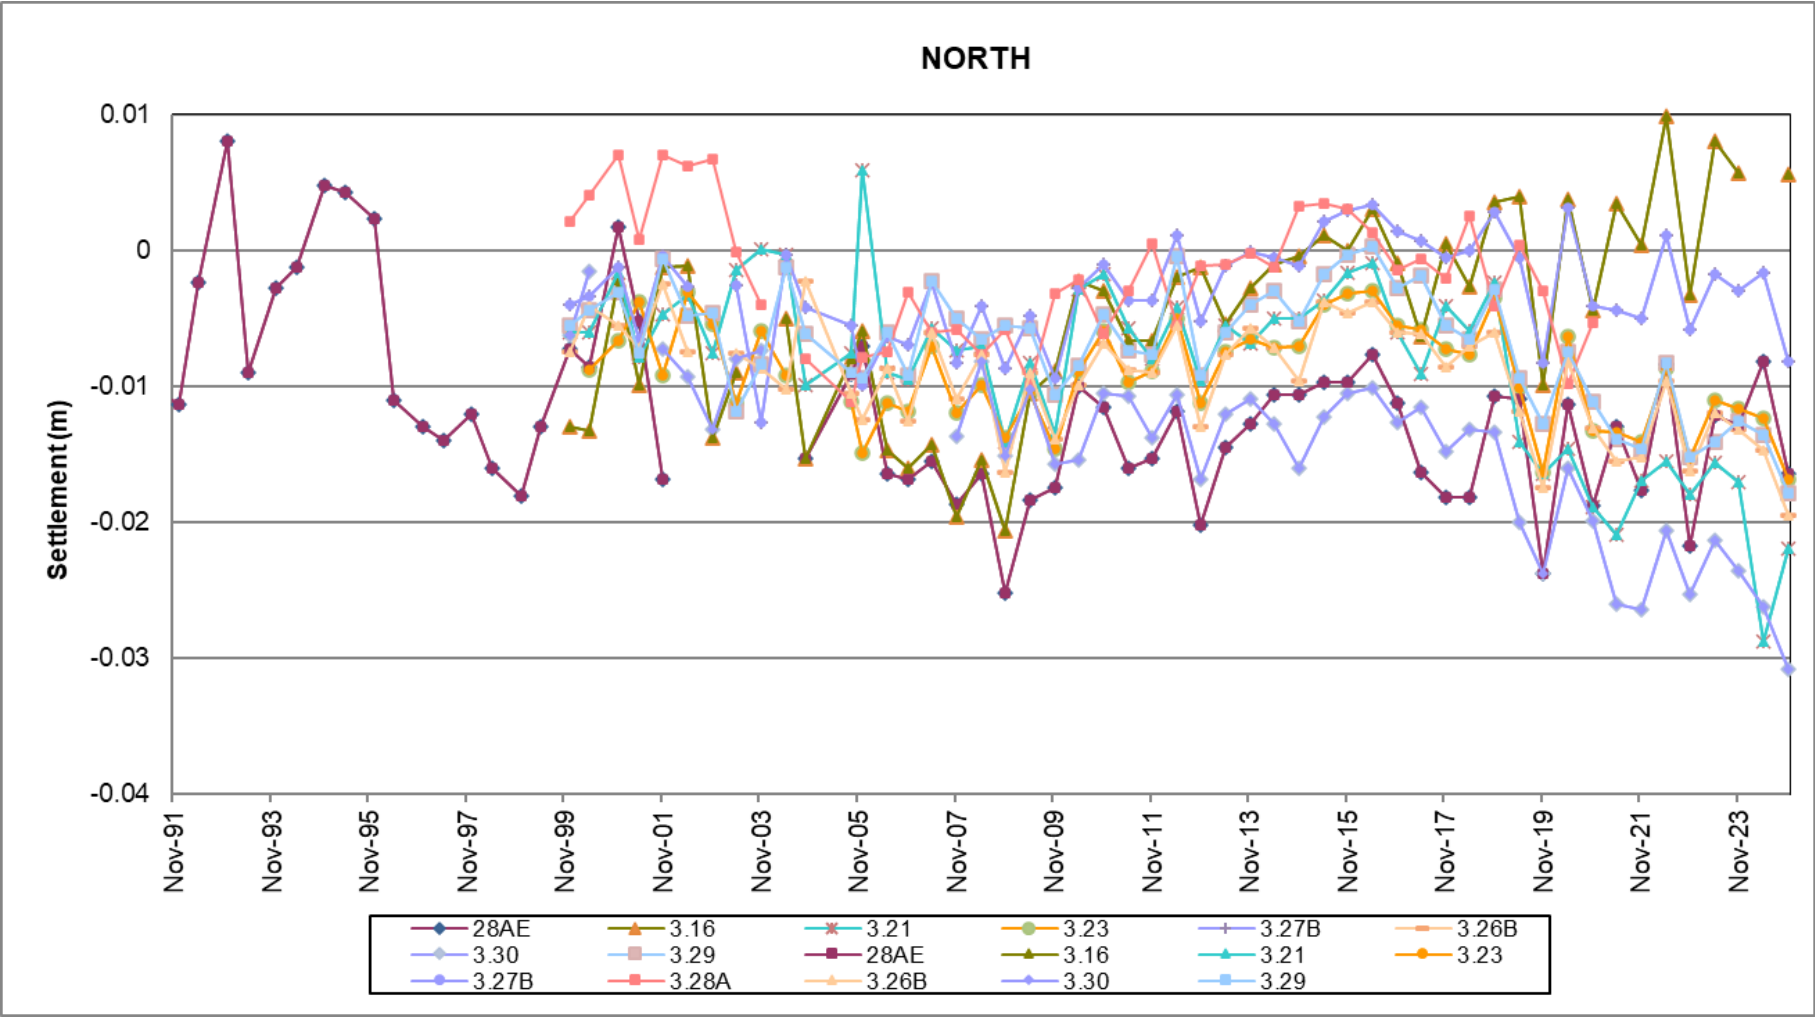
Figure 46. Zone 1 North of Waihi.

One mark, 23C, showed a sharp increase in settlement during the May 2020 survey. This mark is located near a drain and may have been influenced by drainage works nearby during the 2019/2020 period. No visual evidence of settlement effects on surrounding land have been identified to date and nearby piezometers have not shown any unusual changes. The settlement in all subsequent surveys continued at a steady rate with the other surrounding settlement monitoring marks. Due to the settlement at this location continuing at a rate in line with expected settlement, the large drop in settlement from the May 2020 survey has had a correction applied. As a result, this mark no longer exceeds the settlement trigger. Graphs showing the settlement rate for this mark are shown below prior to corrections being added (Figure 46) and after corrections were applied (Figure 47).

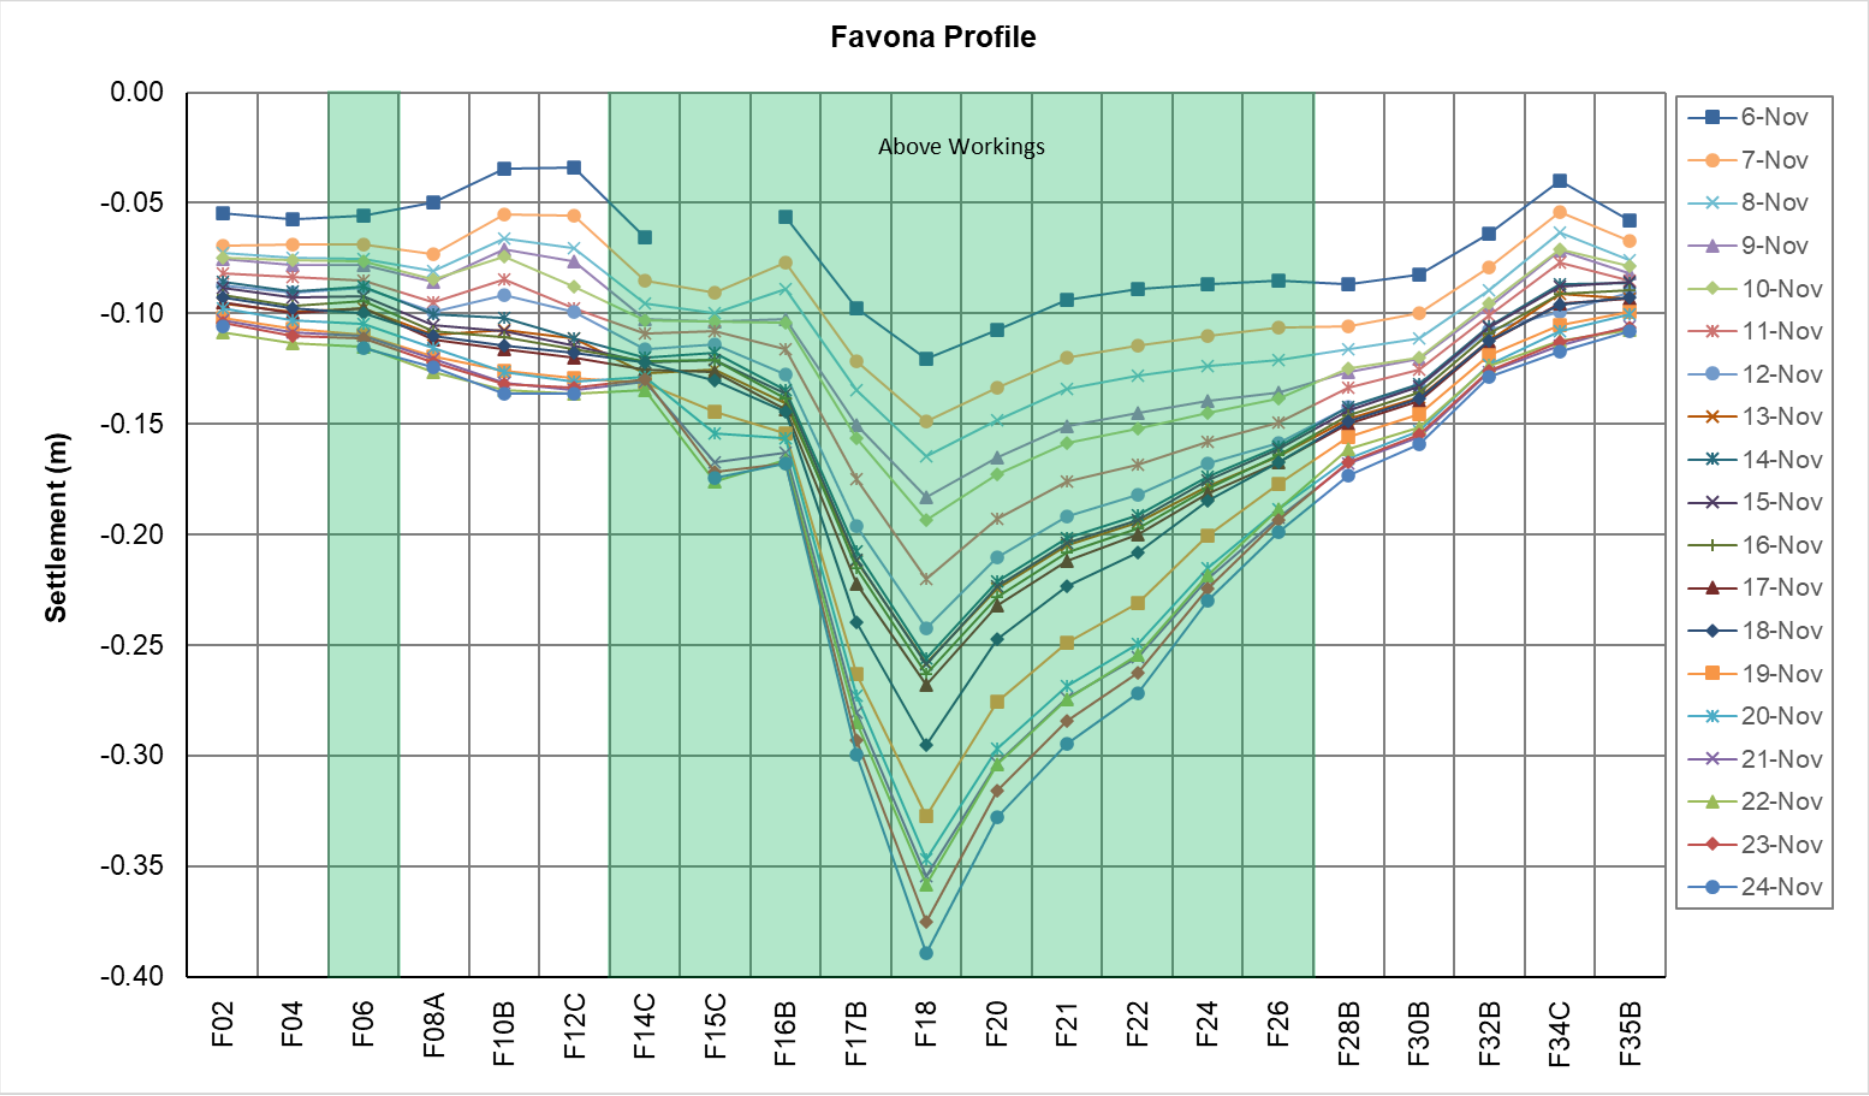
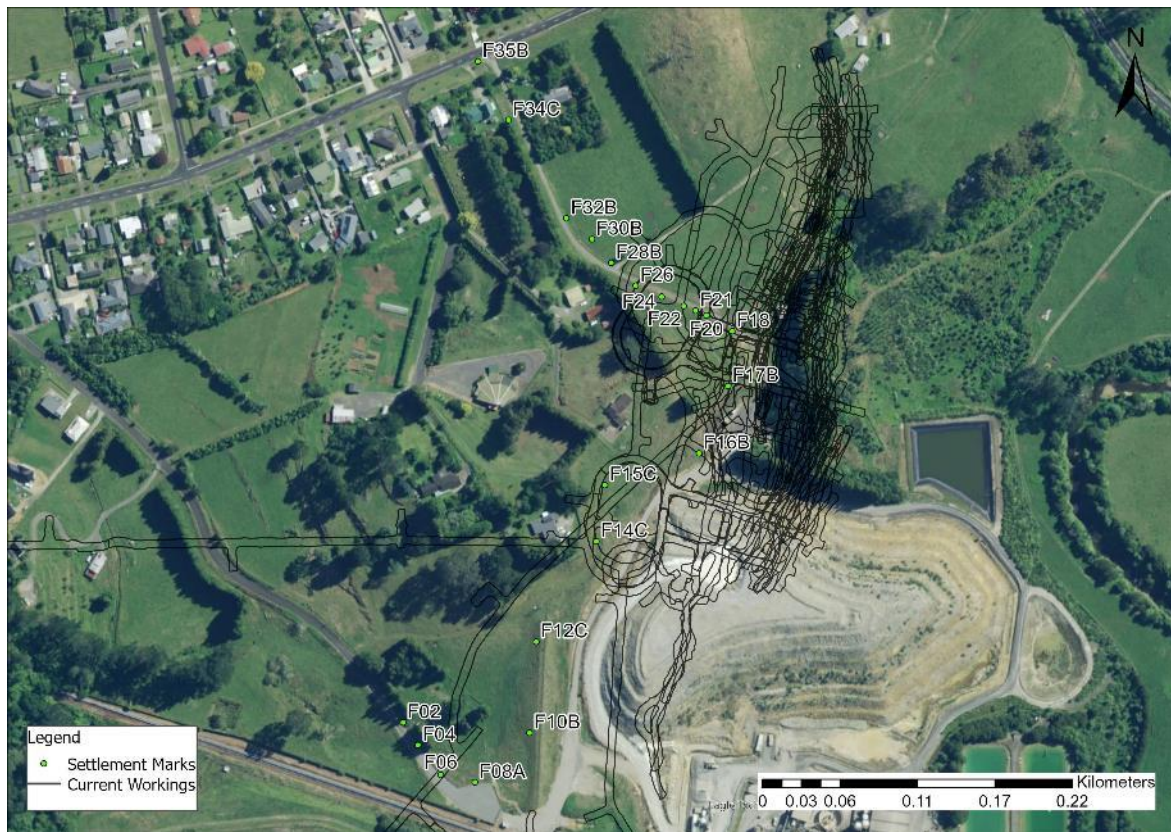
The locations surveyed in 2024 with tilt values between adjacent marks steeper than the 1:1000 criterion are highlighted in

Table 9 above. The locations of the marks in relation to the Favona mine workings are shown in Figure 49 and Figure 50 below.

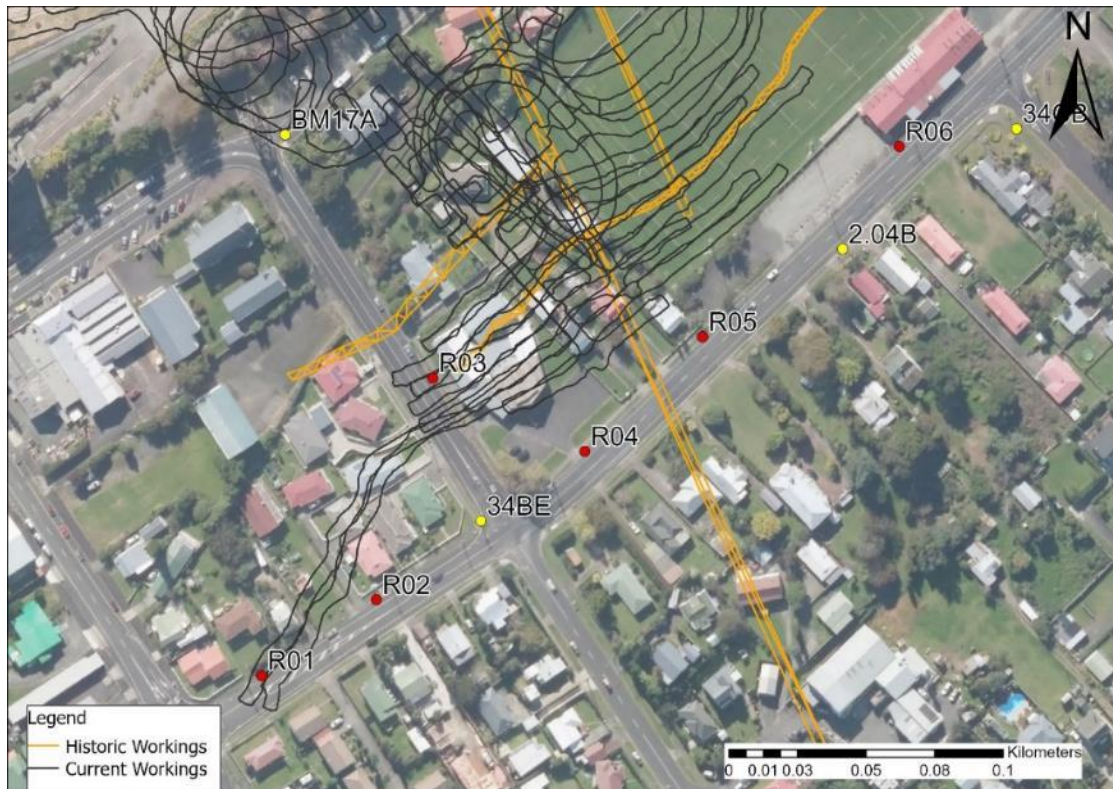
Figure 52. Rex settlement marks (in red) and workings.

No tilt greater than 1:1000 has been identified within this area.

These marks will be added to the historic data in future reports as well as incorporated into the Martha tilt tables going forward. For now, these marks are reported as a separate network and are shown in red in Figure 52.
