Pit Slope Management Plan WAI-350-PLN-001

Department:	Site Services
Site:	Open Pit

OCEANAGOLD WAIHI PIT SLOPE MANAGEMENT PLAN - MARTHA MAY 2019

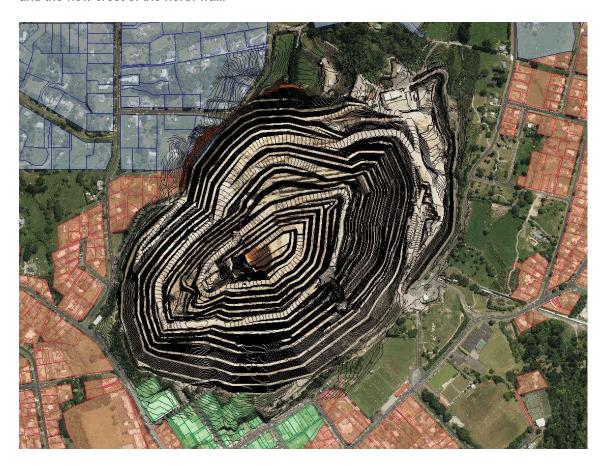
Figure 2 – Plan of Martha Phase 4 Pit within the Project Area

The MP4 cut back will be mined in a single top down sequence. The pit is shown in Figure 2. A realignment of Cambridge and Bulltown Roads will be required prior to excavating the outer limits of Phase 4 north wall. A noise bund and noise fence will also be constructed between the realigned roads and the new crest of the north wall.
