3.0 VOID MIGRATION CALCULATIONS FOR NORTH BRANCH, MARY, NO. 2 AND MARTHA STOPES

Waihi Gold Mine

5.0 GROUND DEFORMATION AT WAIHI

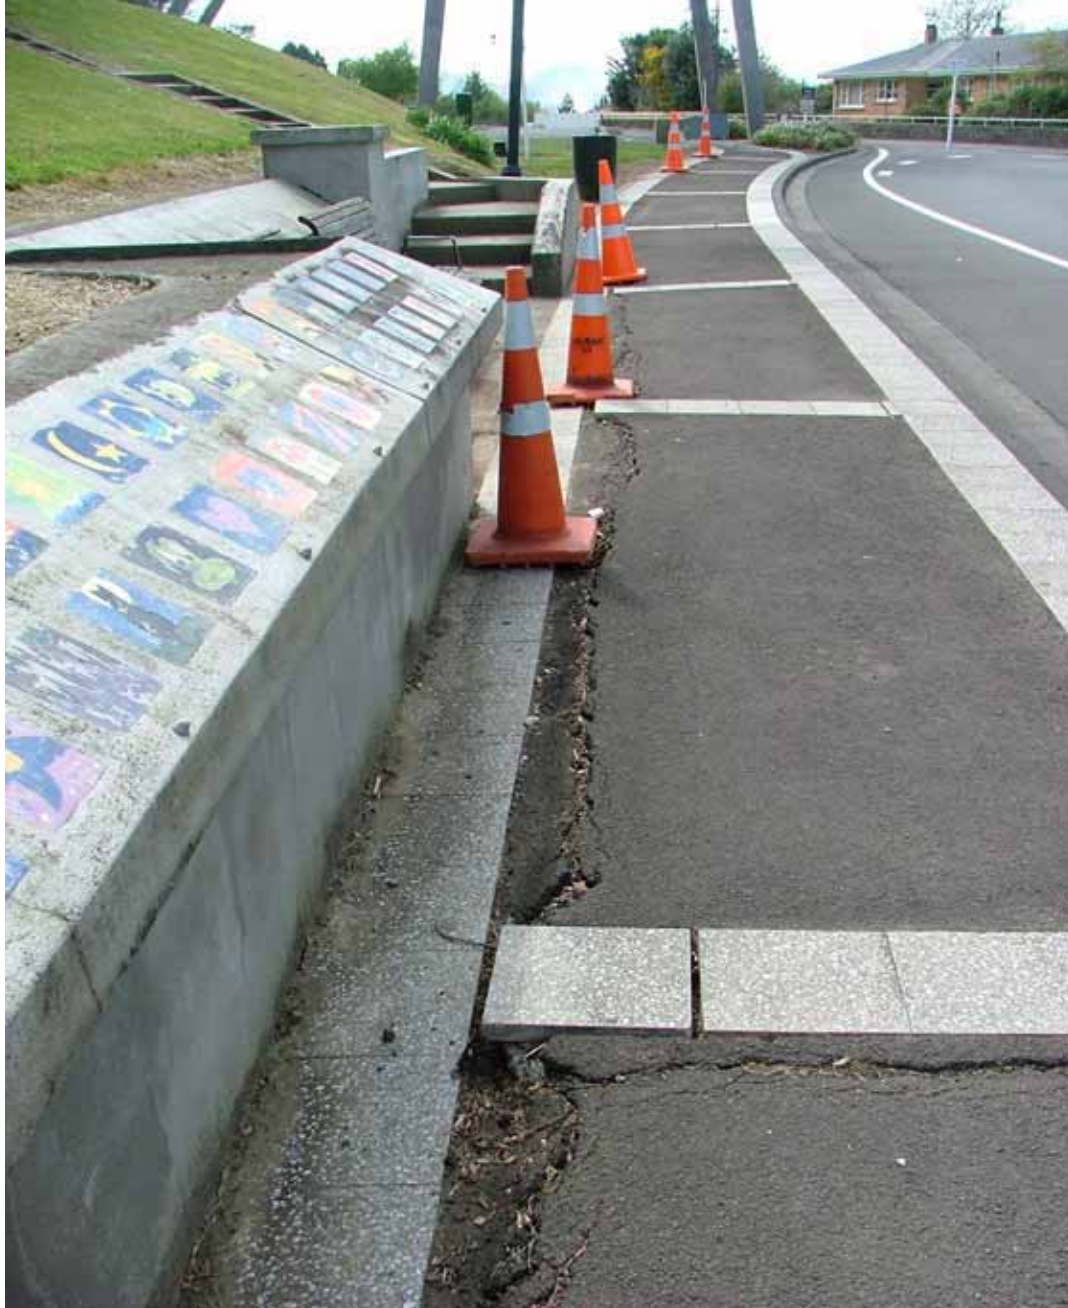
Photo 5. Ground cracking due to lateral northward movement and subsidence, evident along the base of the Millennium Wall in Seddon Street, Sept 2008.

In Seddon Street the possibility that the observed cracking is influenced by stope collapse cannot be ruled out. The ground deformations at the NE end of Seddon Street and the Millennium Wall (Photos 4 & 5) appear to be north side down extensional features (Photo 4), possibly related to the 1961 and 1999 collapse craters, the Royal stopes, and/or to the open pit wall movements.

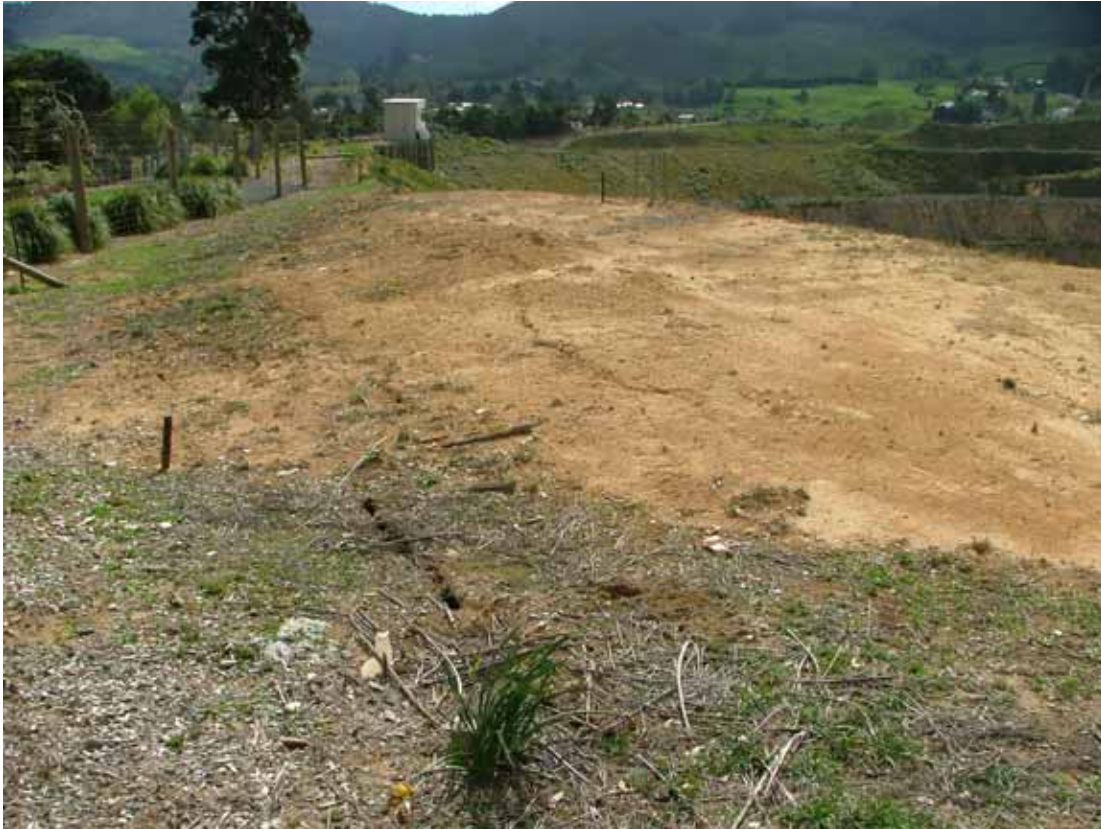
Photo 6 View of surface cracking near the open pit rim which is being monitored with wire extensometers. View looking west.

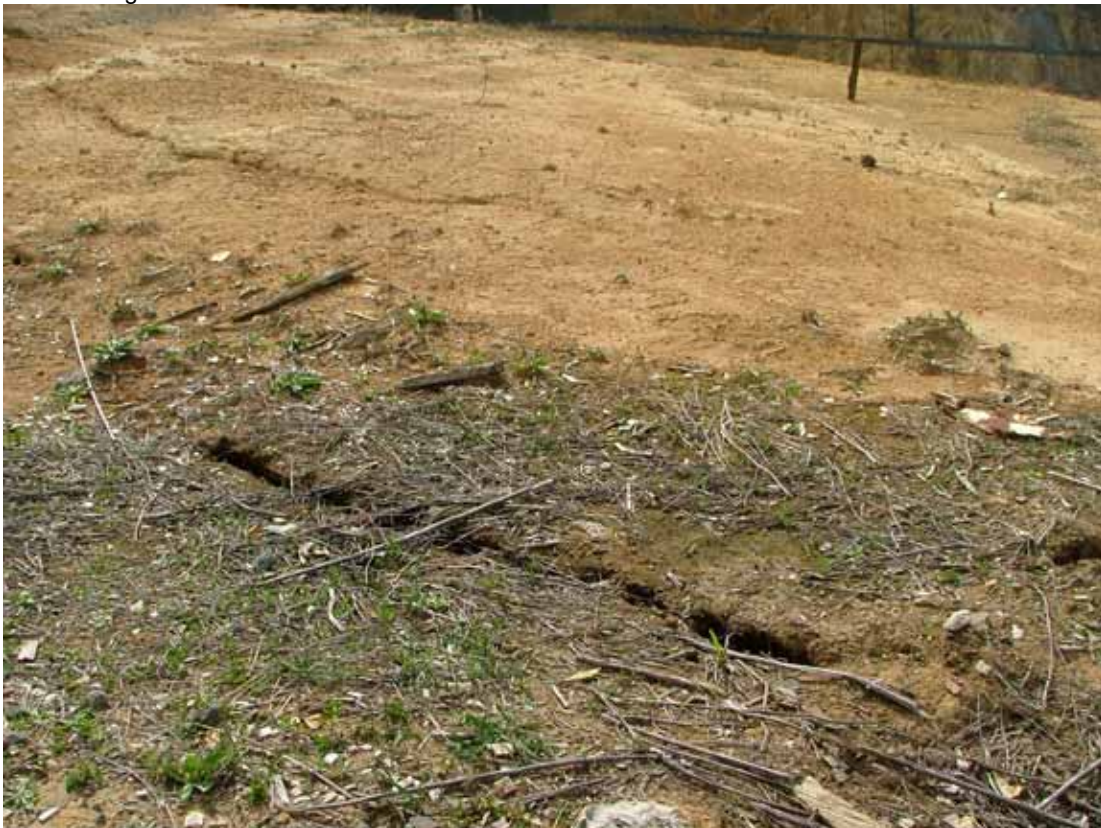
Photo 6 & 7 Open ground cracking with north (pit) side up, close to the pit rim and east of the Judges Kauri.
