Annual Combined Stability Report

2022

Document ID: WAI-200-REP-010-003

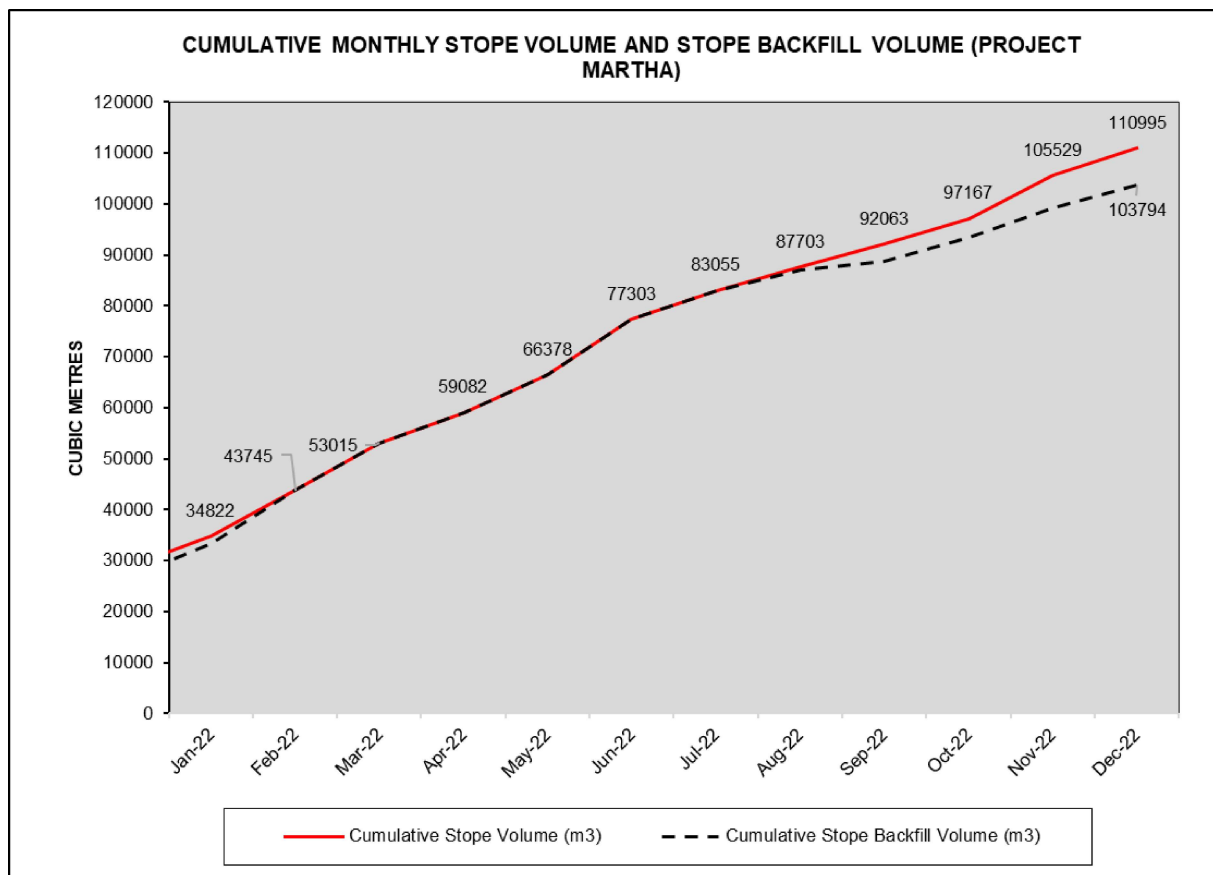
Figure 2: Martha Underground cumulative monthly stope voids and backfill volumes 2022

The cumulative stope volume extracted up until the end of the period was 110,995 m³, with 103,7944 m³ of backfill placed (Figure 2). Stope heights are typically 18 m (floor to floor).

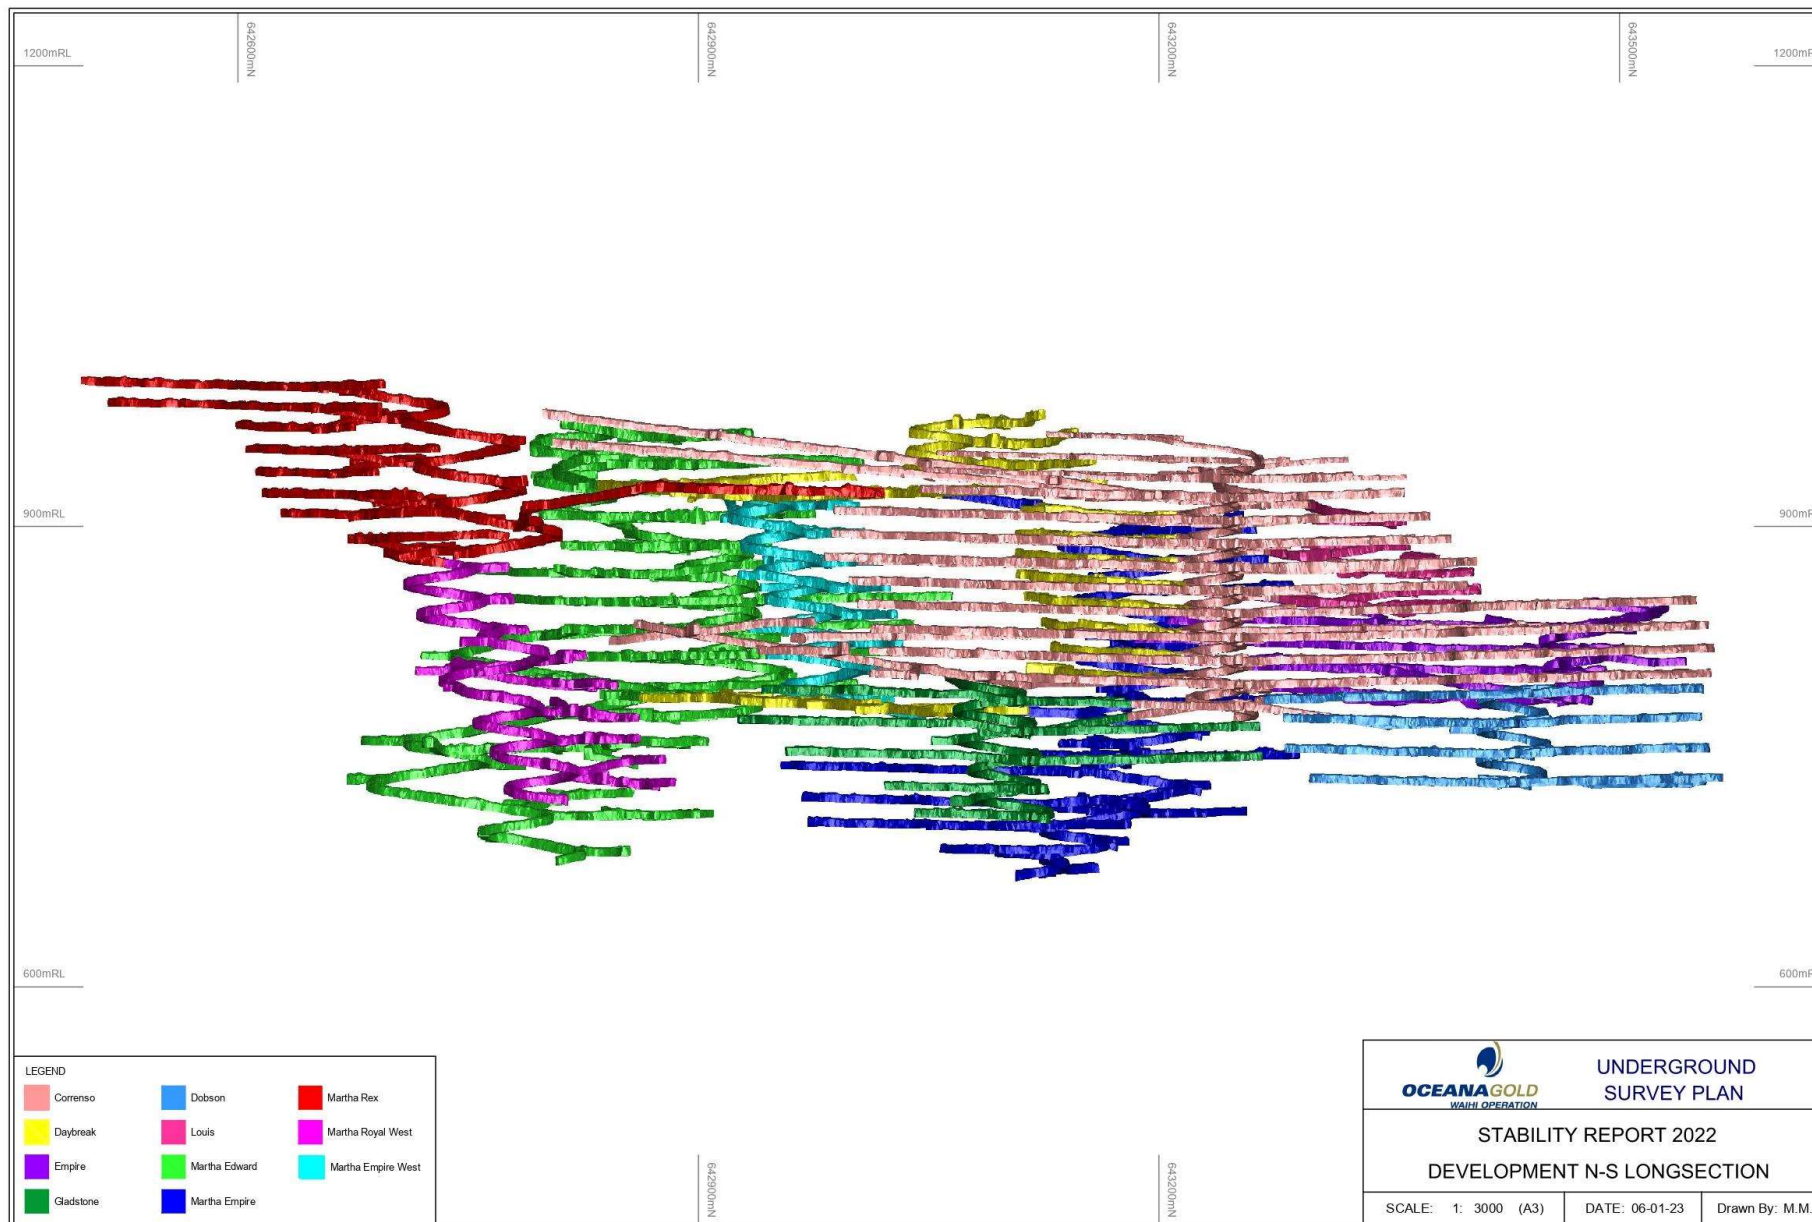
Figure 6: Development – Long Section View (left to right: south to north)

Figures 3 to 7 indicate development progress across the operations as at 31 December 2022.

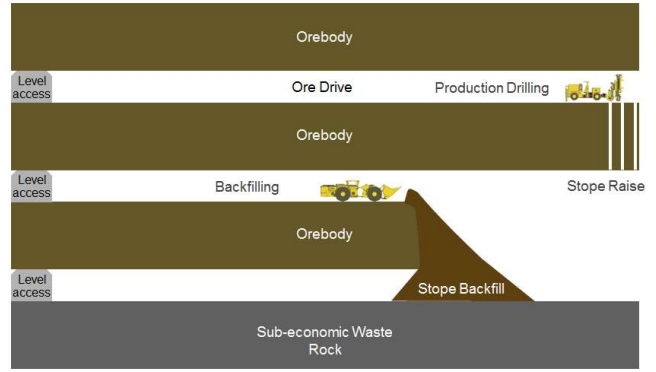
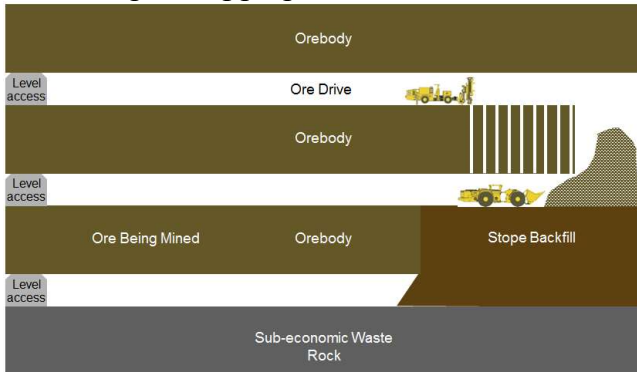
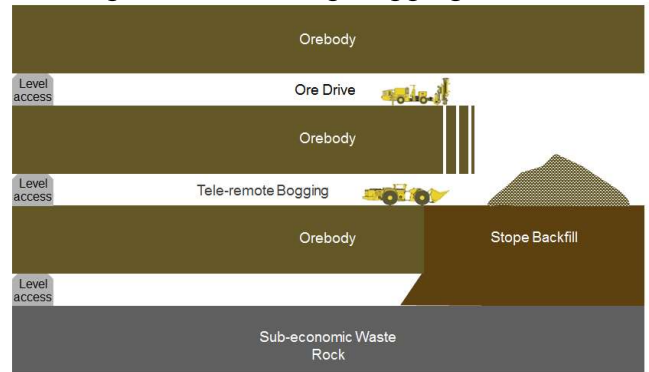
Schematic of Modified Avoca Technique

1 Drill drive access

2 Production drilling

3 Production blasting & bogging

4 Backfilling

5 Blasting & bogging over backfill

6 Progressive blasting/bogging

The stoping methodology is Modified Avoca (refer to Appendix A for a graphical representation). This method requires a 'bottom-up' mining technique, whereby each successively higher stope is mined out by driving on the surface of the previously laid backfill of underlying stopes. This technique also requires development firstly to the extremities of the ore body, then mining back towards the access points.
